**REPORT 5336**

**TITIRANGI NO.3 RESERVOIR  
GEOTECHNICAL REPORT**

**For: Watercare Services Ltd  
2 Nuffield Street  
Newmarket, AUCKLAND**

**By: Tower Foundations Ltd  
P O Box 20-294  
Glen Eden,  
Waitakere, 0641**

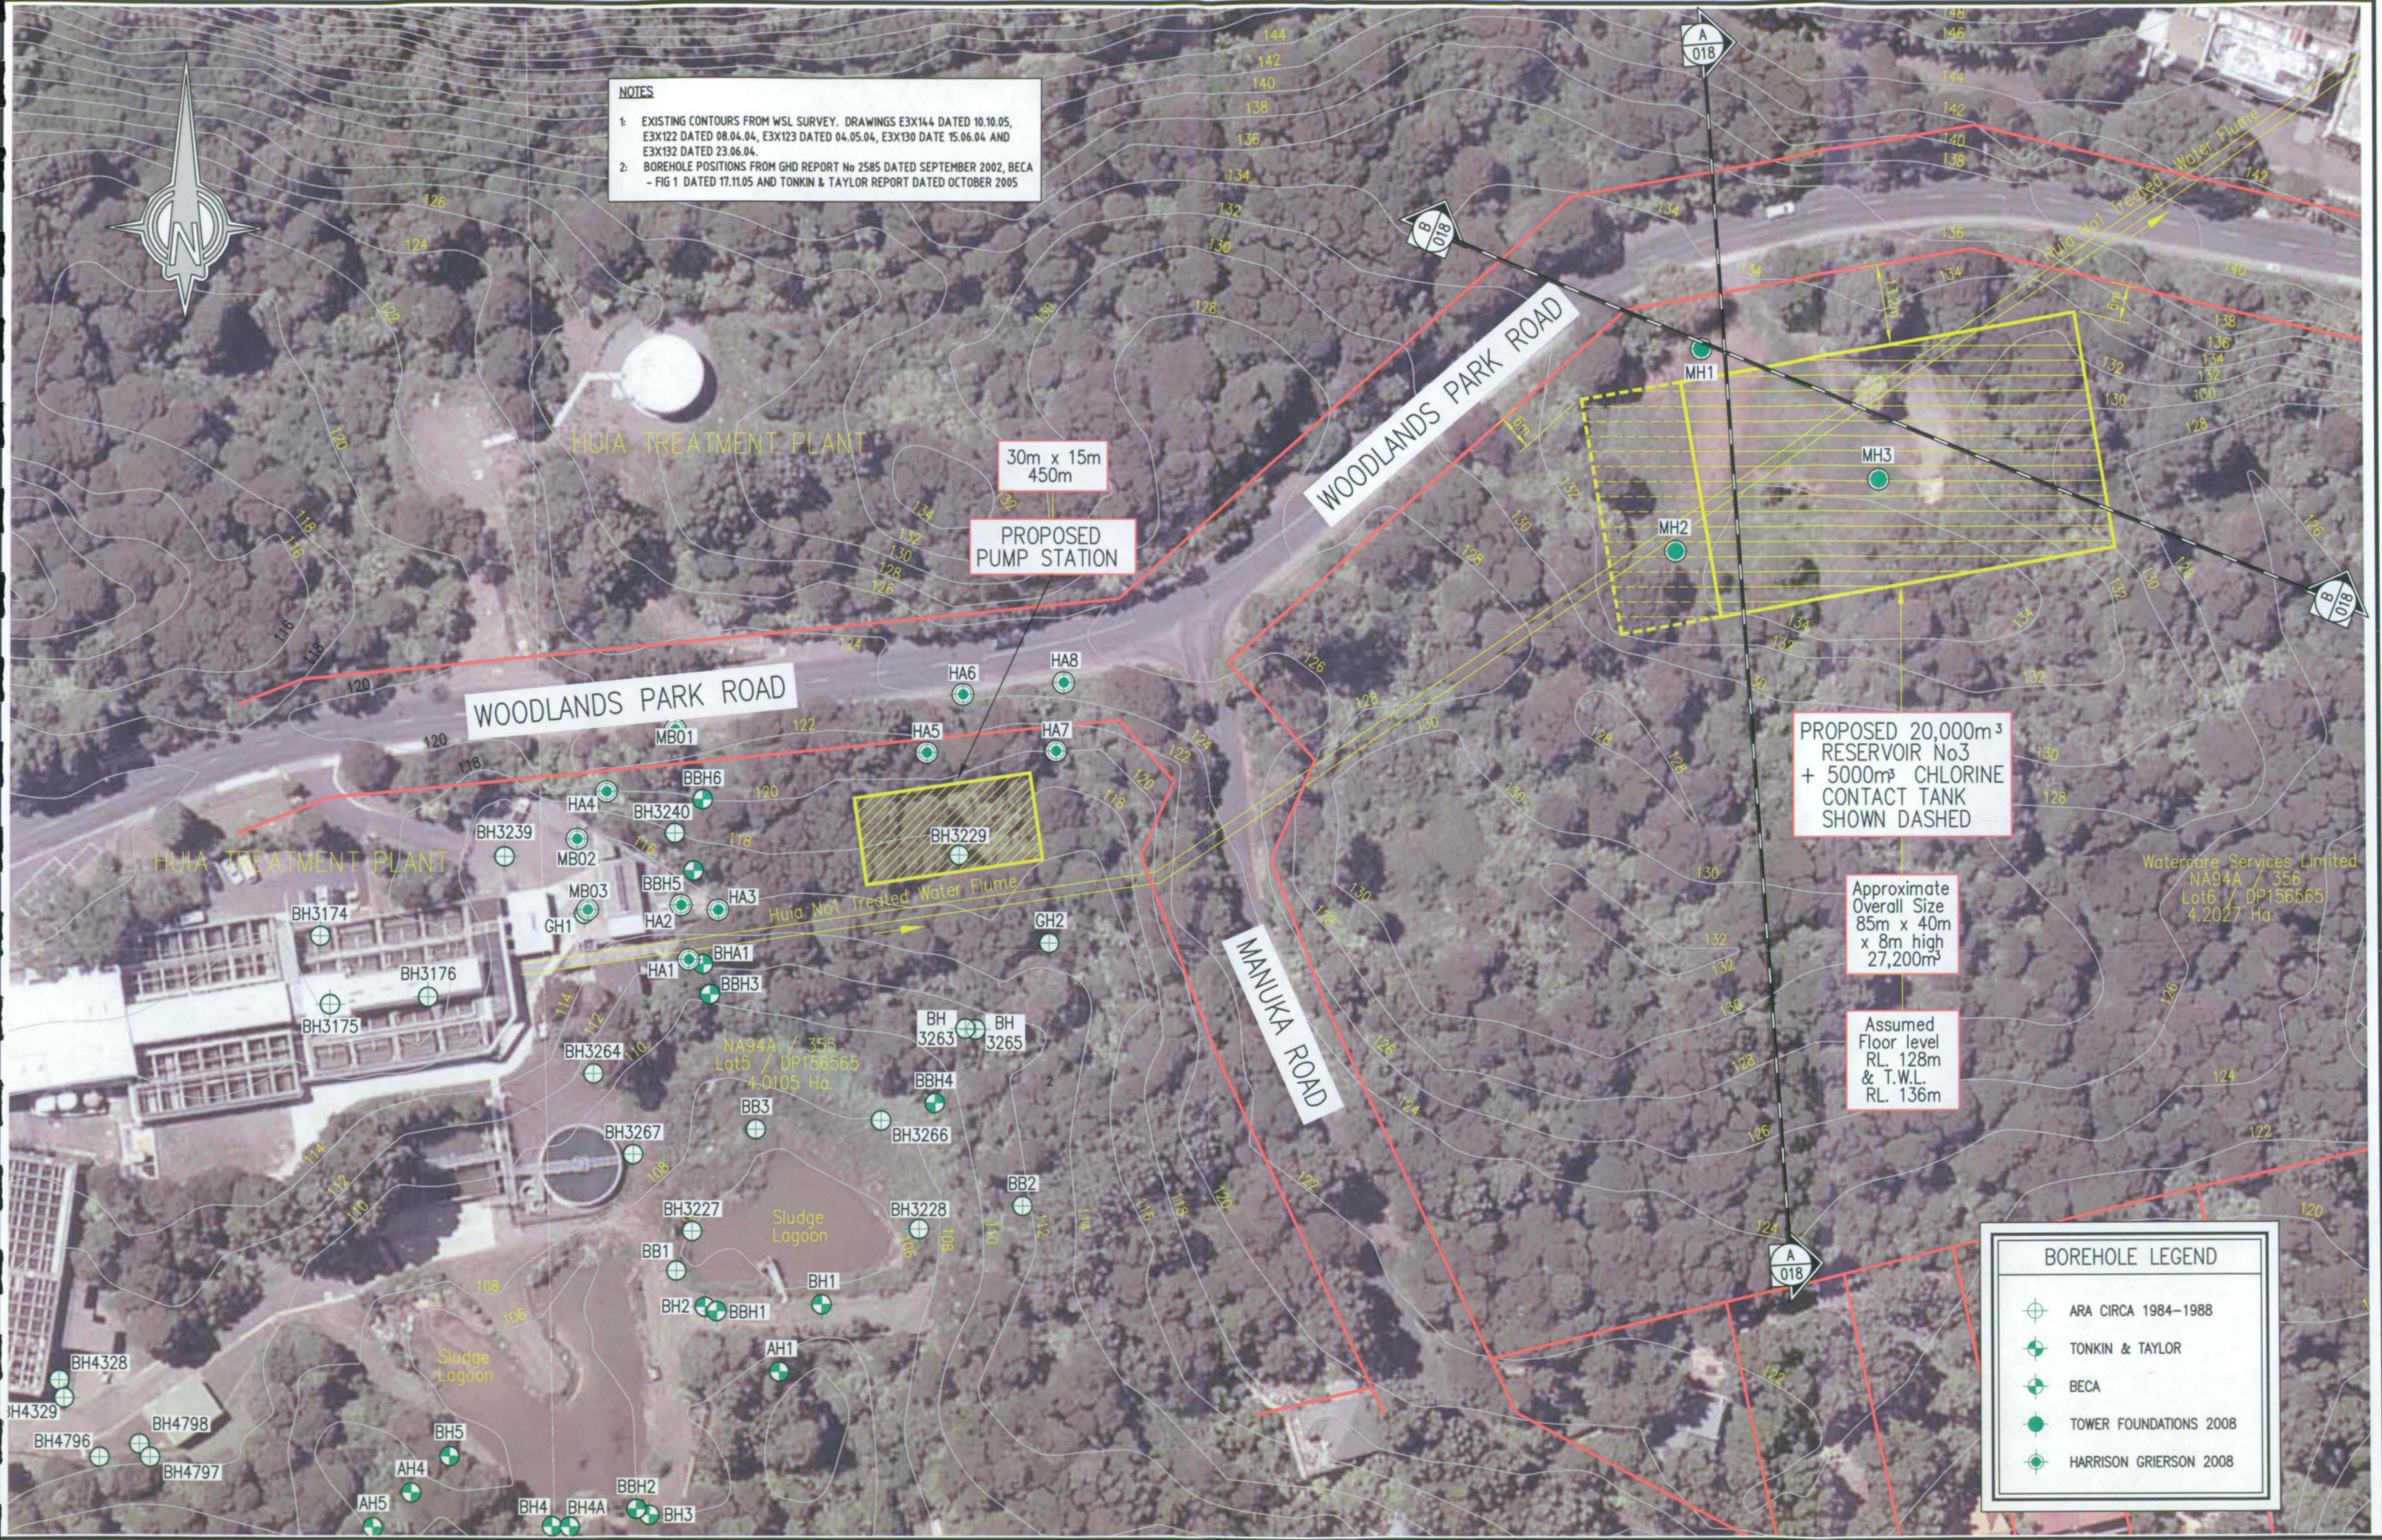
PROPOSED 20,000m<sup>3</sup> RESERVOIR No3 + 5000m<sup>3</sup> CHLORINE CONTACT TANK SHOWN DASHED

Approximate Overall Size 85m x 40m x 8m high 27,200m<sup>3</sup>

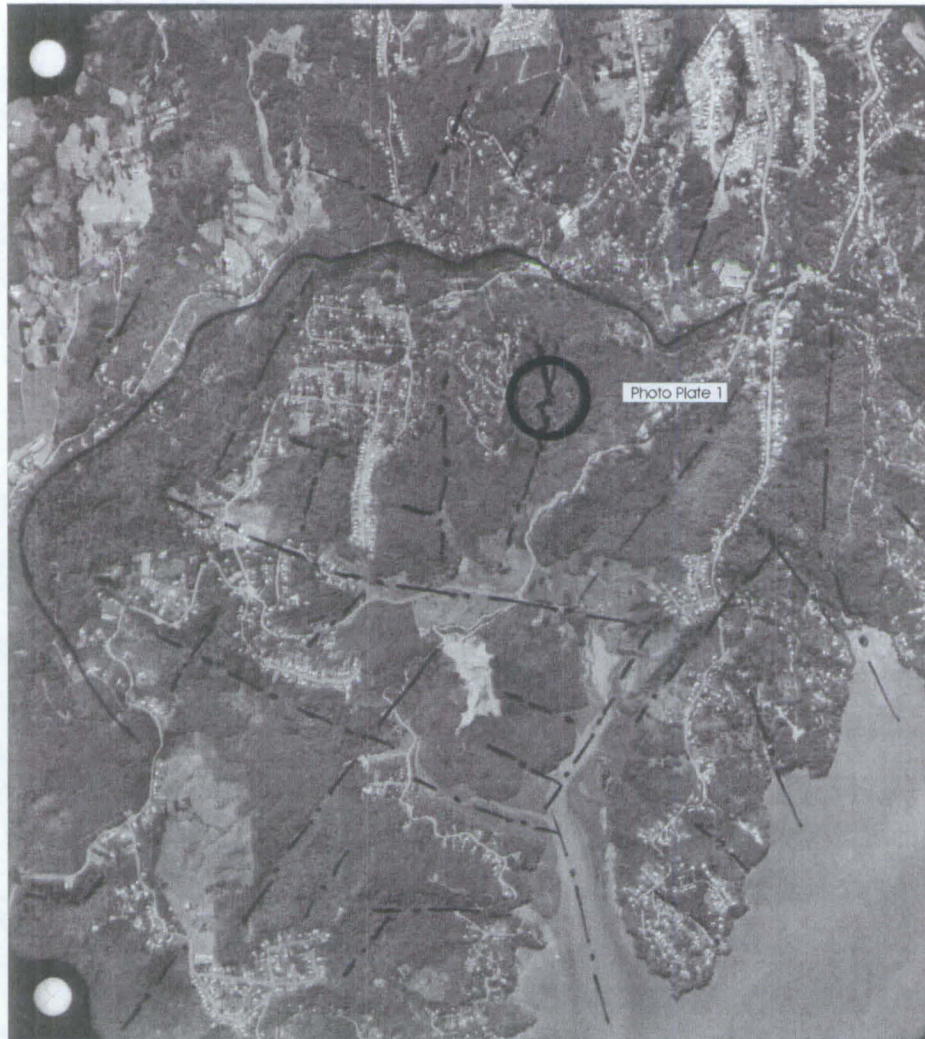
**Figure 2.** Lineaments showing drainage pattern of the catchment

**CLIENT:** Watercare Services Ltd  
**LOCATION:** Reservoir No 3  
**TITLE:** Lineament Study

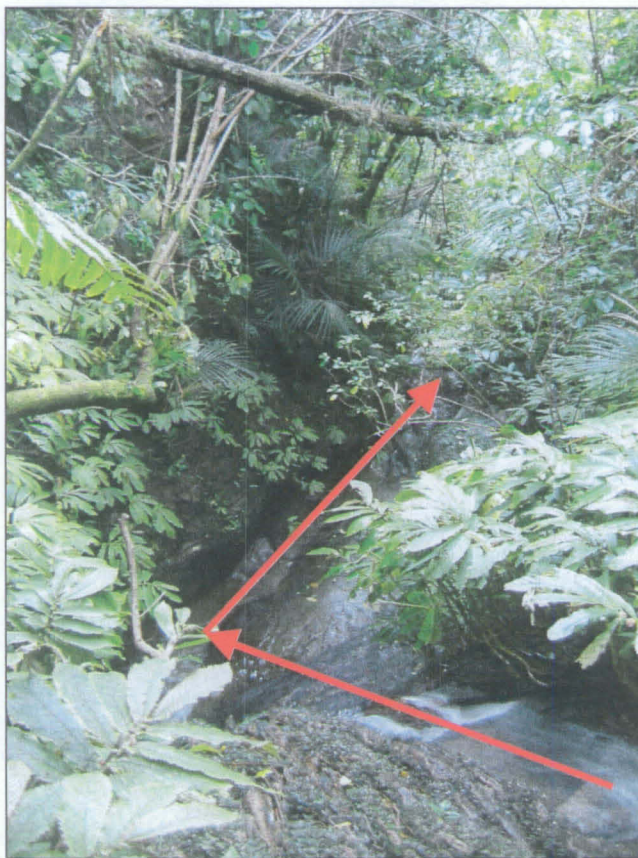
**Plate 1** – Stream following regional structure. (Note sharp right angles in stream alignment)

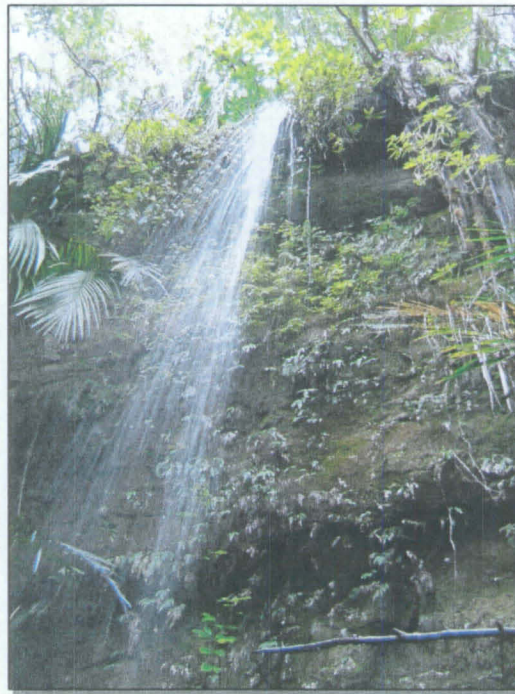
We would expect to see an inconsistency or large variations in bedding dip throughout the catchment if it had been subject to a massive landslide. Observations of the bluff and waterfall below Ngaio Road indicate that the rock belongs to the Cornwallis Formation. It is massively bedded and exhibits only minor fracturing with a north-west dip of approximately 5° (i.e into the bluff ) consistent with the regional dip. The rock mass does not show any evidence of having been subject to deep seated movement (ref **Plate 2**).

**Plate 2** Waterfall below Ngaio Road

These observations support Mansergh's theory of a valley-in-a-valley erosion feature as there is an unbroken sequence of rock from the older ECBF to the younger Cornwallis to the Nihotupu formations.

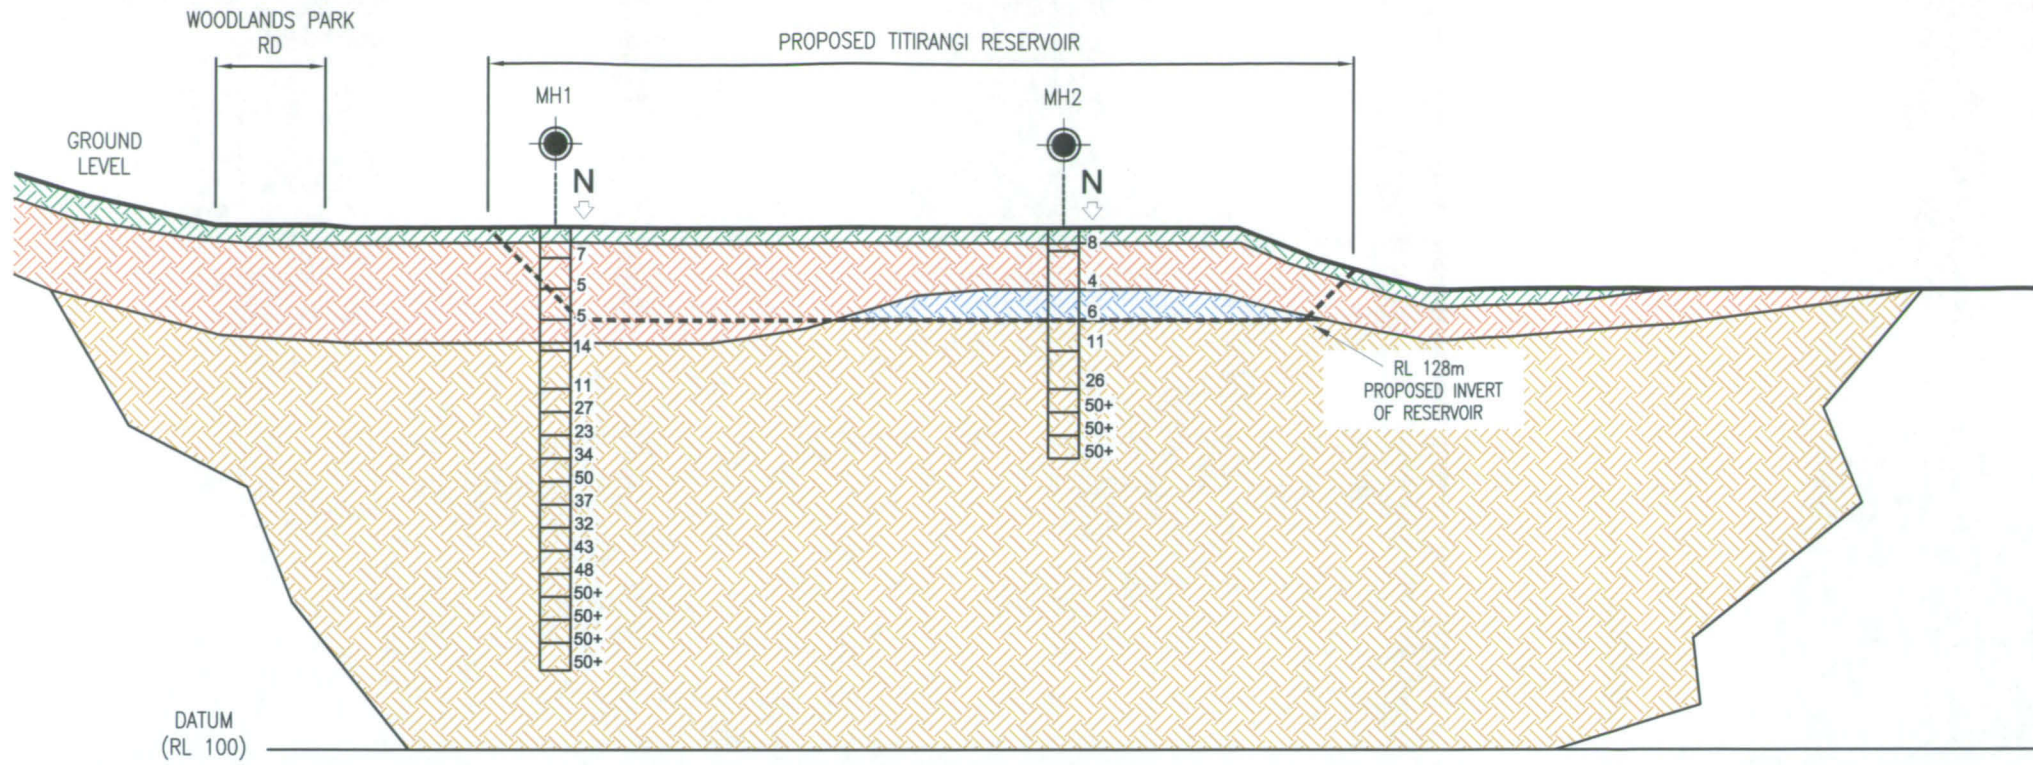
SECTION A  
SCALE 1:1000 (A3) 017

Geological Cross-sections A and B (Watercare Drawing 2005523.018) show the depth and distribution of the geological units with summary boreholes and SPT results for an indication of material strength. The proposed invert of the reservoir is shown on the cross-sections. **Figure 3** shows the profiles of SPT N-count versus mRL. It provides a good indication of the strength of the subsoils in relation to the proposed reservoir invert.

The geological cross-sections indicate that the reservoir will be founded on a thin layer of colluvial material overlying weathered Cornwallis sandstone. This material becomes less weathered or compressible within about 8m to 10m depth. These conditions are suitable for using a shallow raft foundation comprising a slab integrated with a grid of ground beams to distribute loads arising from minor differential settlements.

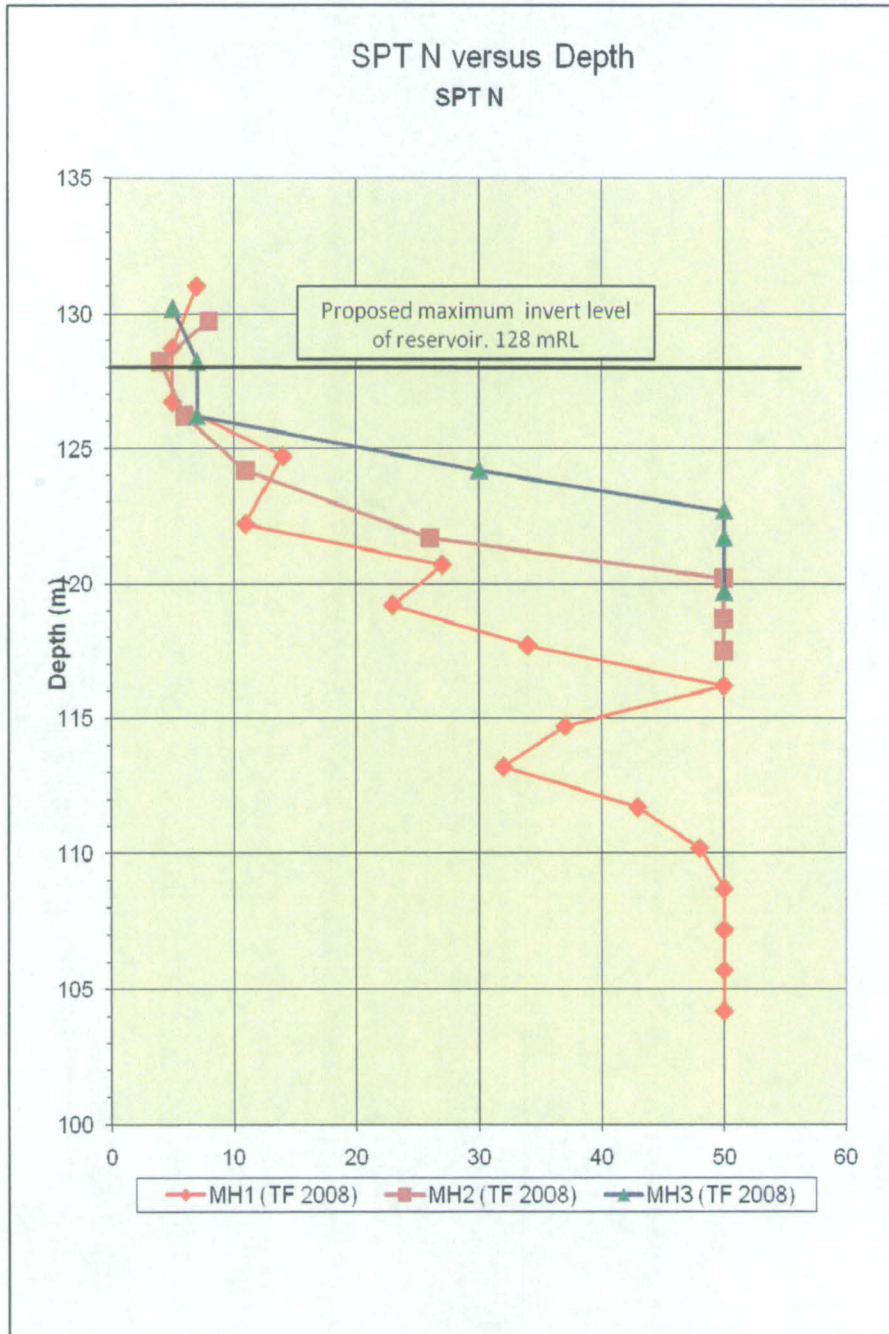
Figure 3 SPT N-count Profiles

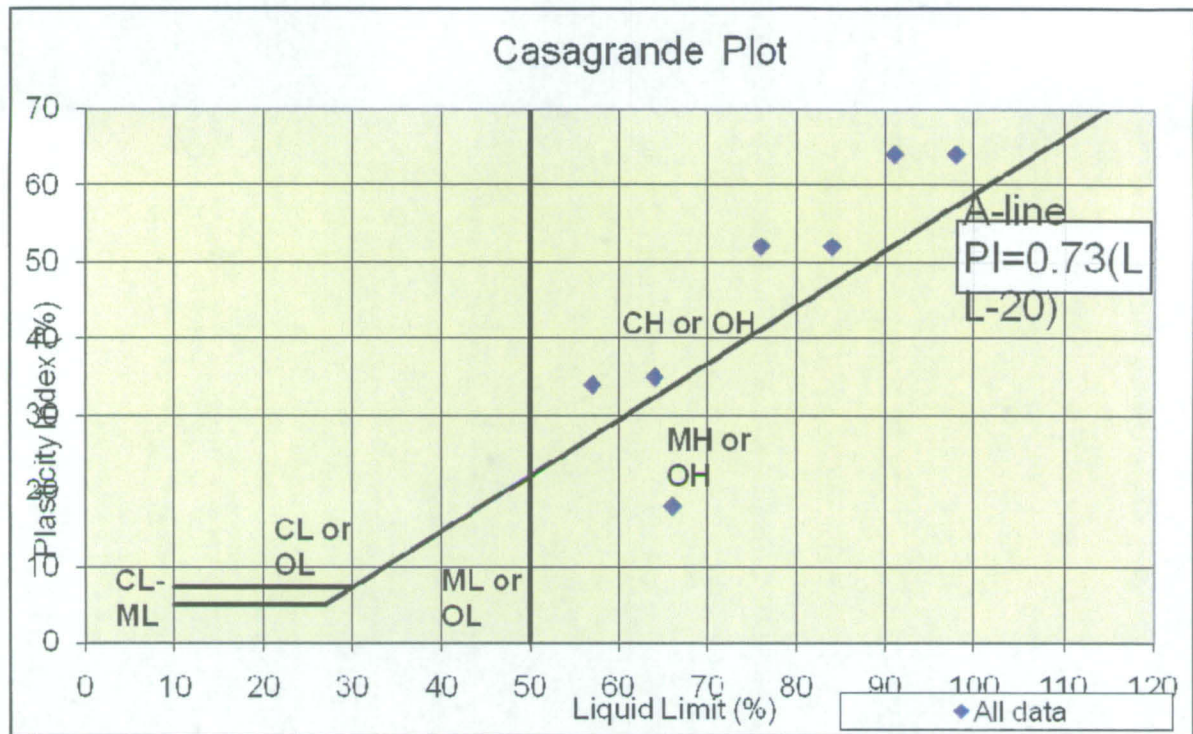
The Casagrande chart shown in **Figure 4** (extracted from the historical review of geotechnical information) shows the three test results from this investigation as well as historical test results. There is some uncertainty as to whether the historical test samples were from Colluvium or the weathered Cornwallis Formation. Given the similarity in composition of the Nihotupu and the Cornwallis formations the liquid and plastic limits (and consequently the plasticity index) would probably be similar, and for this exercise, the differentiation between the two is not necessary.

Figure 4: Casagrande Chart

Figure 4 shows quite variable plasticity materials from medium plasticity silts to high plasticity clays and reflects the variability of the parent material (coarse sandstone to siltstone). The chart indicates that the weathered materials exhibit plastic behaviour over a fairly large range of water contents (18% to 65%) and can sustain fairly high water contents before changing phase to the liquid state.

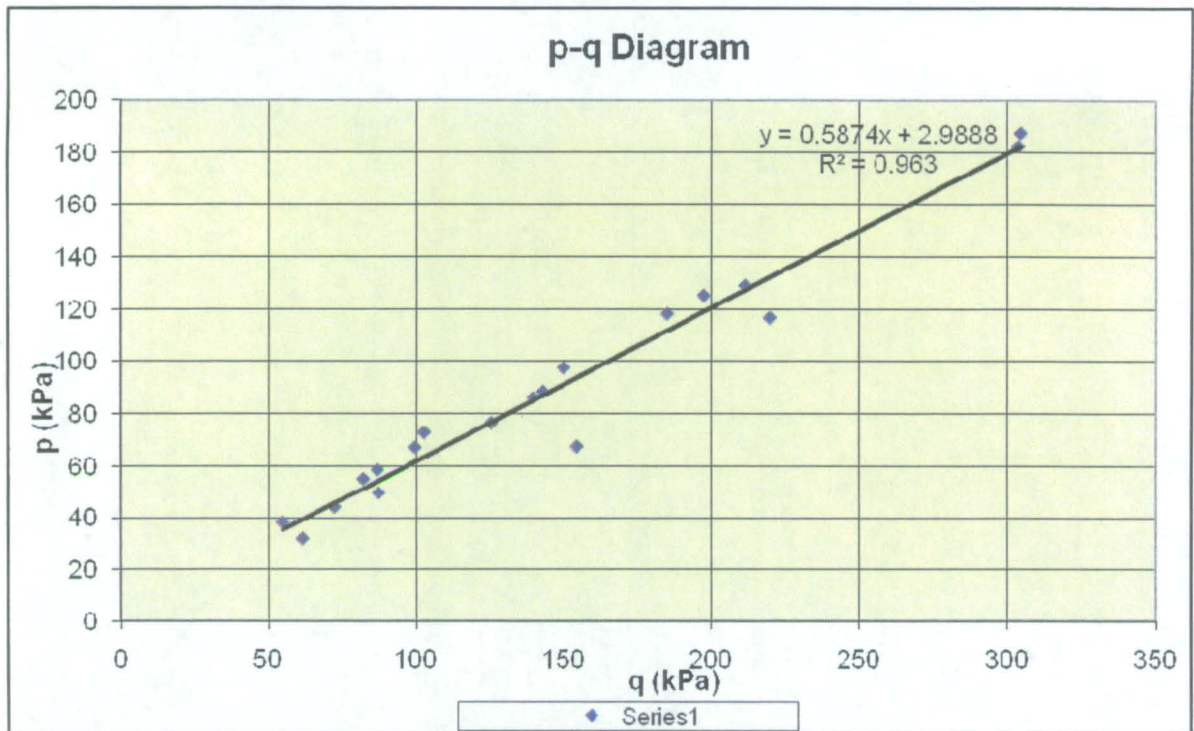
These tests, combined with the historical data provides a total of 18 consolidated-undrained triaxial tests carried out on materials from the upper on 7m of the ground profile. The major and minor stresses at failure have been used to develop the p-q plot shown in **Figure 5**. The results show a definite trend with high correlation to the best fit linear regression line shown.

Figure 5: p-q plot of triaxial test results.

The slope and intersection of the best-fit line from the p-q plot has been transformed to the effective strength failure envelope (tangent to the mohrs circles) by the following formulae:

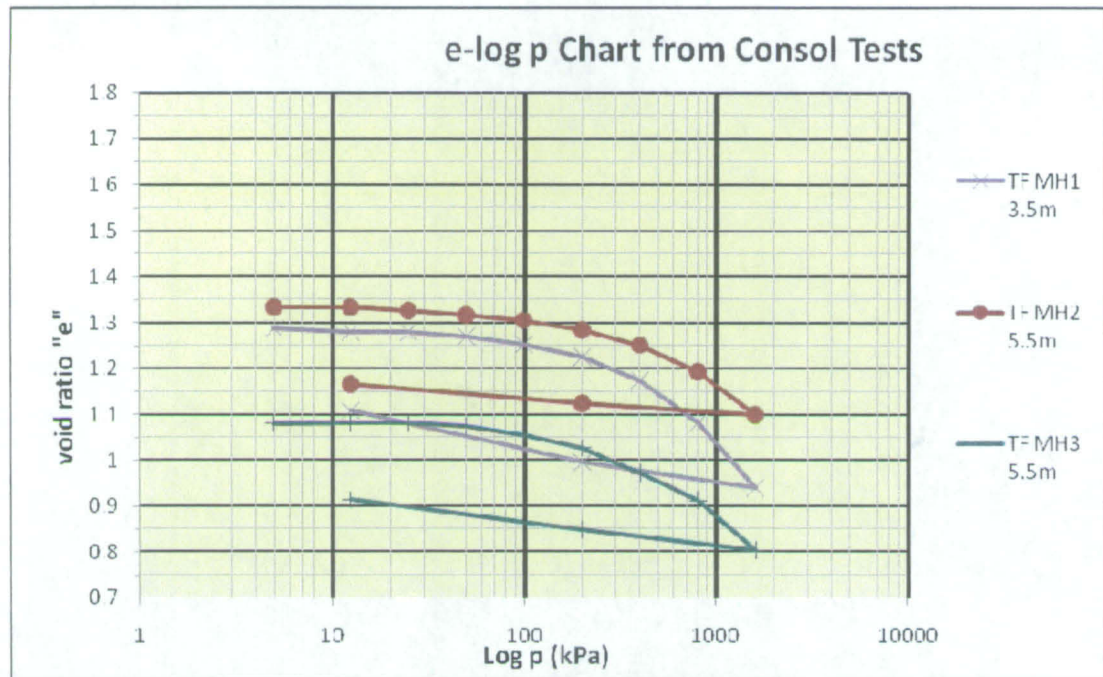
Three one-dimensional consolidation tests have been carried out on the weakest colluvial materials recovered from the investigation.

**Figure 6:** e-log p plot of consolidation test results.

Figure 6 shows relatively consistent consolidation curves for all three samples. There is some variation in the magnitude of the void ratio although the rate of change of the void ratio is very consistent. One point to note is that there is no distinct pre-consolidation point which is expected given that the materials are disturbed residual soils.

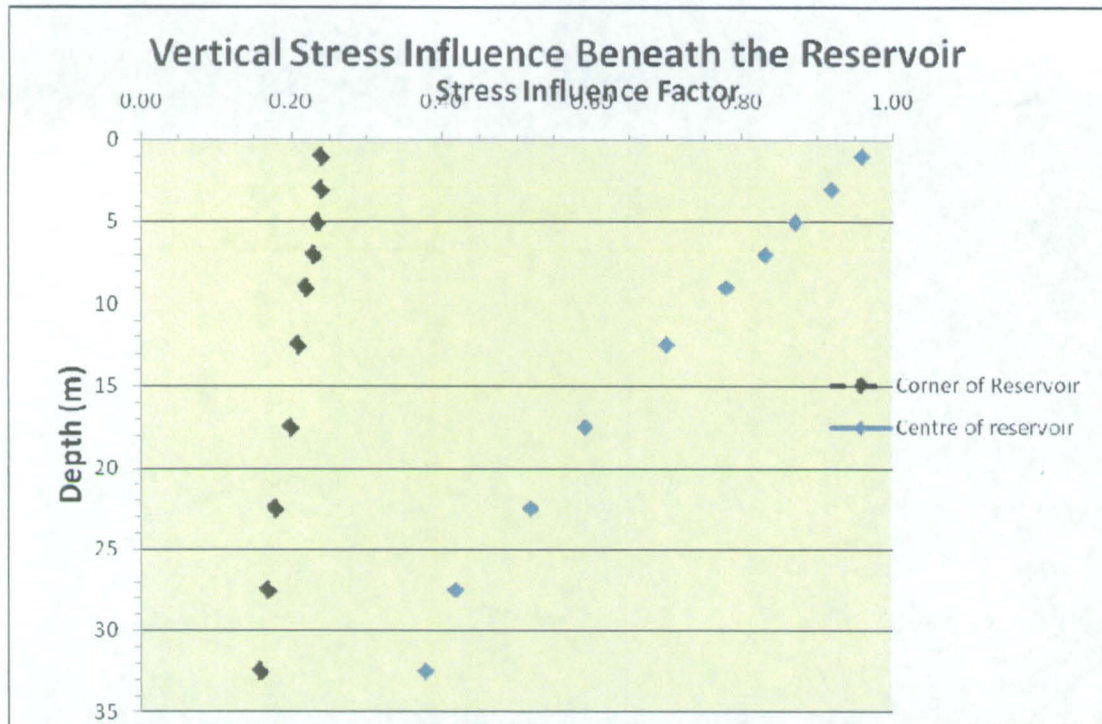
The vertical stresses beneath each of the above critical points have been estimated by Westergard's stress distribution for a uniformly loaded rectangular area on an elastic half-space. The influence curves are attached in **Appendix E**. The resulting profiles of vertical stress influence are shown in **Figure 8**. The profiles show the difference in the vertical stress distribution between the corner and the centre of the tank.

**Figure 8** Vertical Stress profiles beneath the reservoir.

A uniform load of 90kPa has been applied to the stress influence profiles in **Figure 8** to represent a reservoir of approximately 8m height. The resulting stress distributions have been used in the calculation of settlement.

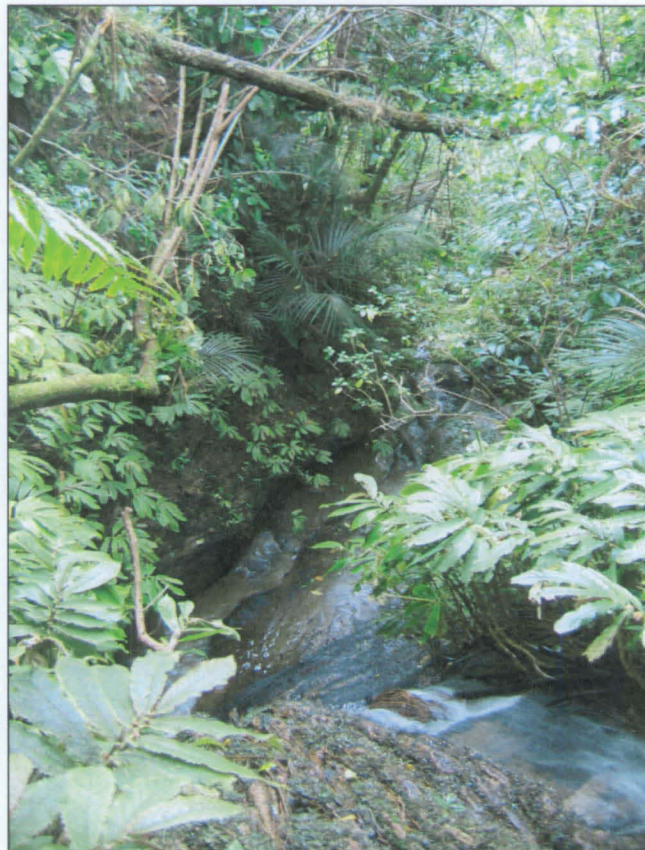
Photo Plate 1 – Stream following regional structure  
(Note sharp right angles in stream alignment)

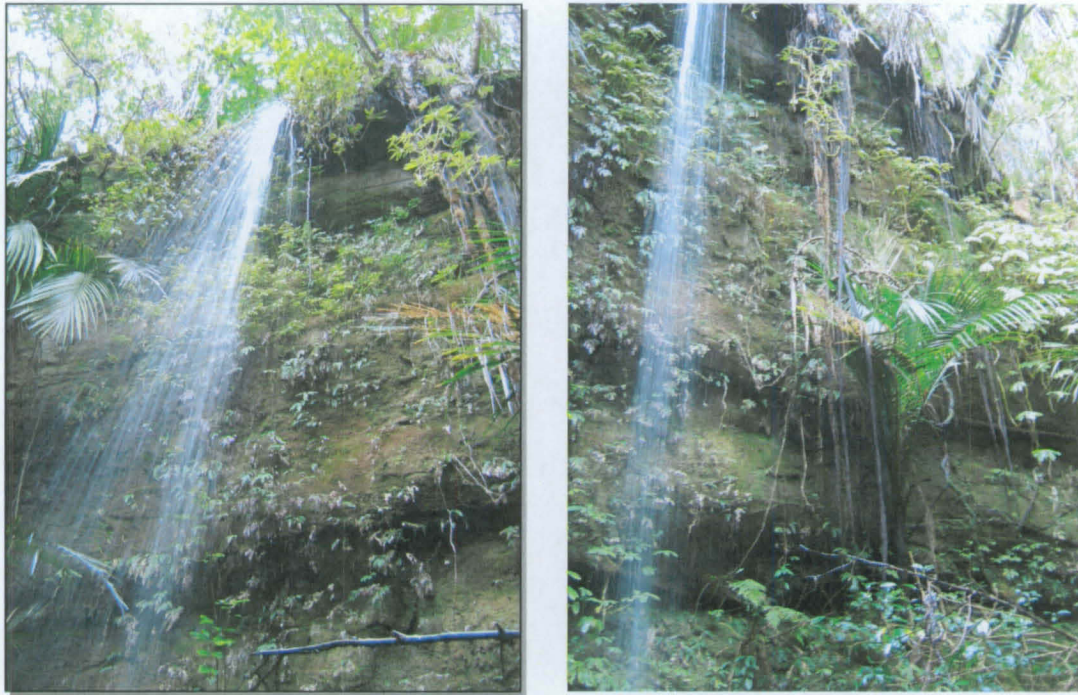
Photo Plate 2 – Bluff/Cliff below Ngaio Road  
(note massive un-fractured nature of the Cornwallis Formation)

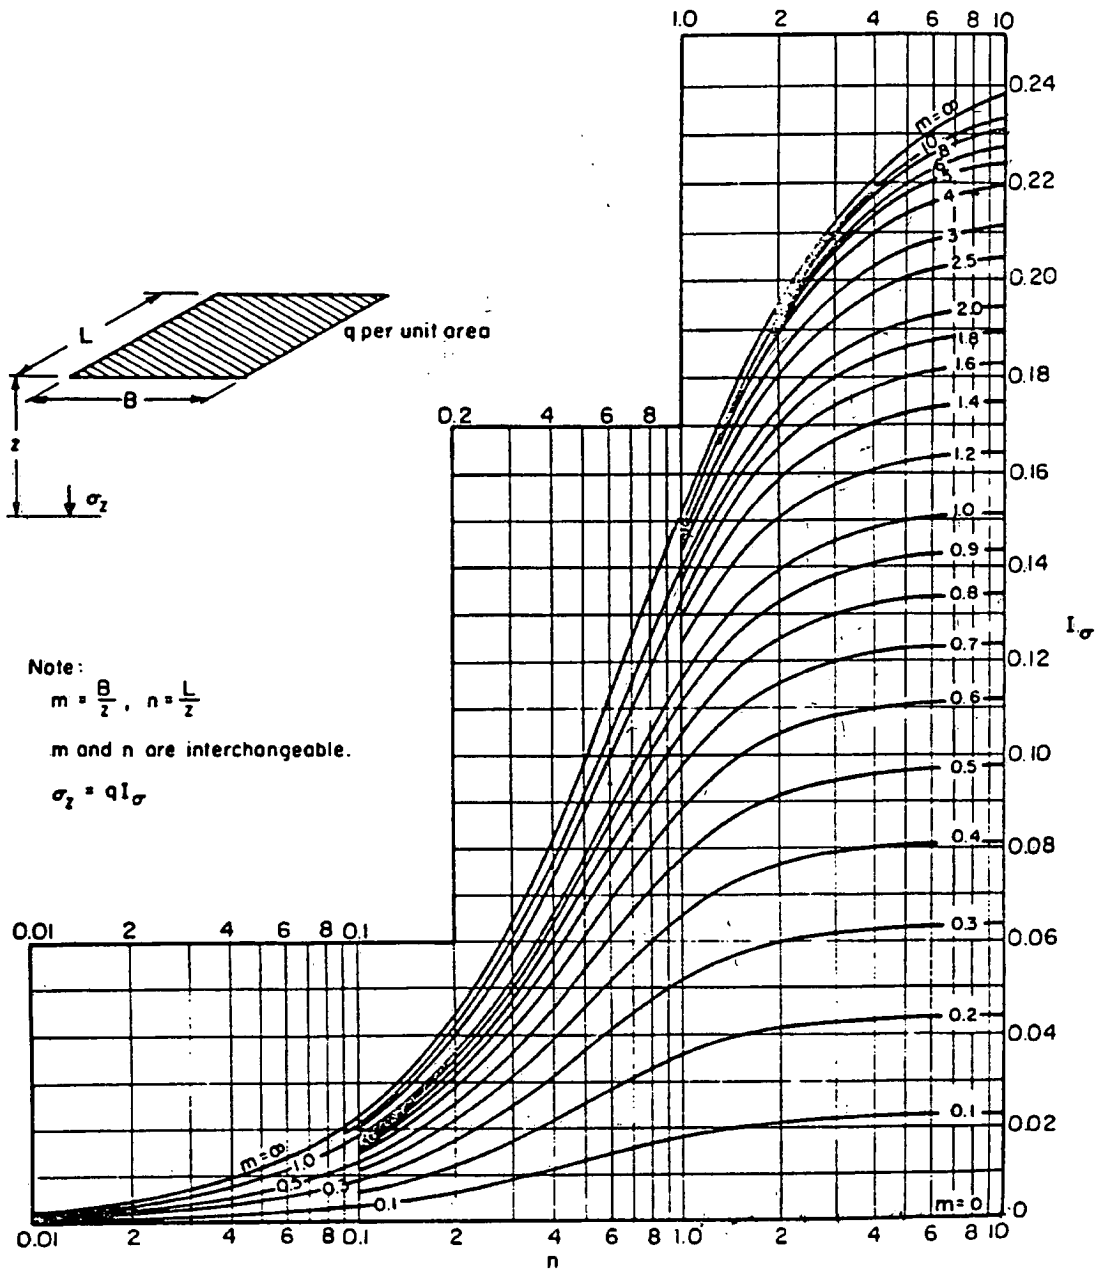
Figure C-3. Influence Factor  $I_\sigma$  for the increase in vertical stress beneath a corner of a uniformly loaded rectangular area for the Westergaard stress distribution (from NAVFAC DM 7.1)
