Watercare Services Limited

Huia Filter Station

Geotechnical Risk Assessment

September 2002

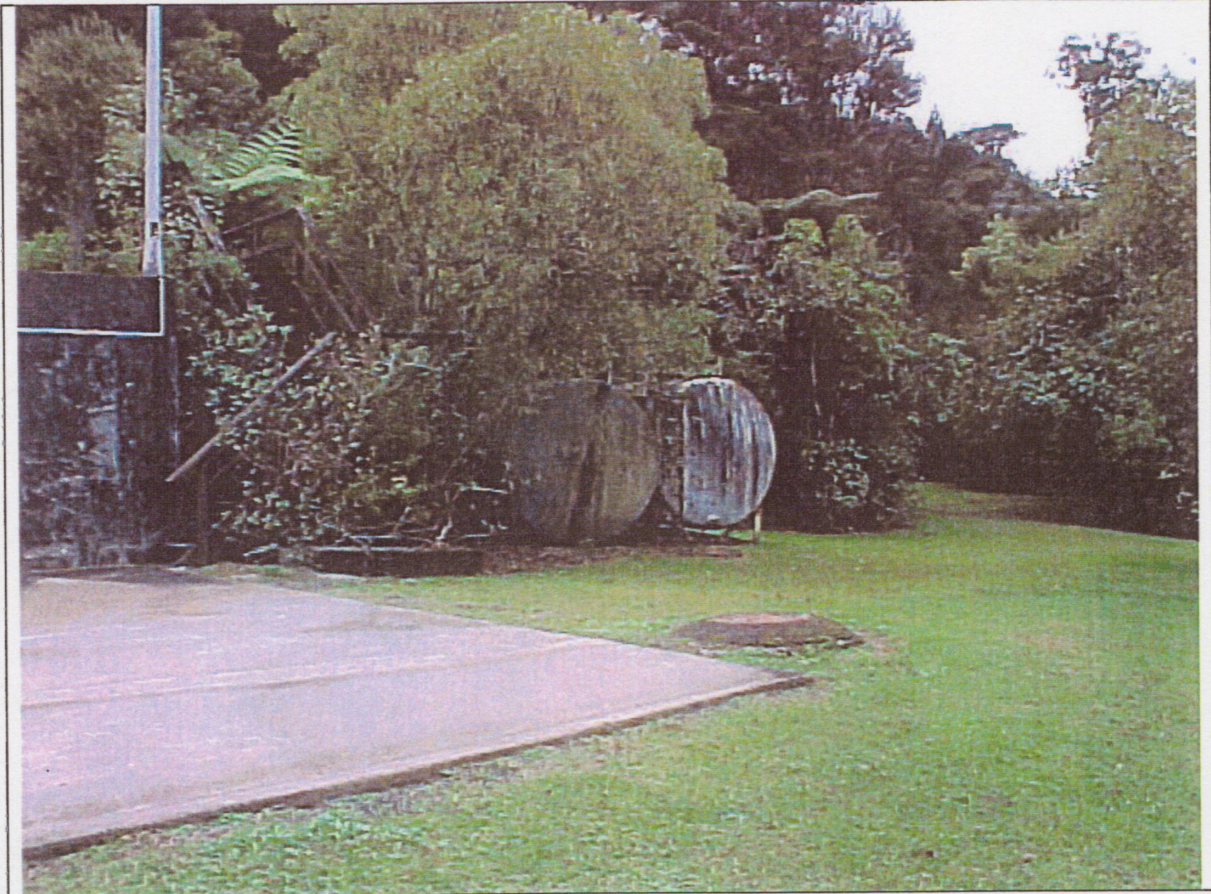
Proposed Location for Sludge Thickener, adjacent to existing Wash Water Tanks

It is likely that the sludge thickener structure will be excavated to below the level of existing fill/clay layer, identified on the available borelogs, with likely founding onto the recent colluvium/alluvium layer. Depending on the clay and sand content of this material this layer may be subject to immediate and consolidation settlement. The absence of organic rich soils (except for some thin layers of peat found in the western side of the site) negates the risk of long-term creep settlement. In addition, none of the other nearby water retaining structures show any obvious signs of settlement. It is likely therefore that settlements will be within tolerable limits and that piling will not be required.

No obvious signs of large-scale instability were noted near the proposed site for the sludge thickener. Soil creep is likely on slopes steeper than $\sim 25^\circ$. All structural design should ignore passive lateral support provided by the surrounding downslope soil.

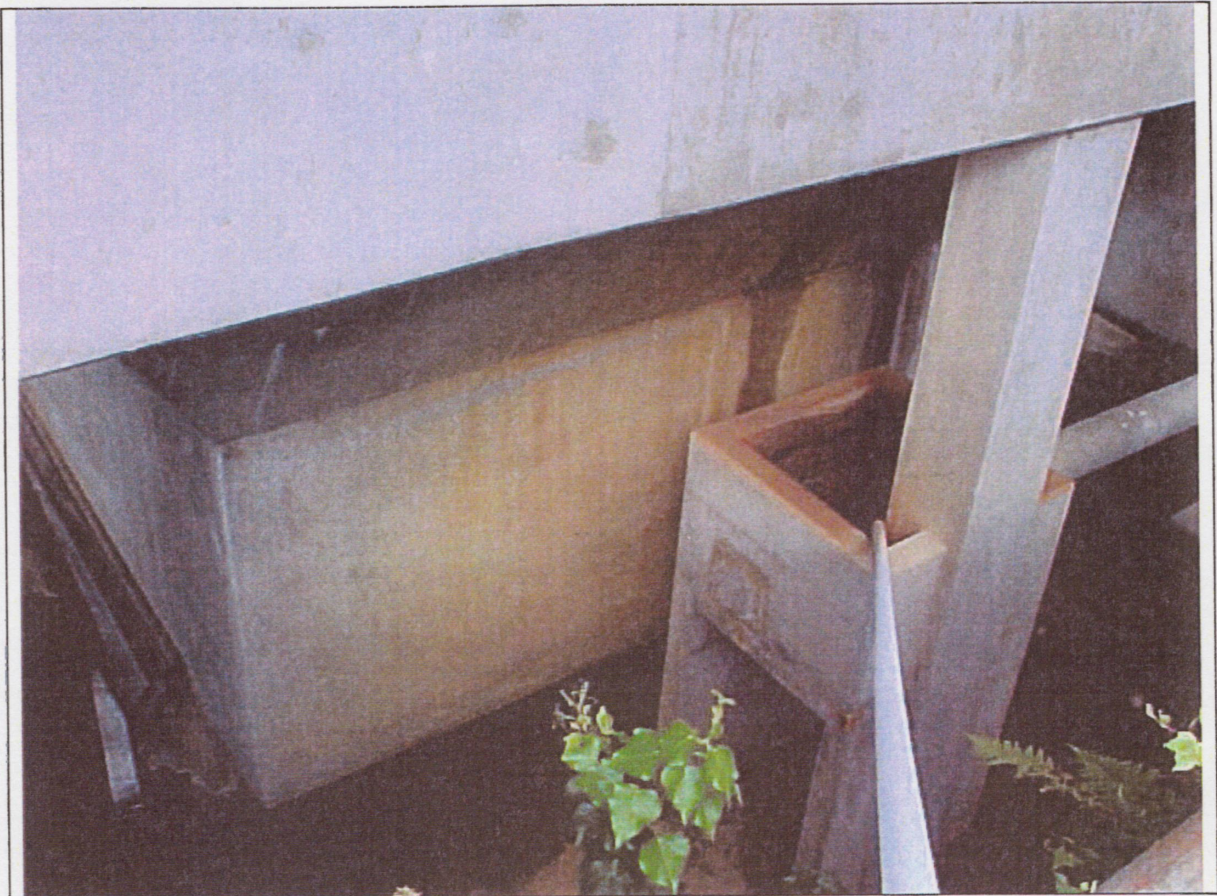
Proposed Location for Filter to Waste Tank below existing Clarifiers

As discussed above it is proposed to construct a filter to waste tank underneath the existing clarifier tanks. The proposed tanks are expected to be approximately 2m in height. The additional loading is therefore expected to be in the order of 20kPa. The existing clarifier tanks are supported on shallow foundations consisting of slabs supported by outer beams. The clarifiers are separated into four separate slab structures. This is likely to limit differential stresses and cracking of the slab caused by differential settlements. From the design drawing the beams are approximately 580mm thick and the slab approximately 200mm thick.

No details on how the beams and floor slab were constructed. If fill was placed under the floor slab, settlement of this material may have resulted in minor voids to have occurred between the bottom of the floor slab and the material below. Additional loading to the floor slab may therefore cause additional stress to be transferred to the slab without sufficient support from the material below. This should therefore be checked during detailed investigations of the site.

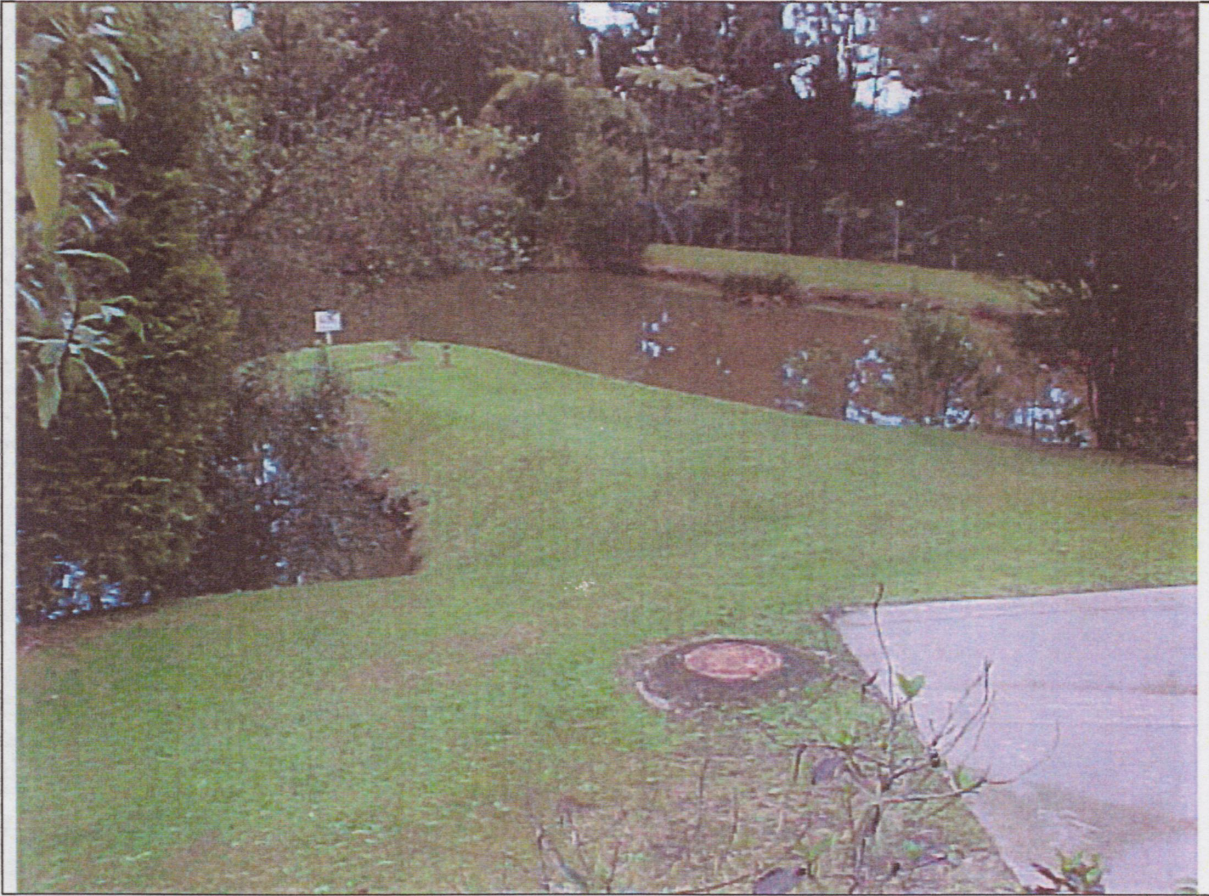
Existing Lagoons south of Proposed Location for Sludge Thickener

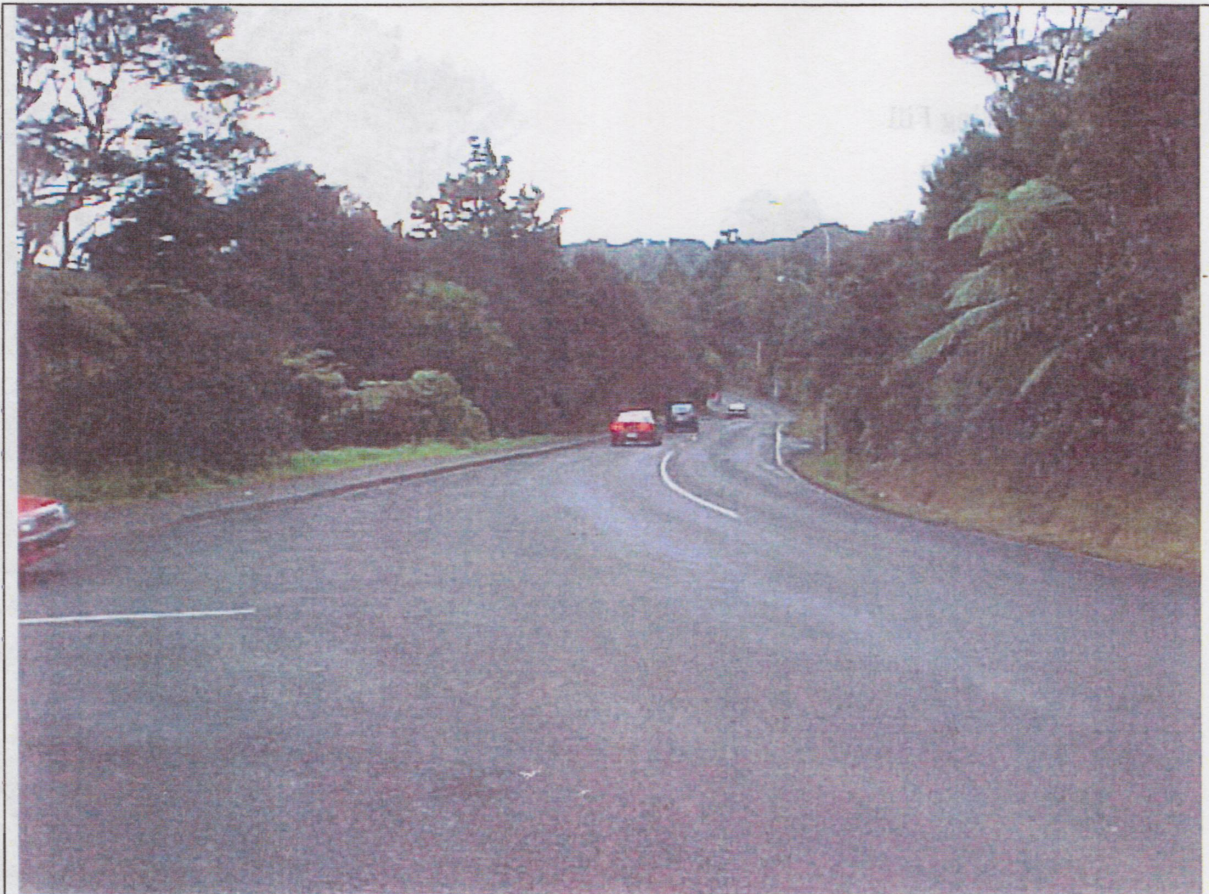
The road along this route is generally constructed by cut of the upslope hillside and sideling fill of the downslope side. At approximately the intersection of Manuka Road, Waima Road crosses over an old gully and both sides of the road are built by a fill embankment approximately 2m in height.

Looking West along Waima Road at intersection of Manaku Road

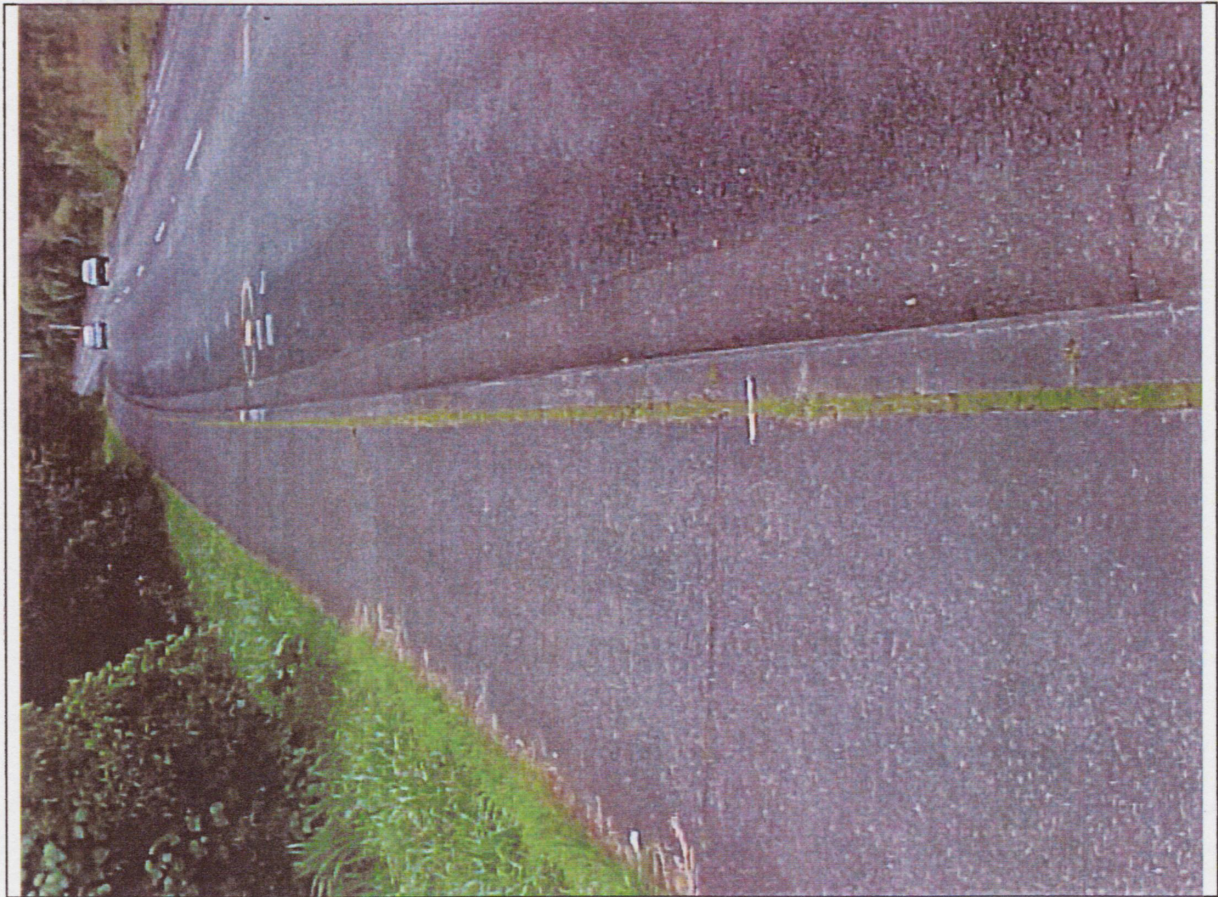
Numerous minor sideling fill failures were noted along the southern side of Waima Road between the filter station and the Nihotupu Reservoir. None of these had caused any noticeable distress to the road surface except for one near the intersection of Scenic Drive, where some recent patching of the road surface is likely as a result of a slightly larger sideling fill failure. The sideling fill failures are likely as a result of poor compaction and over steep slopes.

Looking West along Waima Road – showing minor sideling fill movement

It is recommended that test pits be excavated at 100m intervals along the northern side of the road with scala penetrometers and shear strength tests undertaken at regular depth intervals.

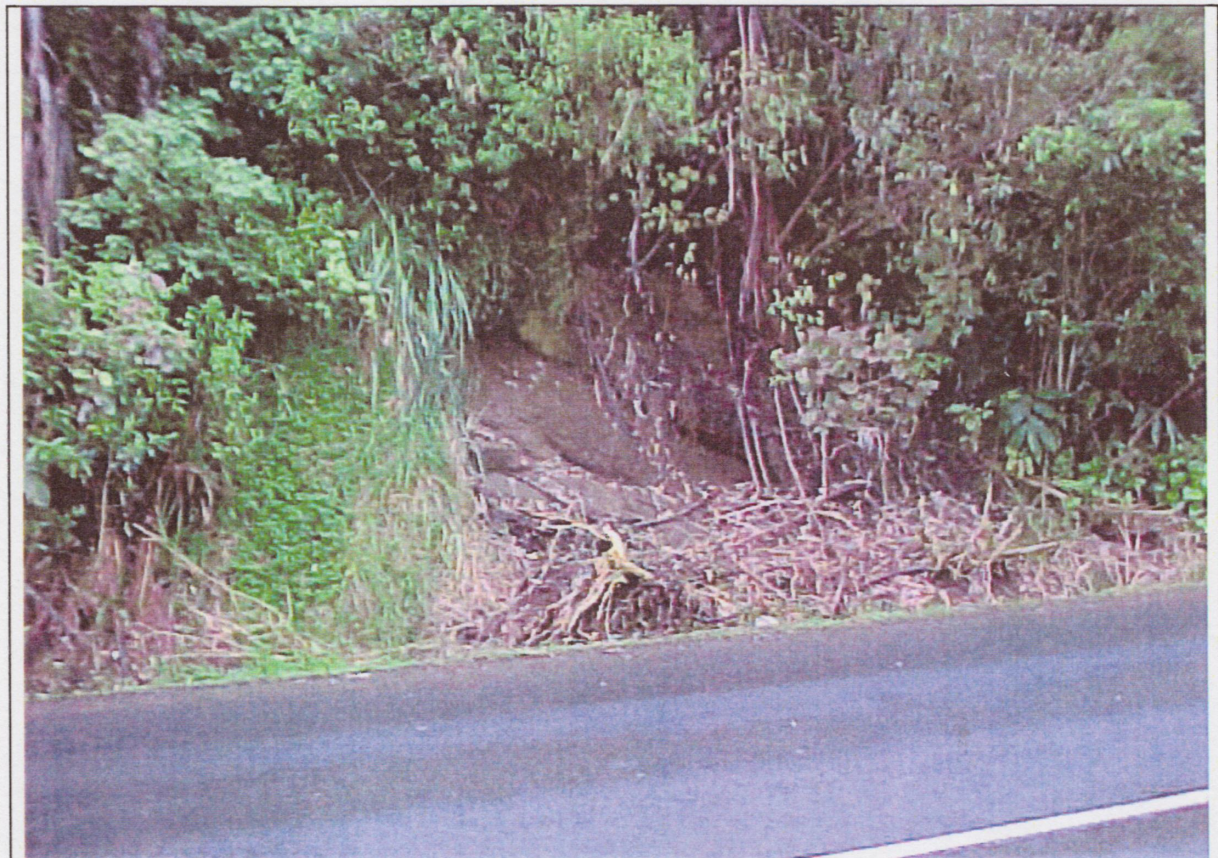
An outcrop of sandstone was noted on the northern side of Waima Road, near the intersection with Scenic Drive.

The northern side of Waima Road near Nihotupu Filter Station – showing exposed sandstone

The general impression from the site walkover was that the most stable position for a proposed pipeline would be along the northern side of Waima Road.
