Woodlands Park Road Reservoirs

Geotechnical Factual Report

GS13/424

Date: 13th December 2013
Reference: GS13/424 / 1-C0935.25
Status: Final

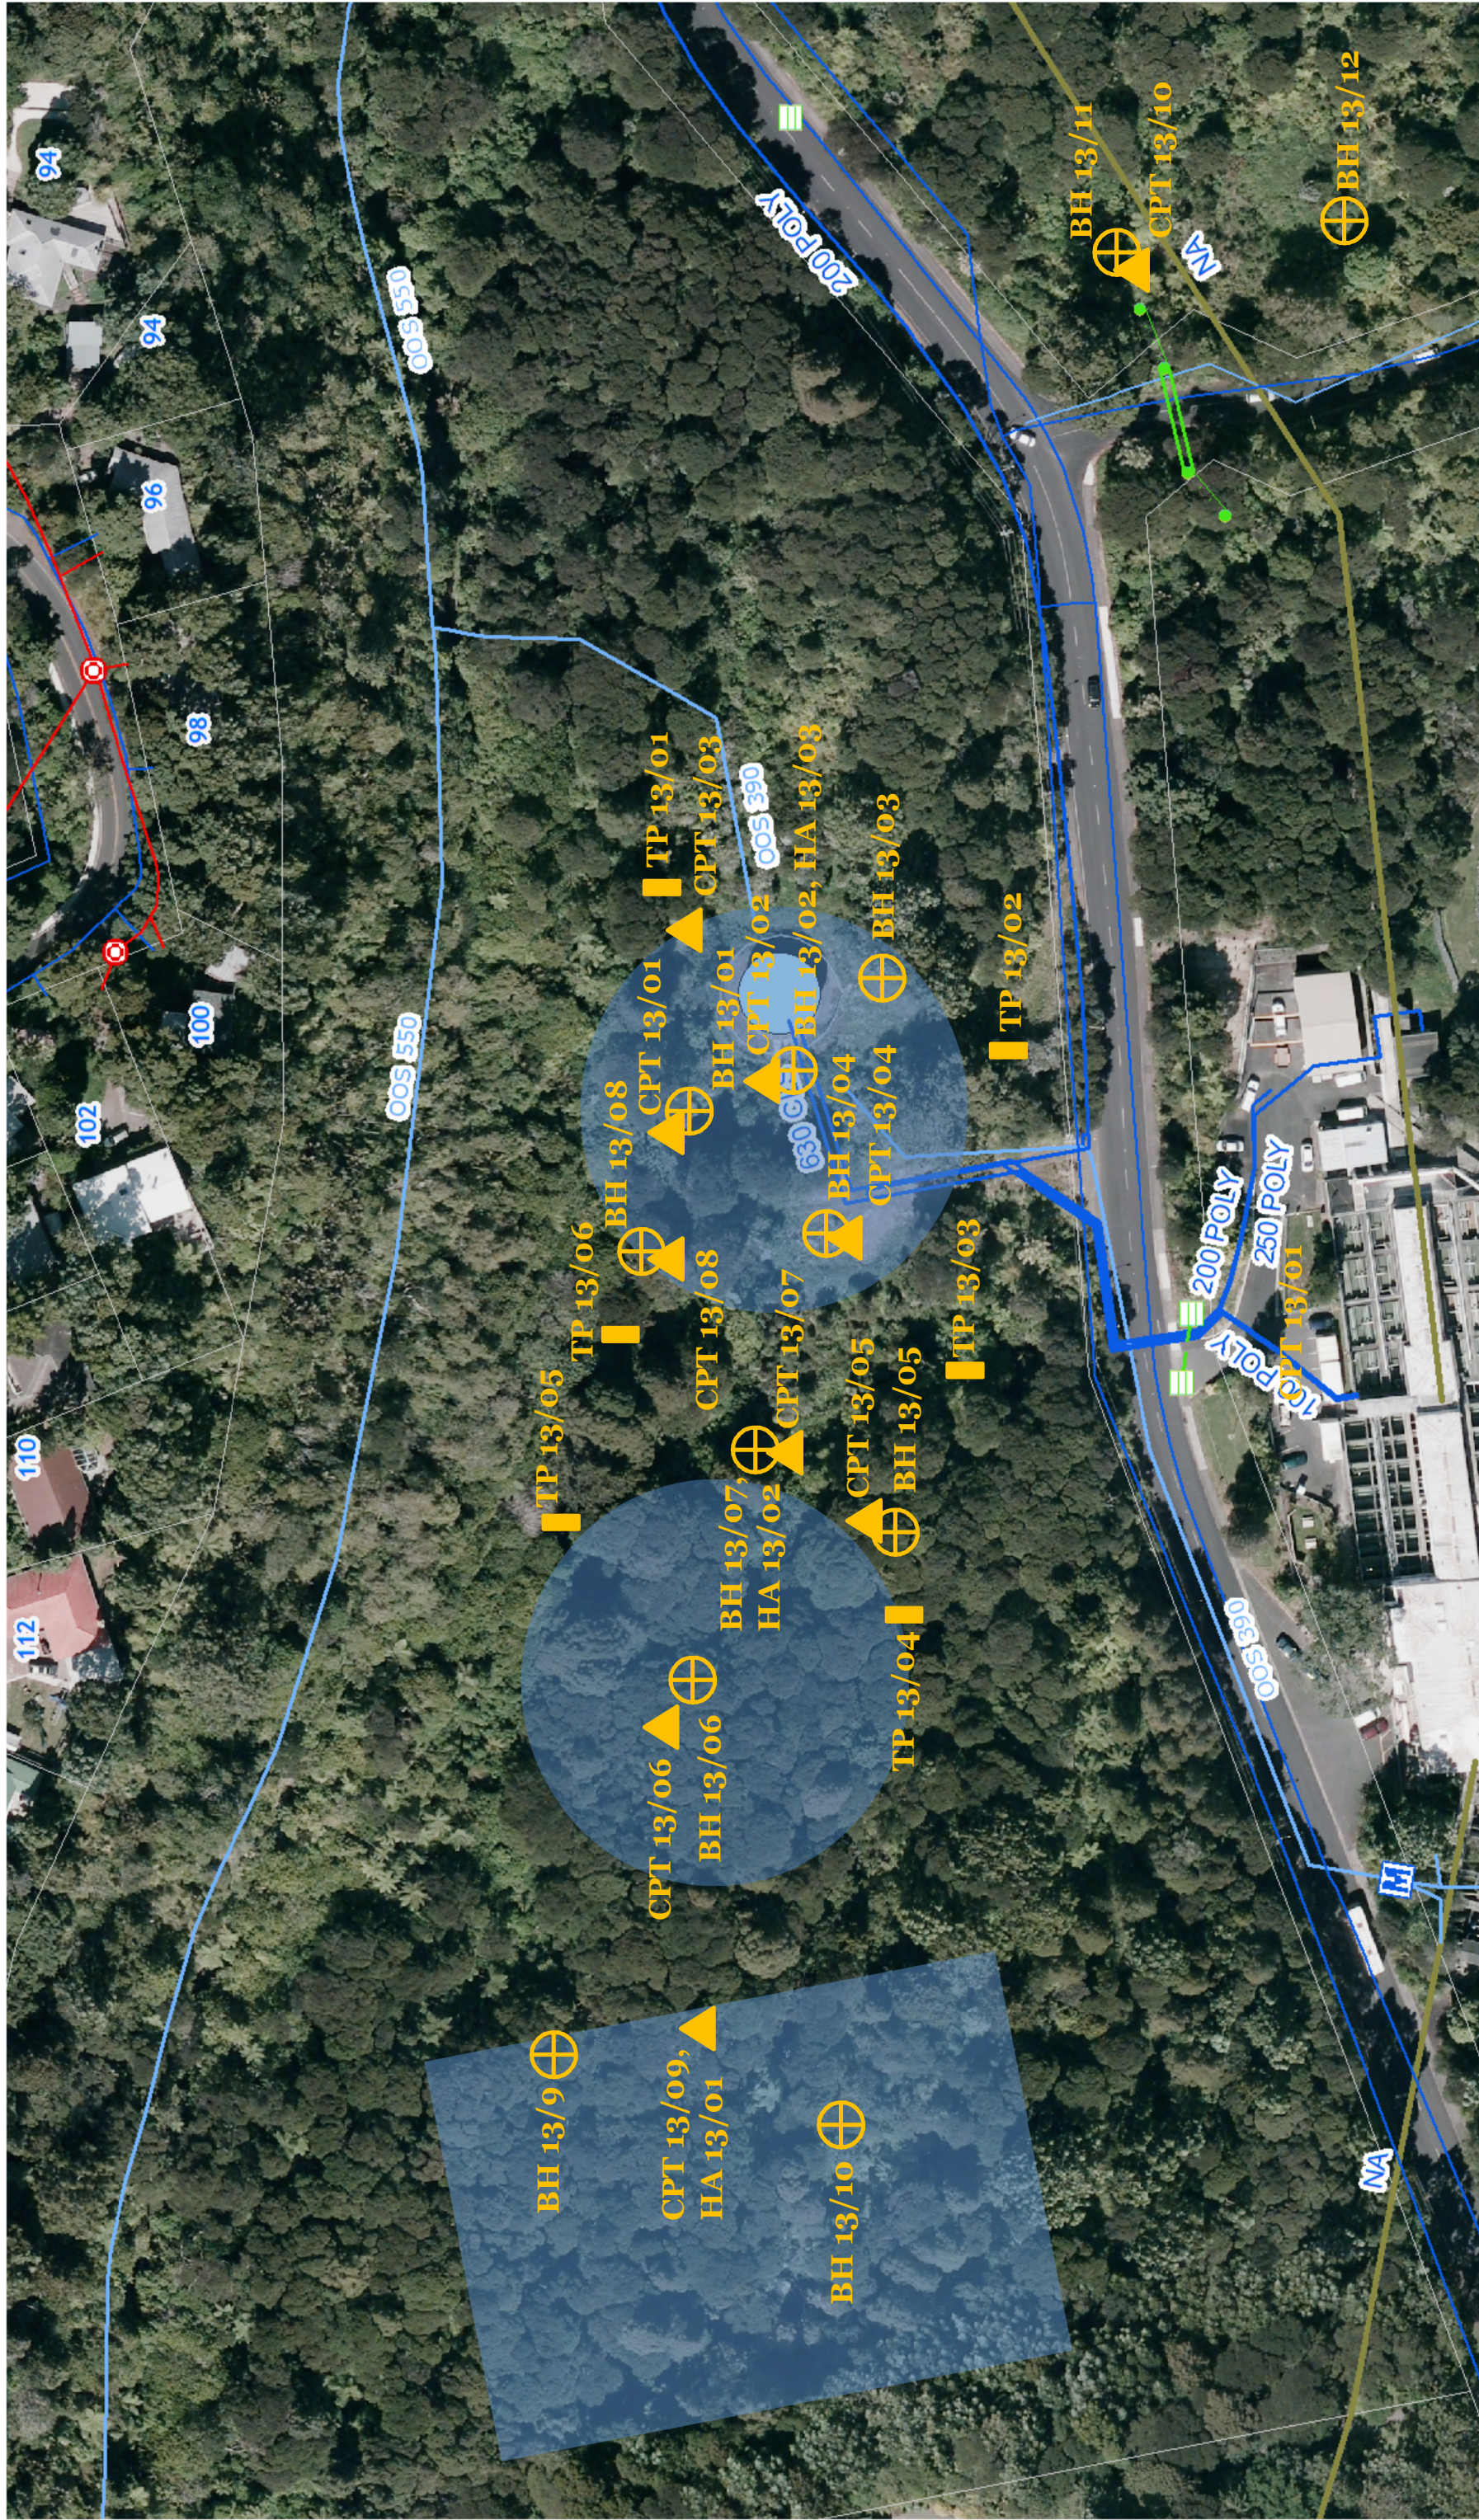
Appendix A
Geotechnical Site Plan

Manuka Road Reservoirs- Proposed Investigations
 (Revision 2: CPT added at rectangular tank site, BH13/12 moved south)

Key
 BH = Borehole (nominally 15 m deep, except BH 13/08 at 30 m)
 CPT = Cone penetration test (to refusal)
 TP = Trial pit (2 m to 4 m deep depending on requirements)

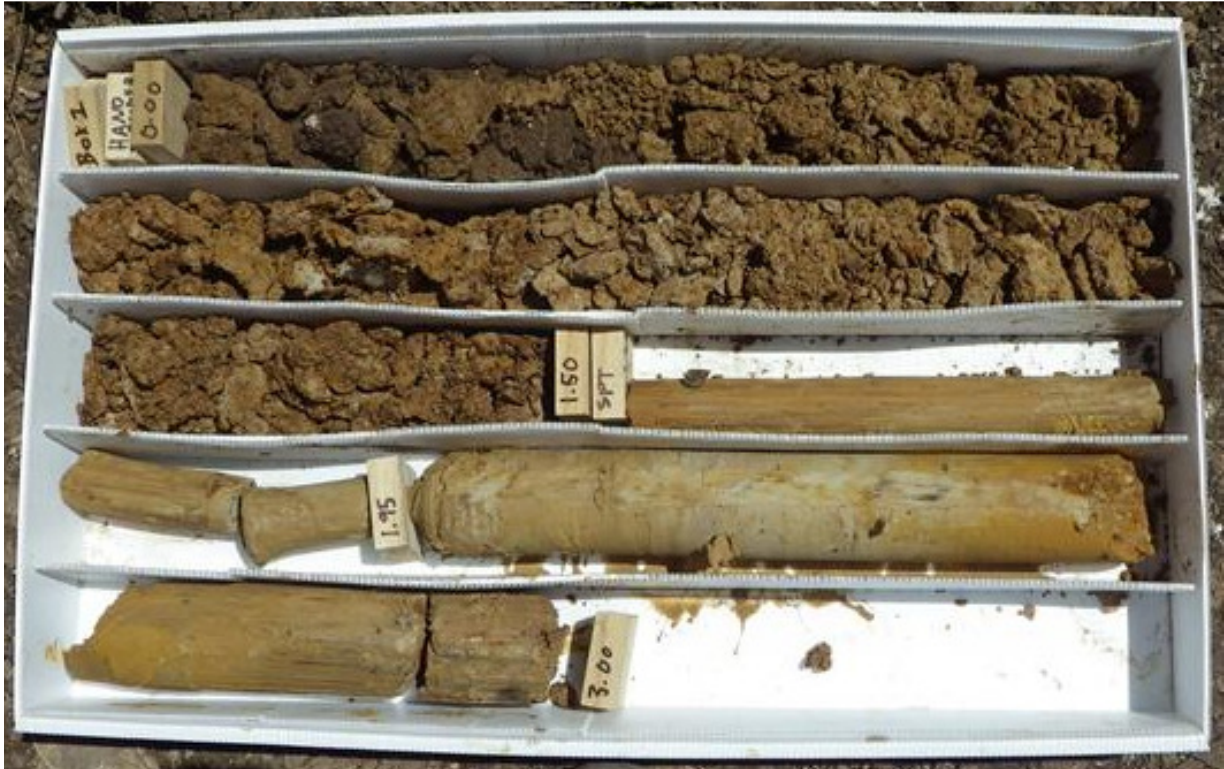
0.00m – 3.00m	Box 1 of 5
---------------	------------

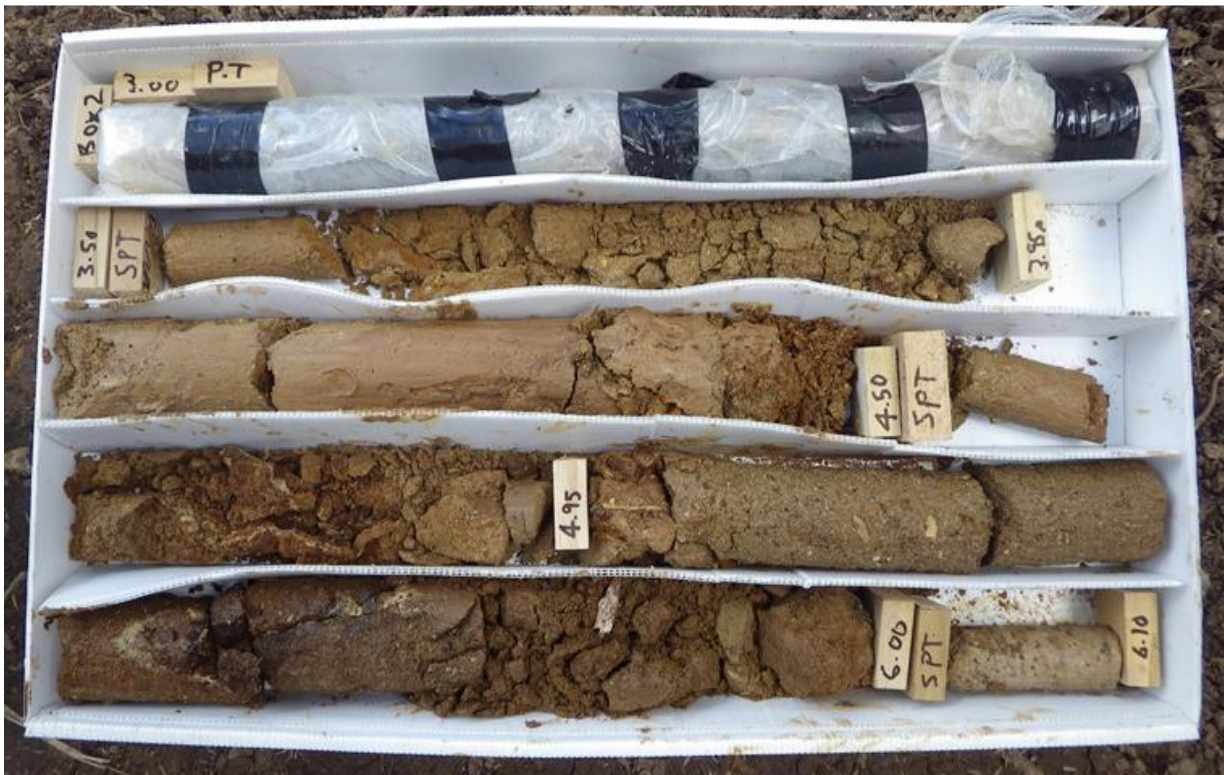
3.00m – 6.10m	Box 2 of 5
---------------	------------

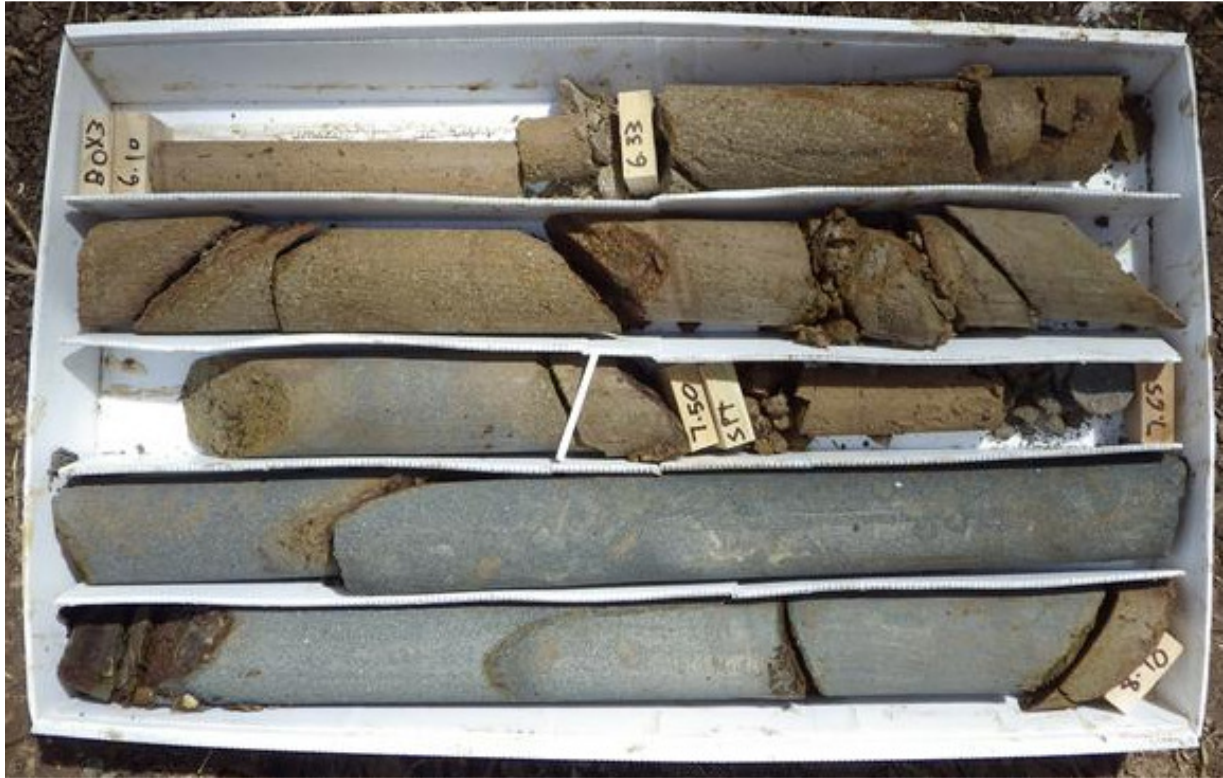
6.10m – 8.90m Box 3 of 5

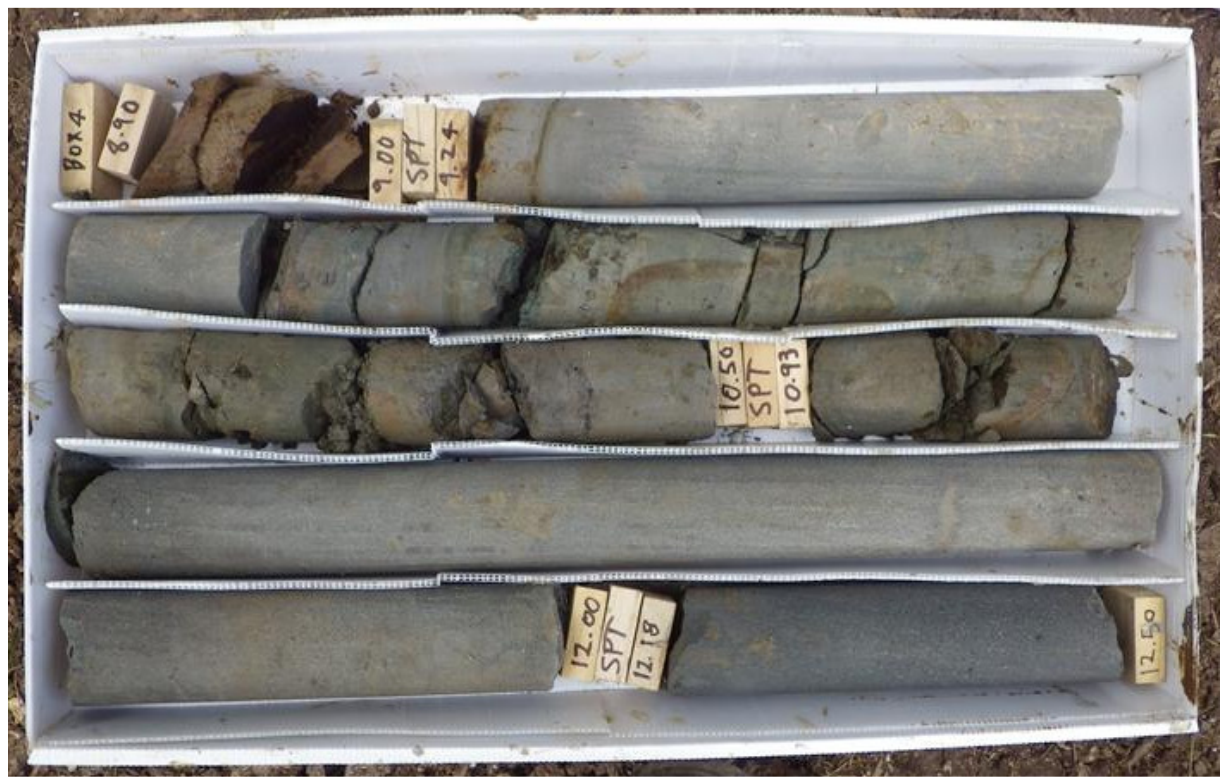
8.90m – 12.50m Box 4 of 5

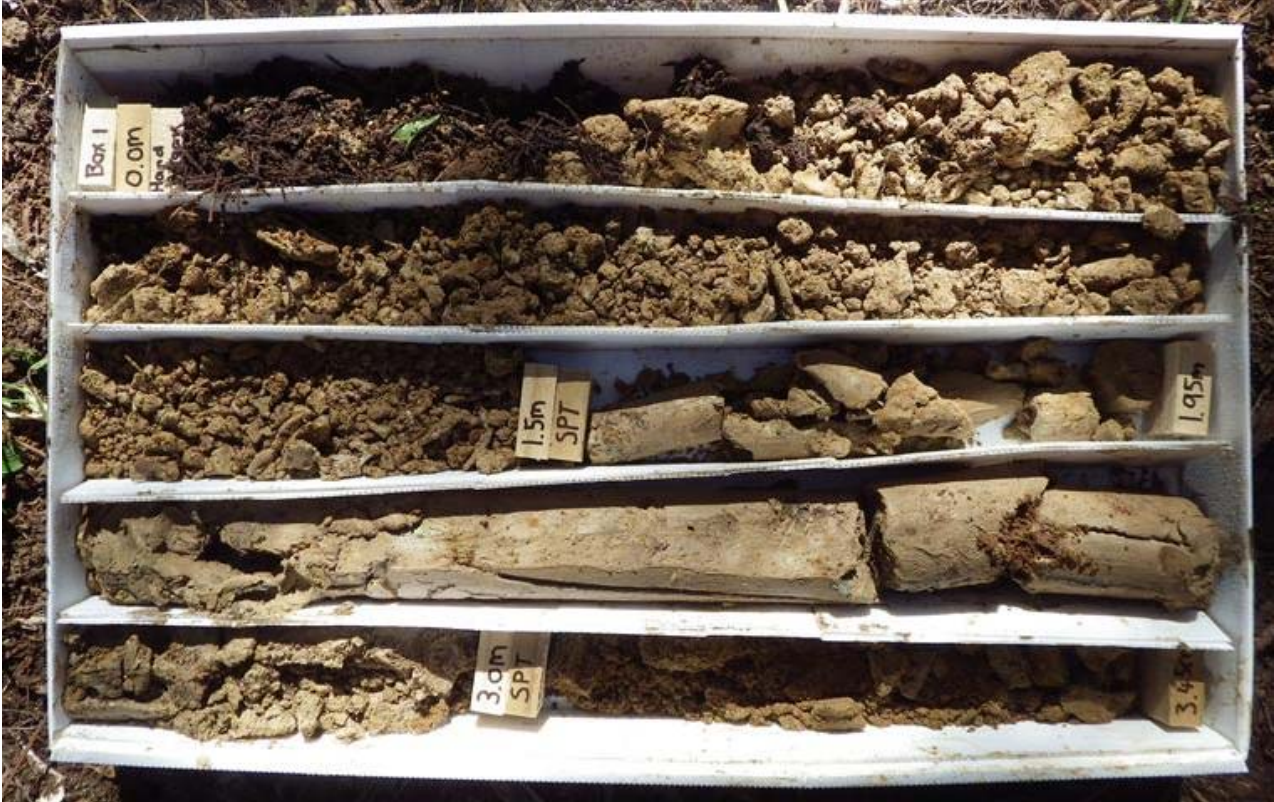
0.00m – 3.45m Box 1 of 11

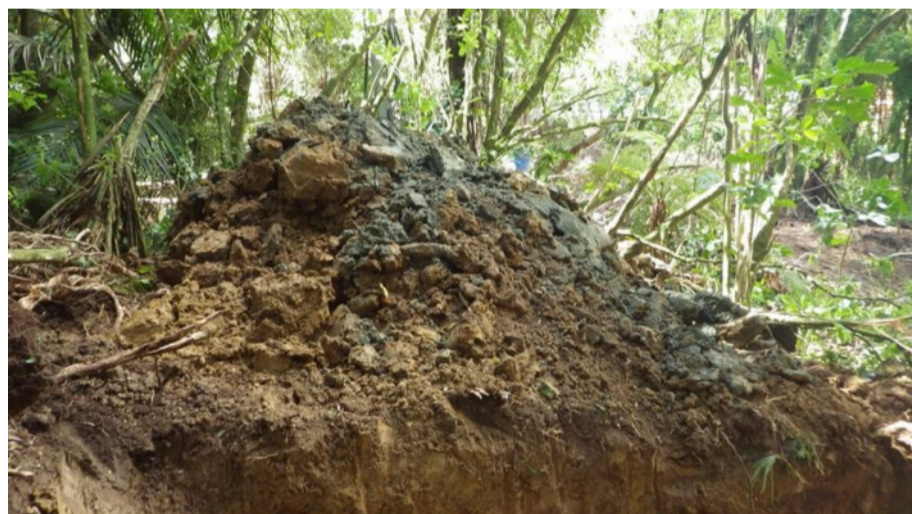
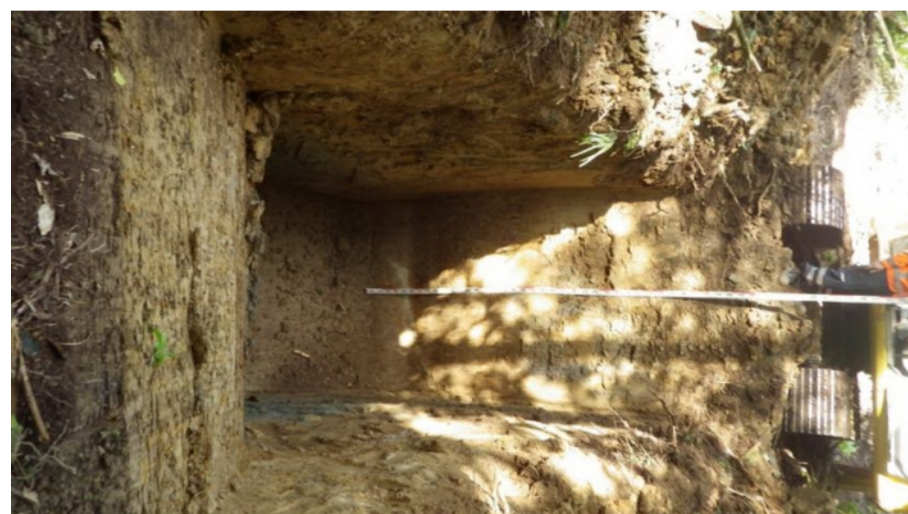
SKETCH OF EXPOSURE
TP13/06 - Excavation
TP13/06 - Stockpile

Clayey SILT; with trace to medium sand, greenish grey, very stiff, moist, plastic, some fibrous wood organics, some limonite staining, trace white pumiceous specks.		3														130/48		
	Fine sandy CLAY; with some silt, greenish grey, stiff, wet, plastic, some lenses of pinkish brown silty fine sand and silt, trace white pumiceous specks.																115/28		
	End of Test Pit at 4.0m. Target depth reached. Two bulk soil samples taken at 2.0m and 4.0m. Minimal seepage observed from 2.20m to 4.0m.	1184															60/N/A		Bulk Sample

Test pit was backfilled upon completion.
 SV S23B, Correction Factor 1.337.
 T.S = Topsoil.

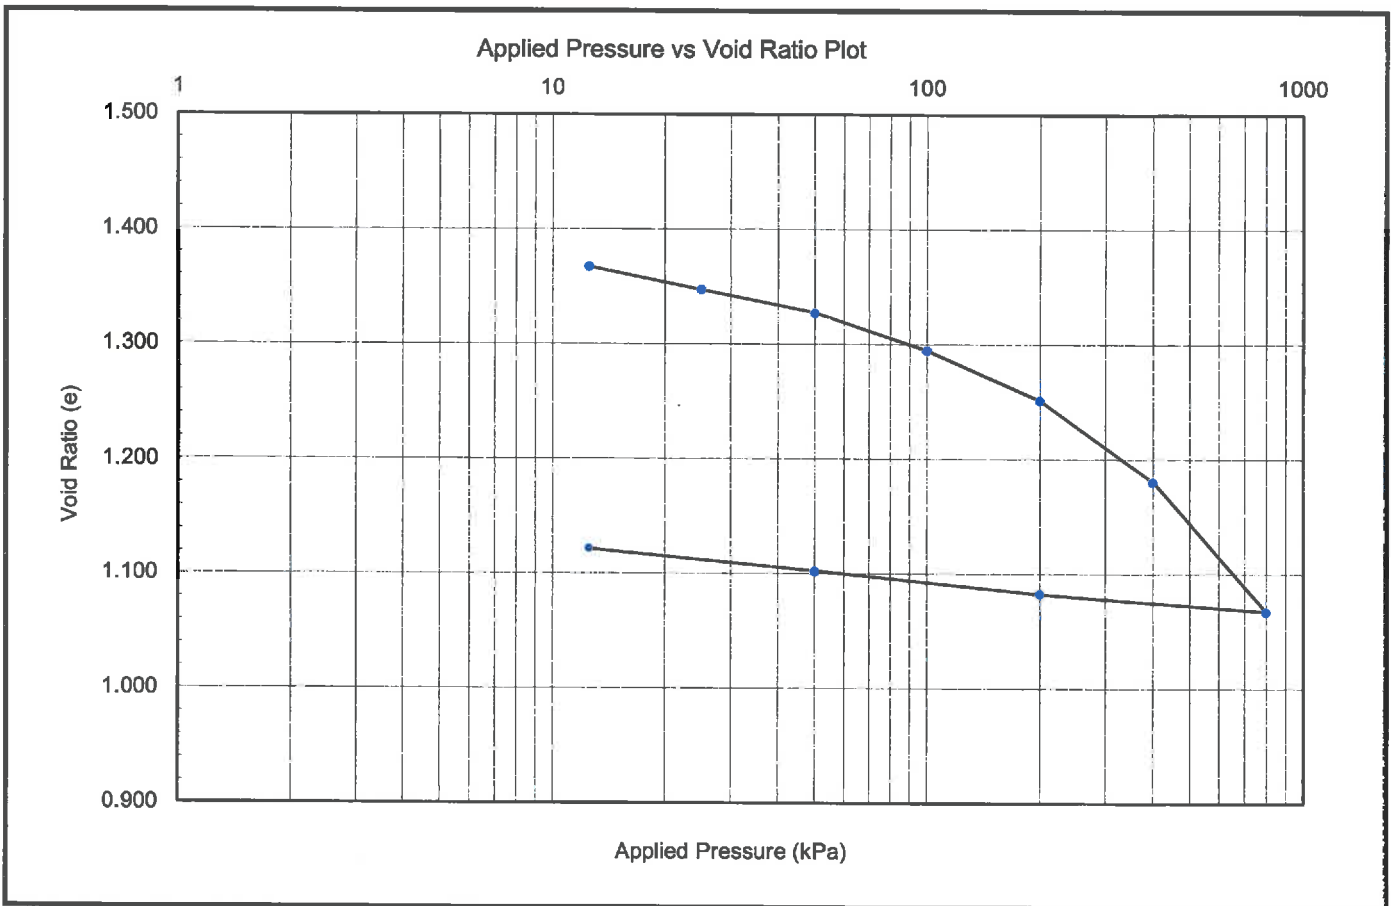
Project No: **1-C0935.25**
 Lab Ref No: **001b/13**
 Folder No: **SEC13/AU/050**

Test Method:		Notes:
One Dimensional Consolidation Test:	NZS 4402:1986 Test 7.1	Load increments applied at 1.35hr intervals
Water Content:	NZS 4402:1986 Test 2.1
