REPORT 7535

Watercare Services Ltd

**Huia Water Treatment Plant Rebuild
Geotechnical Investigation and
Assessment**

October 2010

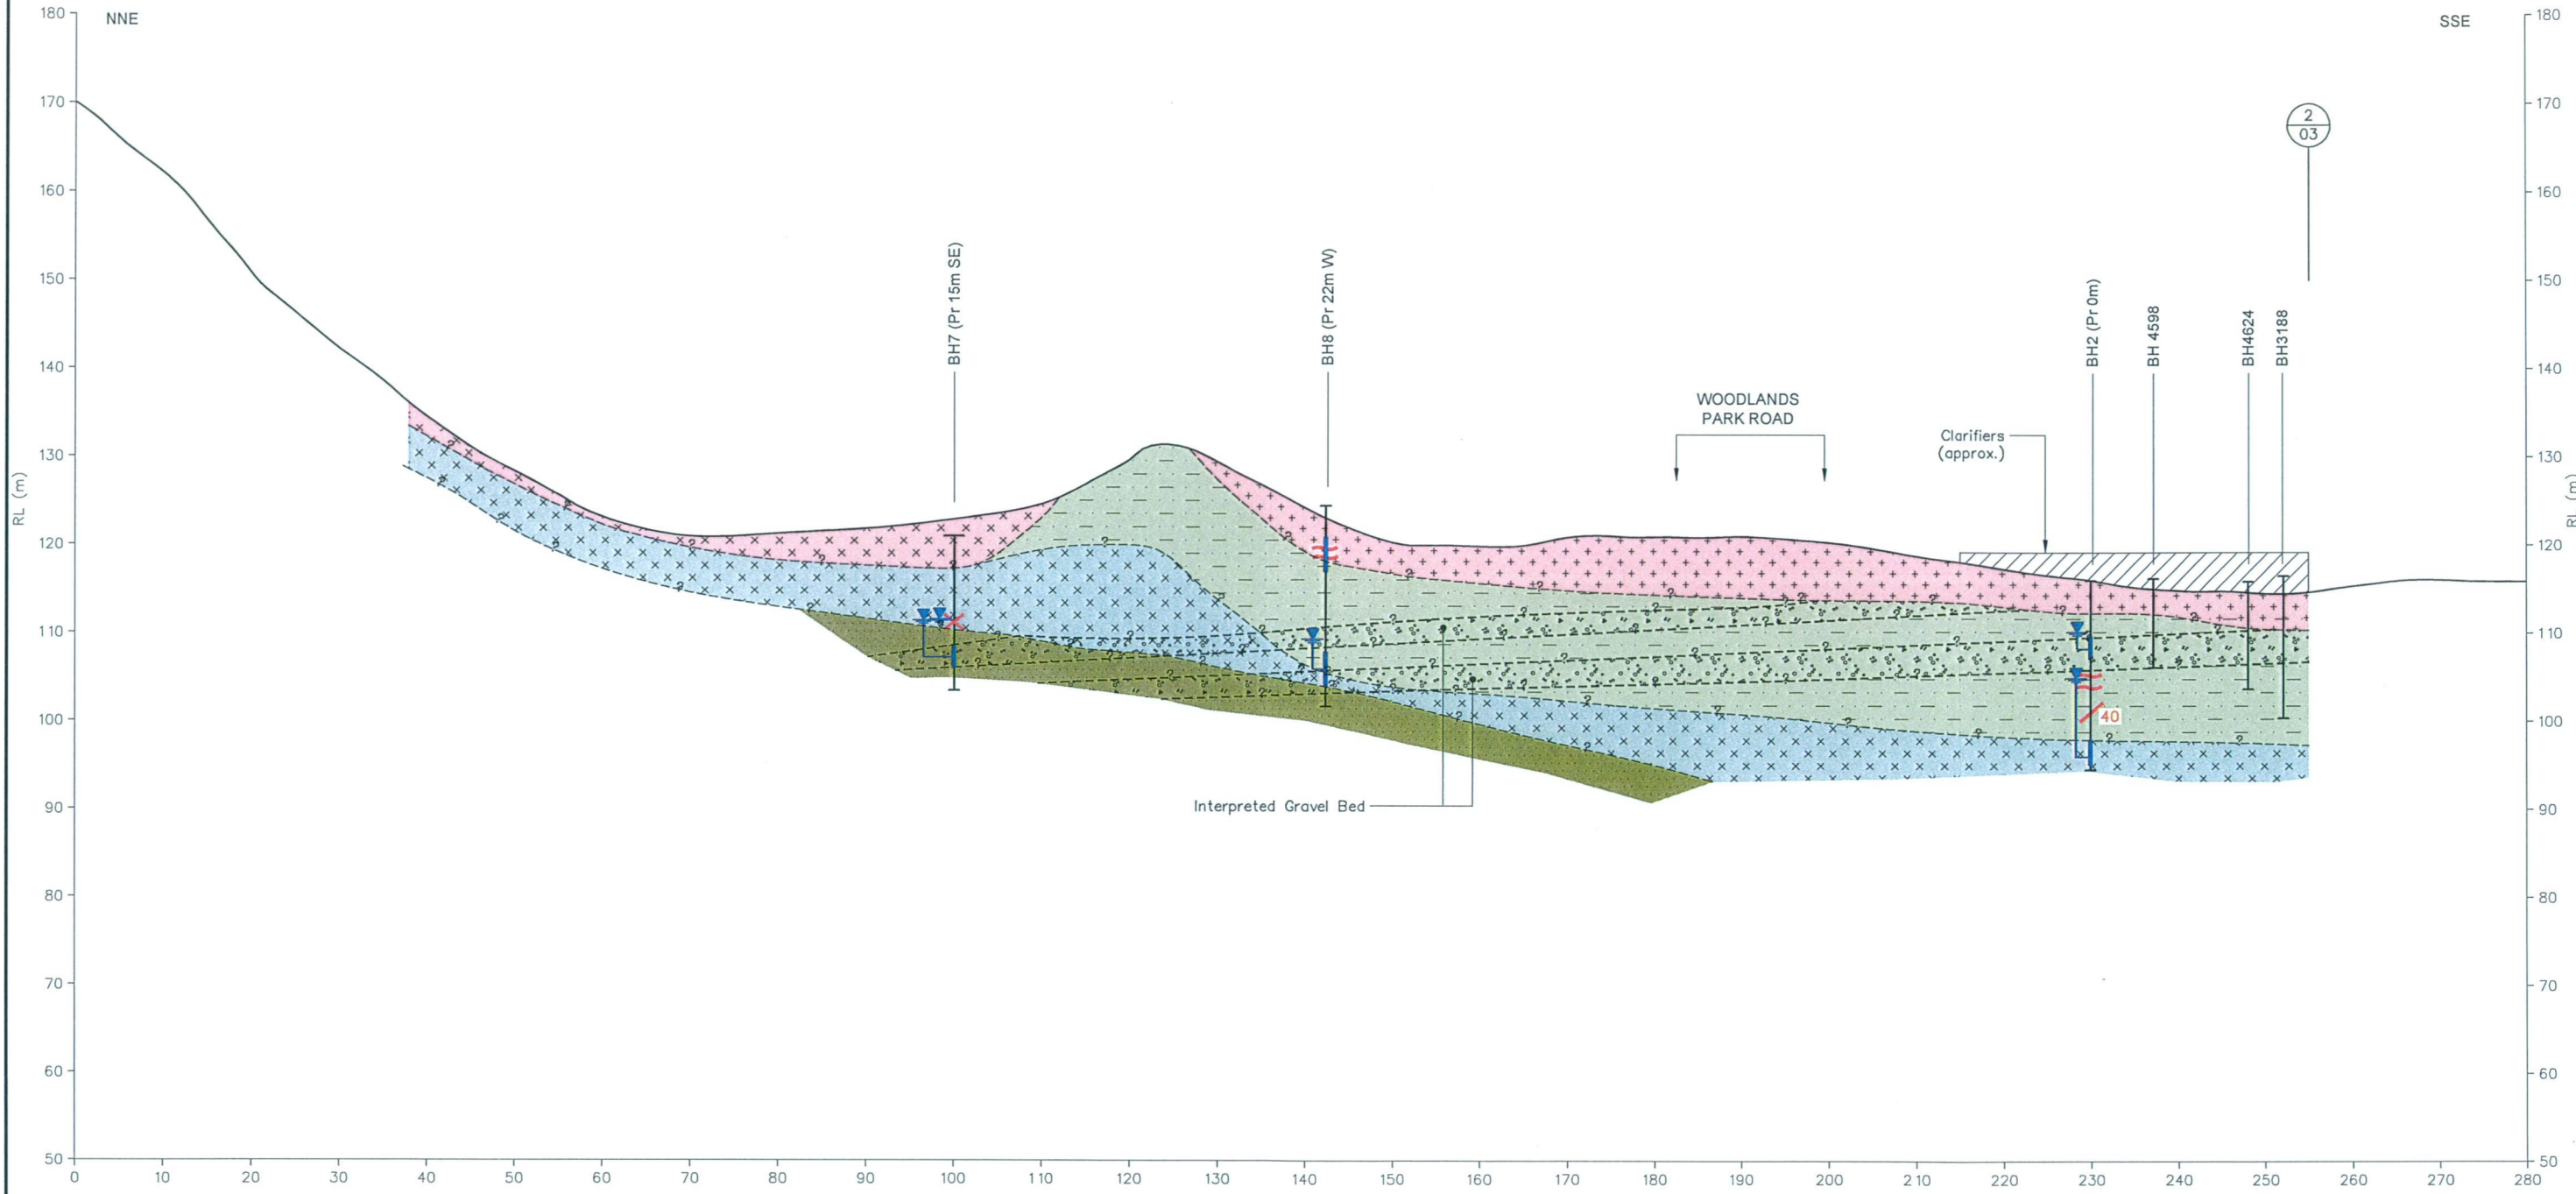
DRAWING STATUS: PRELIMINARY DRAFT		
CLIENT, PROJECT		
WATERCARE SERVICES LTD		
HUIA WATER TREATMENT PLANT INVESTIGATION		
TITLE		
PROPOSED INFRASTRUCTURE UPGRADE		
Geological Cross Section 1		
SCALES (AT A3 SIZE)	DWG. No.	REV.
1:750	27064.001-02	0

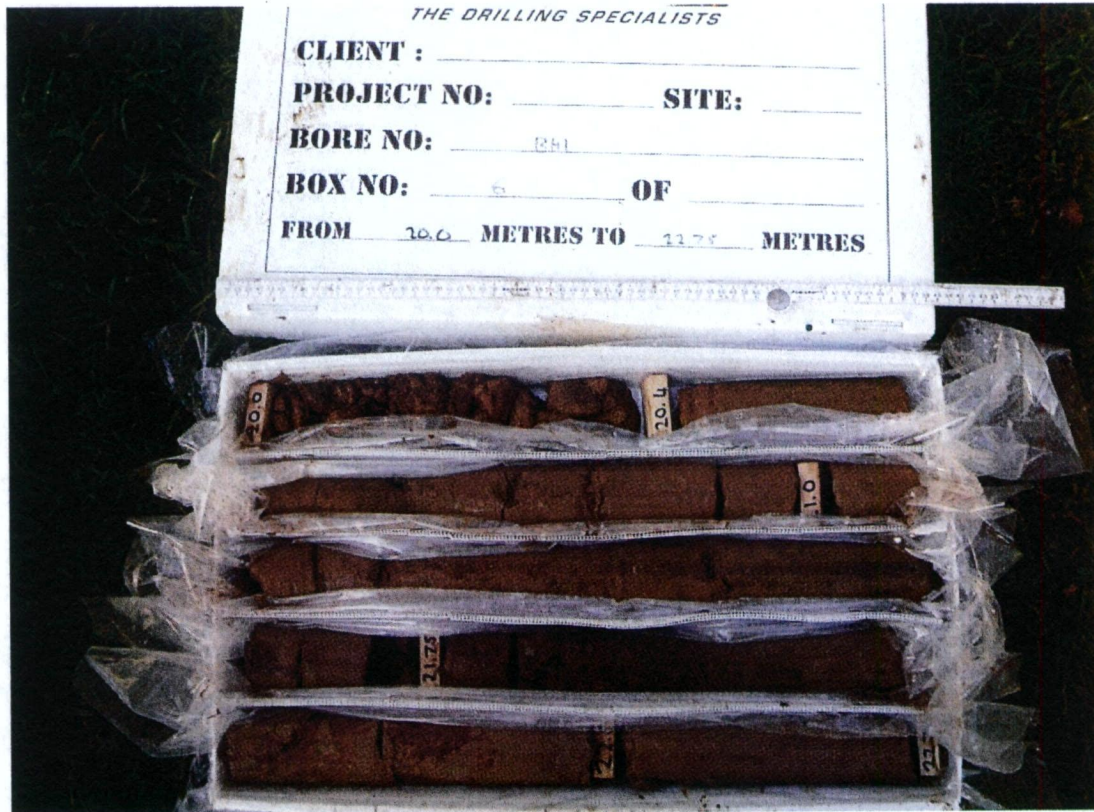
BH 1_Box 06_20.00-22.75m.jpg

CLIENT : _____
PROJECT NO: _____ **SITE:** _____
BORE NO: BH1
BOX NO: 6 **OF** _____
FROM 20.0 **METRES TO** 22.75 **METRES**

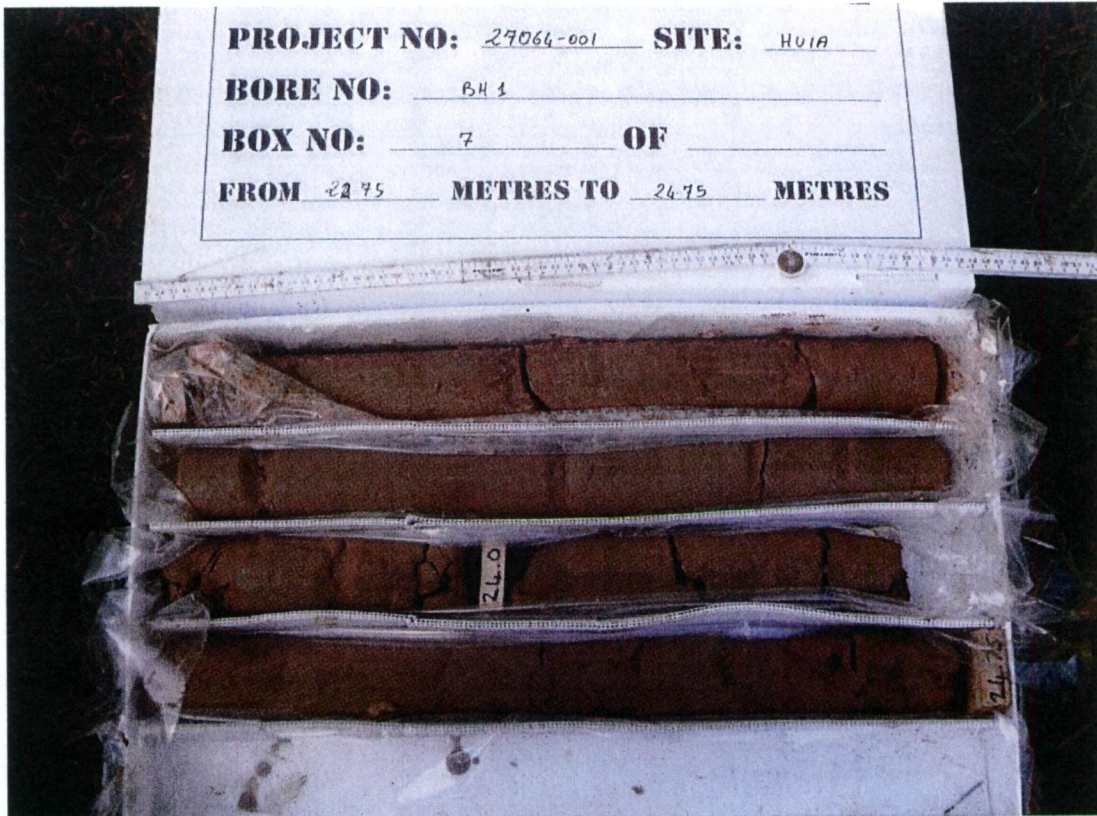
BH 1_Box 07_22.75-24.75m_EoB.jpg

PROJECT NO: 27064-001 **SITE:** HUIA
BORE NO: BH 1
BOX NO: 7 **OF**
FROM 22.75 **METRES TO** 24.75 **METRES**

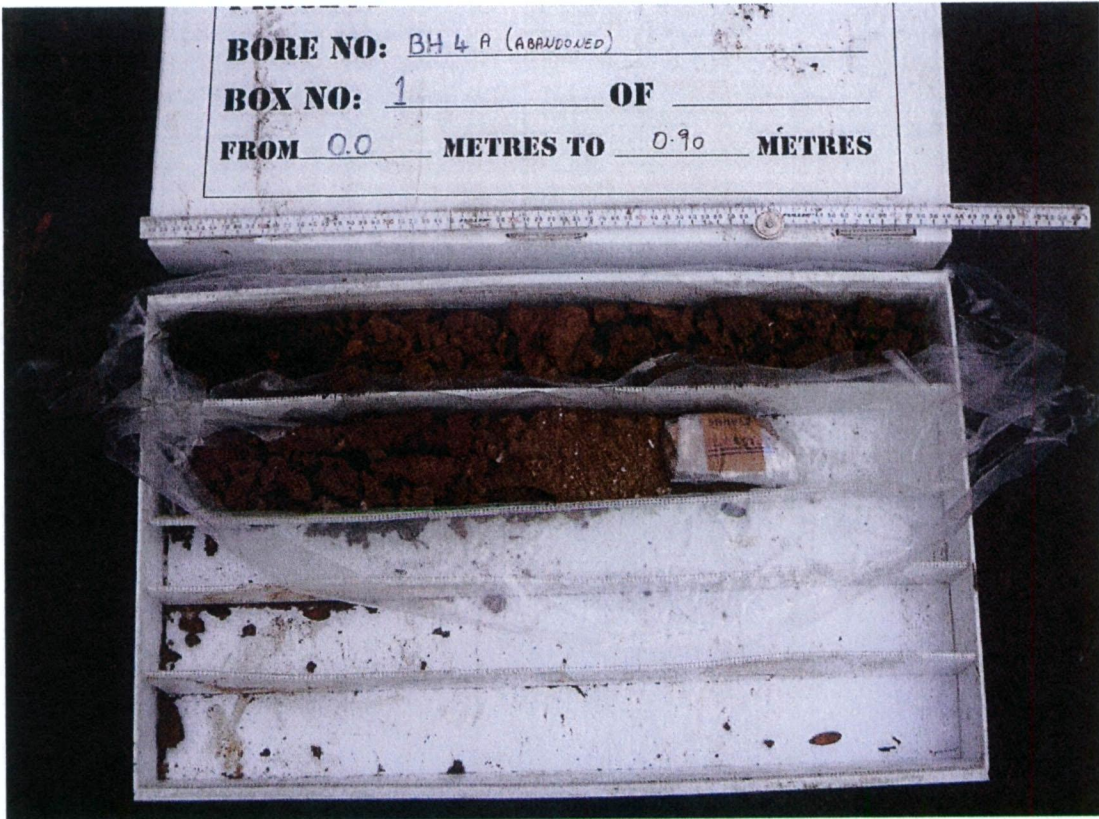
BH 4A_Box 01_00.00-00.90m_EoB.jpg

DESCRIPTION OF CORE										ROCK DEFECTS										
GEOLOGICAL UNIT	ROCK OR SOIL TYPE, WEATHERING, HARDNESS, STRENGTH, COLOUR, LITHOLOGICAL FEATURES (bedding, cement, foliation, mineralogy, texture, etc...);										SIGNIFICANT JOINTS, BEDDING, CRUSHED AND SHEARED ZONES/SEAMS									
	UW	SW	HW	WW	R4	R2	R1	PT LOAD / UCS TEST (MPa)	CORE LOSS / LIFT (%)	METHOD, CORE & CASING	TEST SYMBOL	DEPTH (m)	GRAPHIC LOG	DEFECT LOG	FRACTURE LOG spacing of natural fractures (cm)	DATE / DEPTH	ROD (%)	WATER	DRILL WATER LOSS (%)	CORE BOX RL (m)
FILL	Silty SAND, dark brown on top becoming orange brown, hard to auger. Fragments of metals, bolts and asbestos																			
	0.9m: CONCRETE END OF BOREHOLE AT 0.9m. Unable to Penetrate. Hole backfilled.

We note that apparent asbestos containing material was identified in the fill in BH 4A. The presence of this hazardous substance should be taken into account when planning and undertaking earthworks in that area and the extent of this material may need to be confirmed by a geo-environmental investigation if this area is to be disturbed during the re-build.

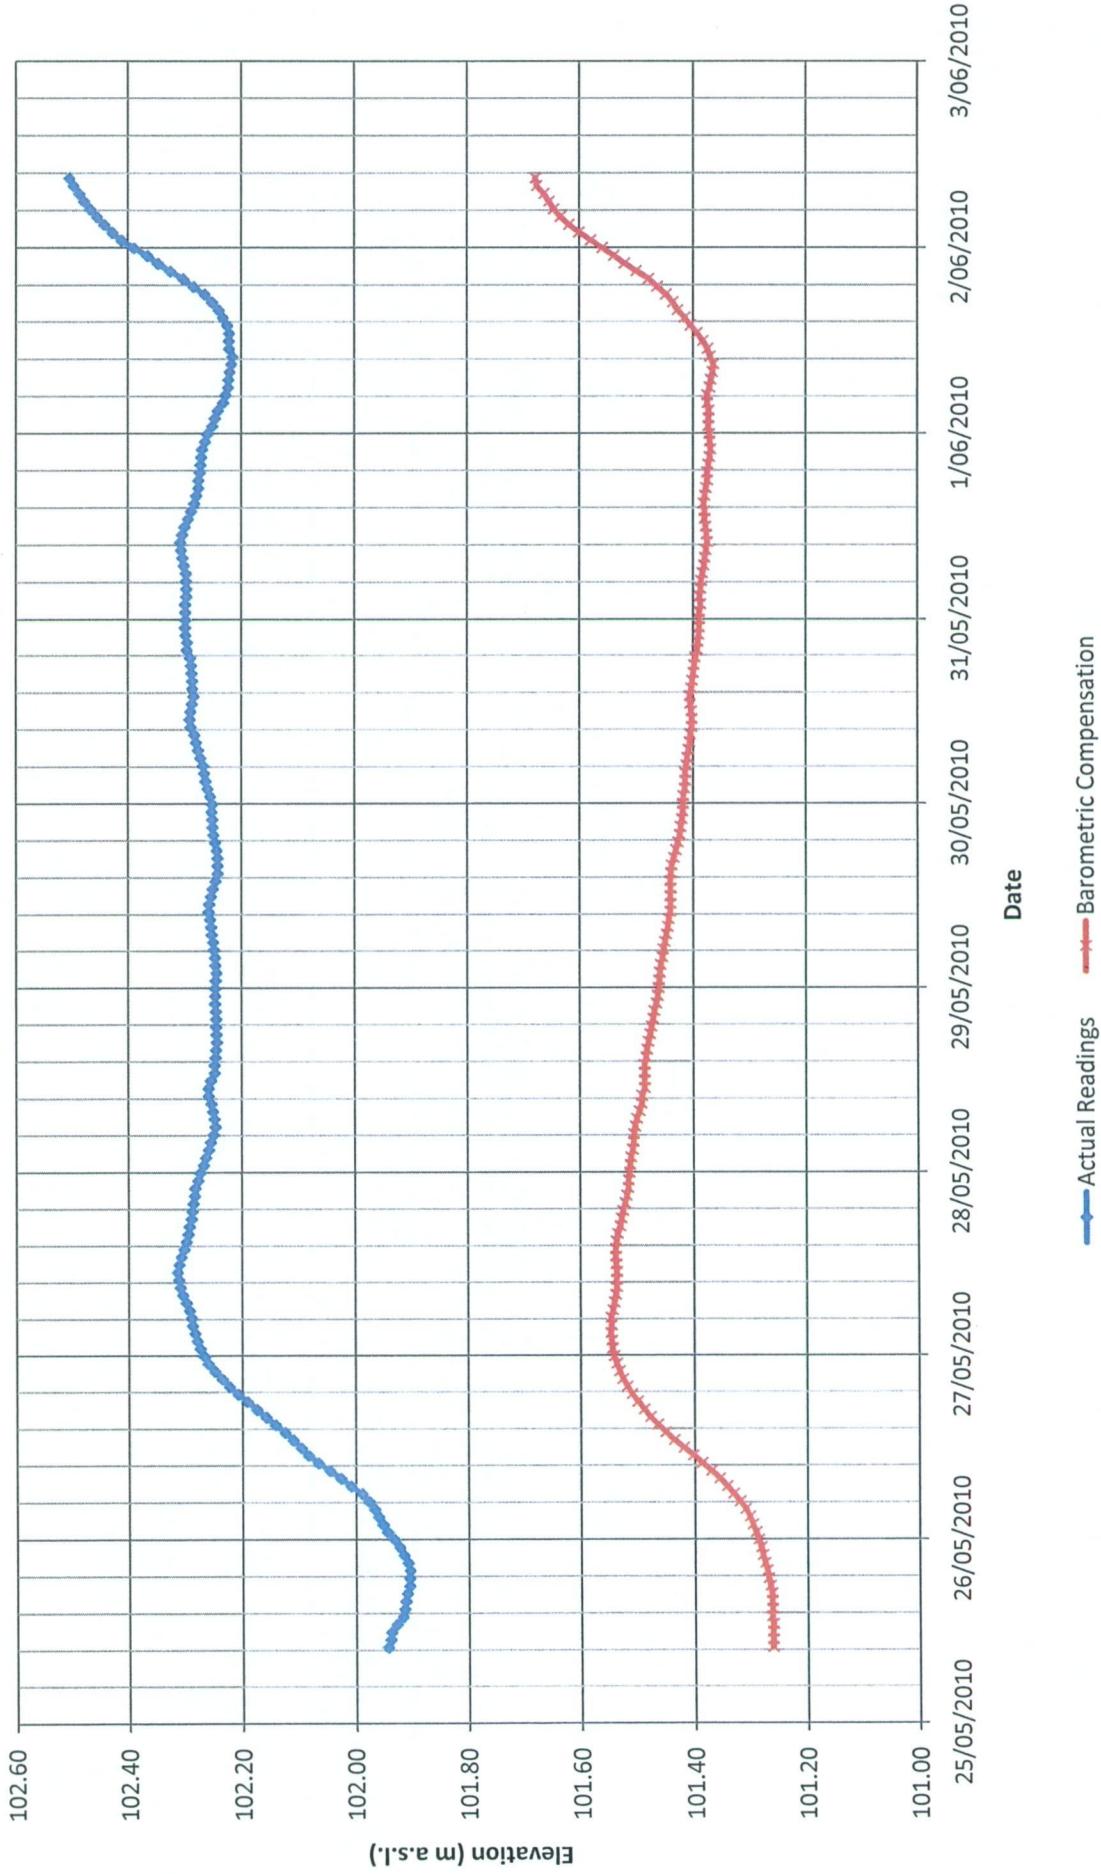
Huia Watercare Treatment Plant - Diver BH 1; depth 9.3m b.c. (CW-HW Cornwallis Formation)

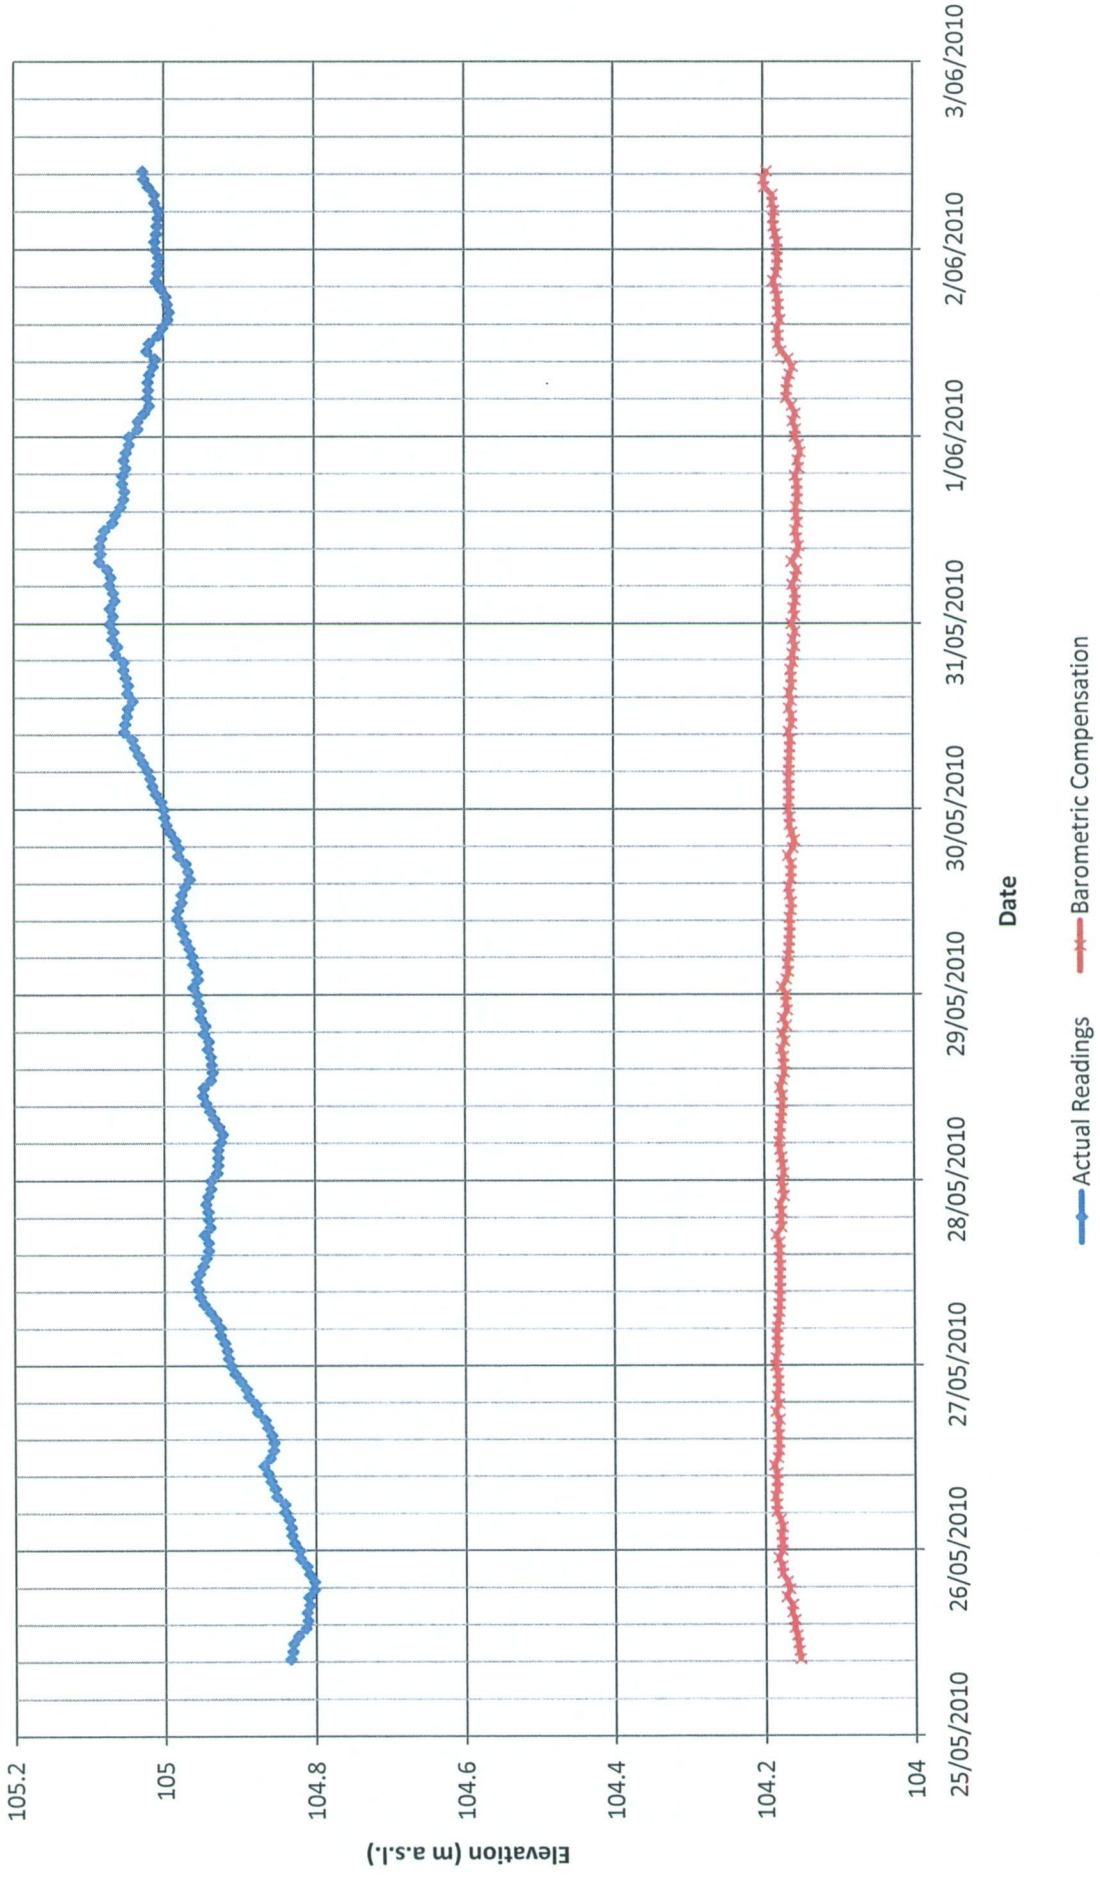
**Huia Watercare Treatment Plant - Diver BH 3; depth 23.3m b.c.
(MW-SW Cornwallis Formation)**

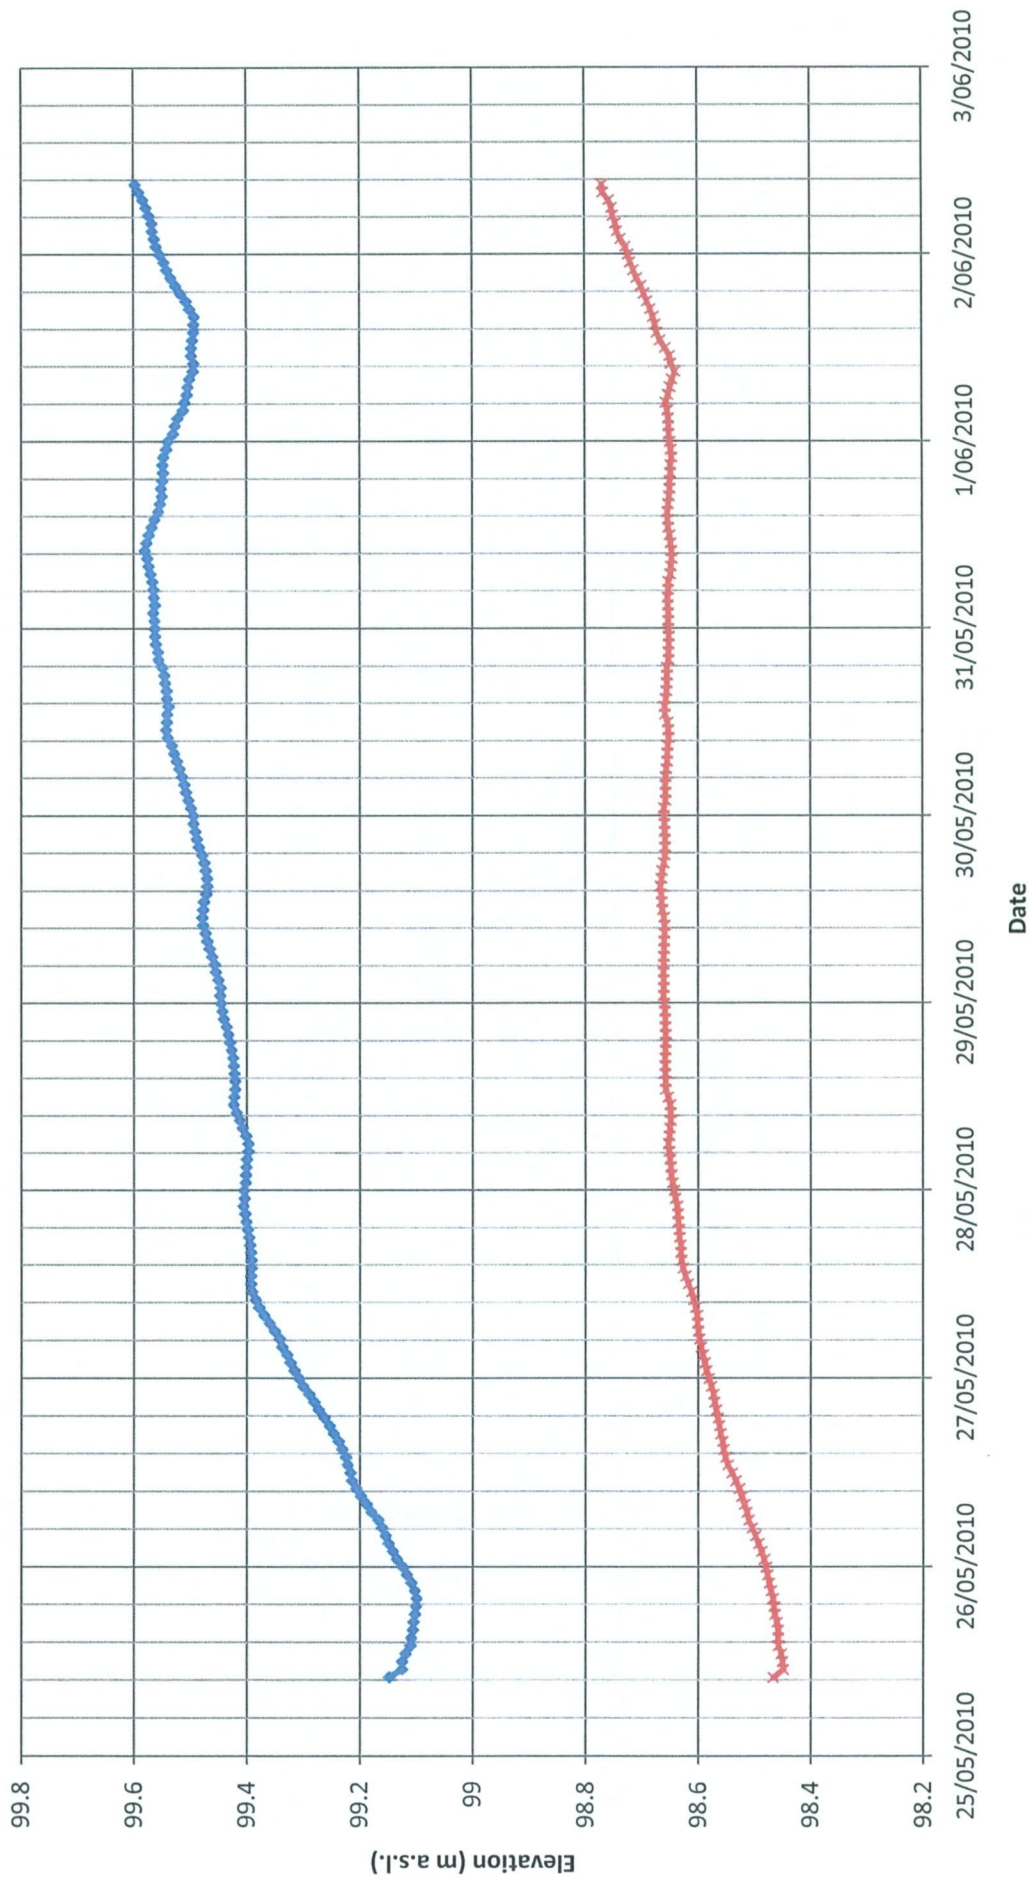
Huia Watercre Treatment Plant - Diver BH 6; depth 10.7m b.c.
(CW-HW Cornwallis Formation)

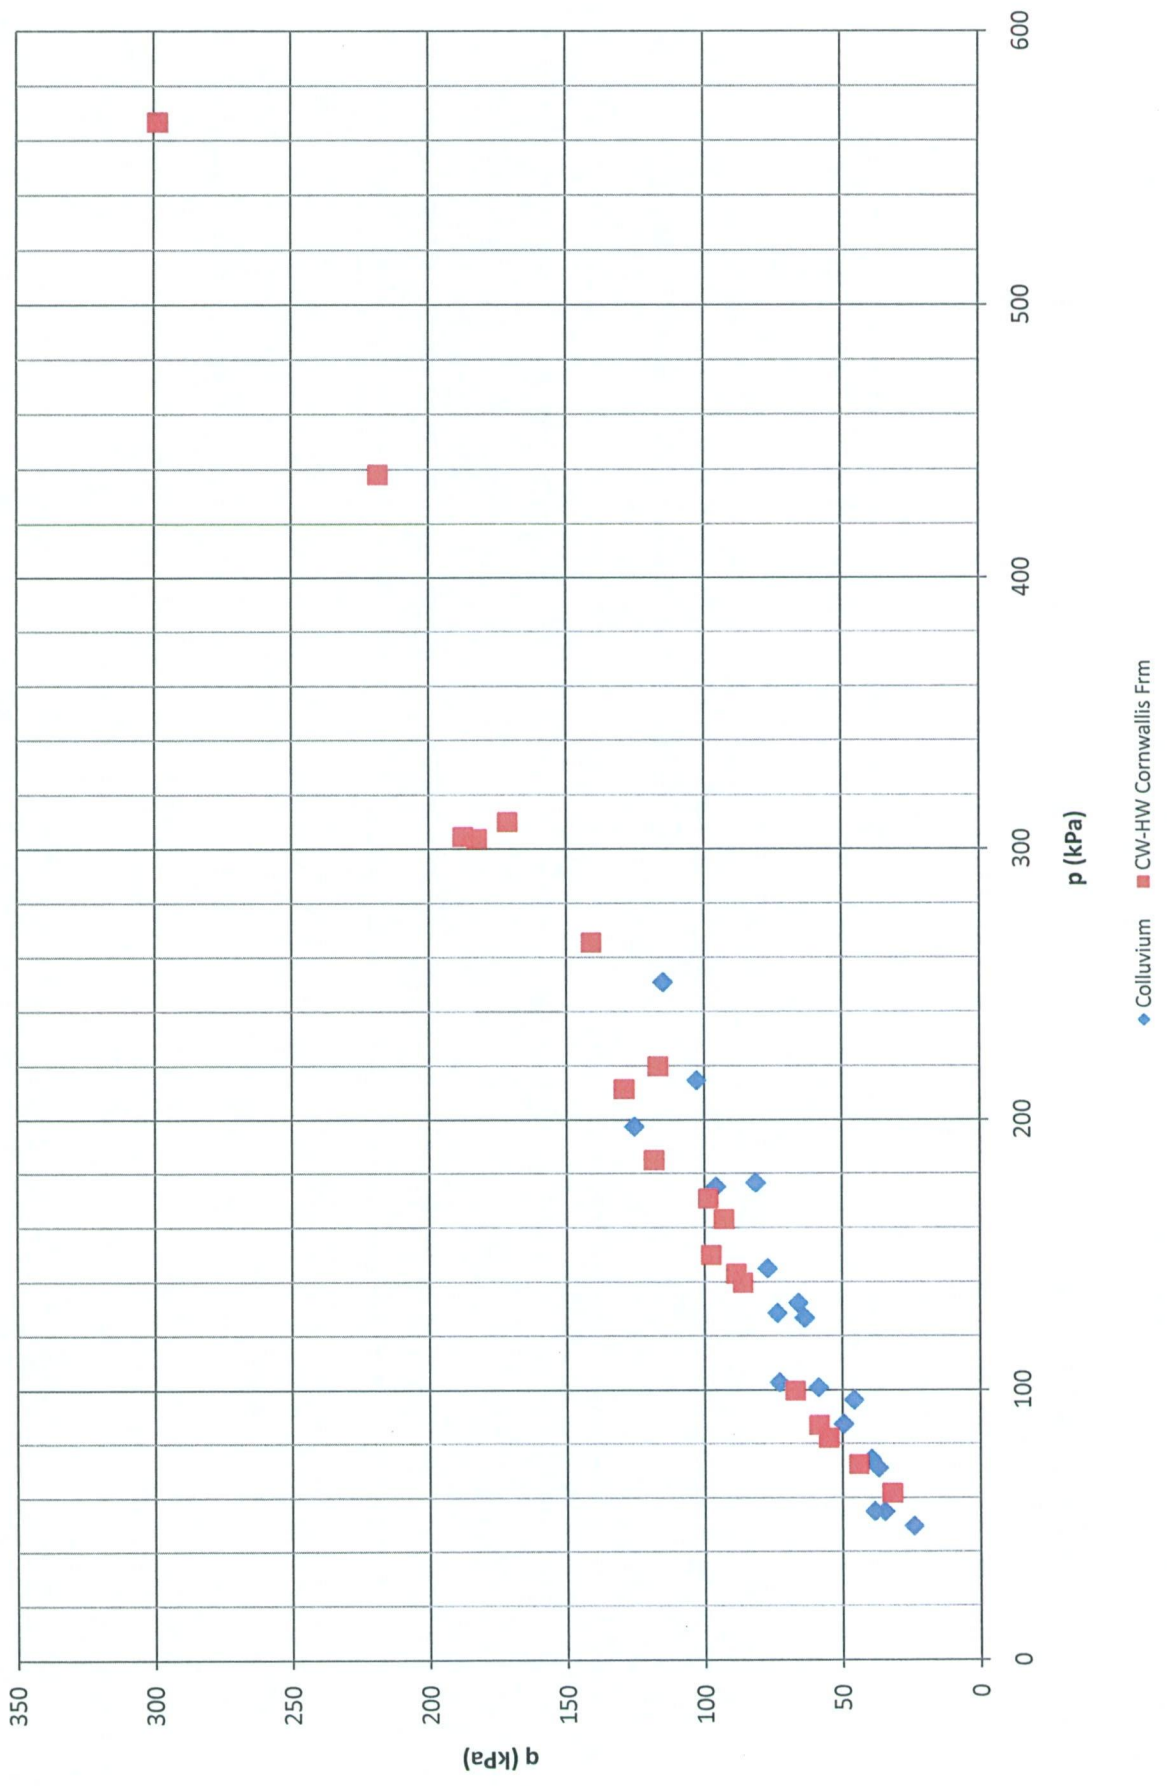
Watercare Huia Treatment Plant - Triaxial Test Results All Data

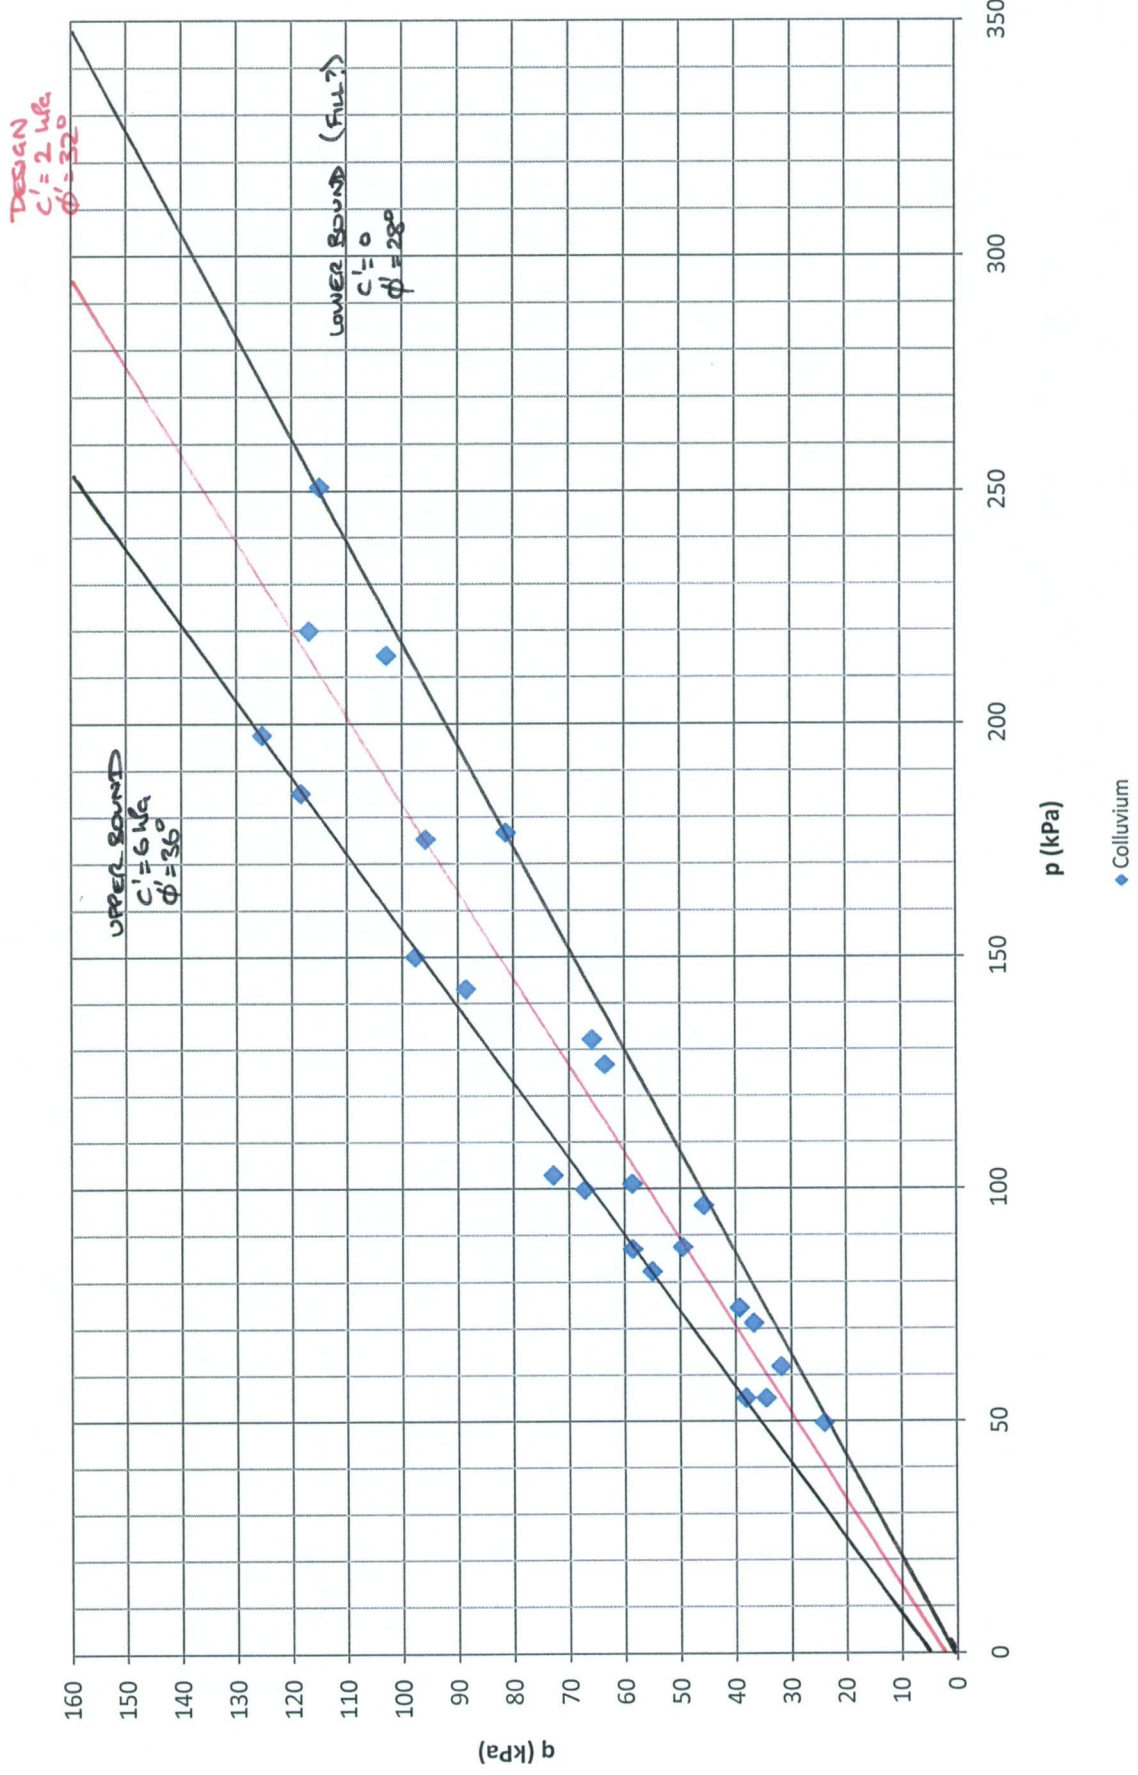
Watercare Huia Treatment Plant - Triaxial Test Results All Data Colluvium

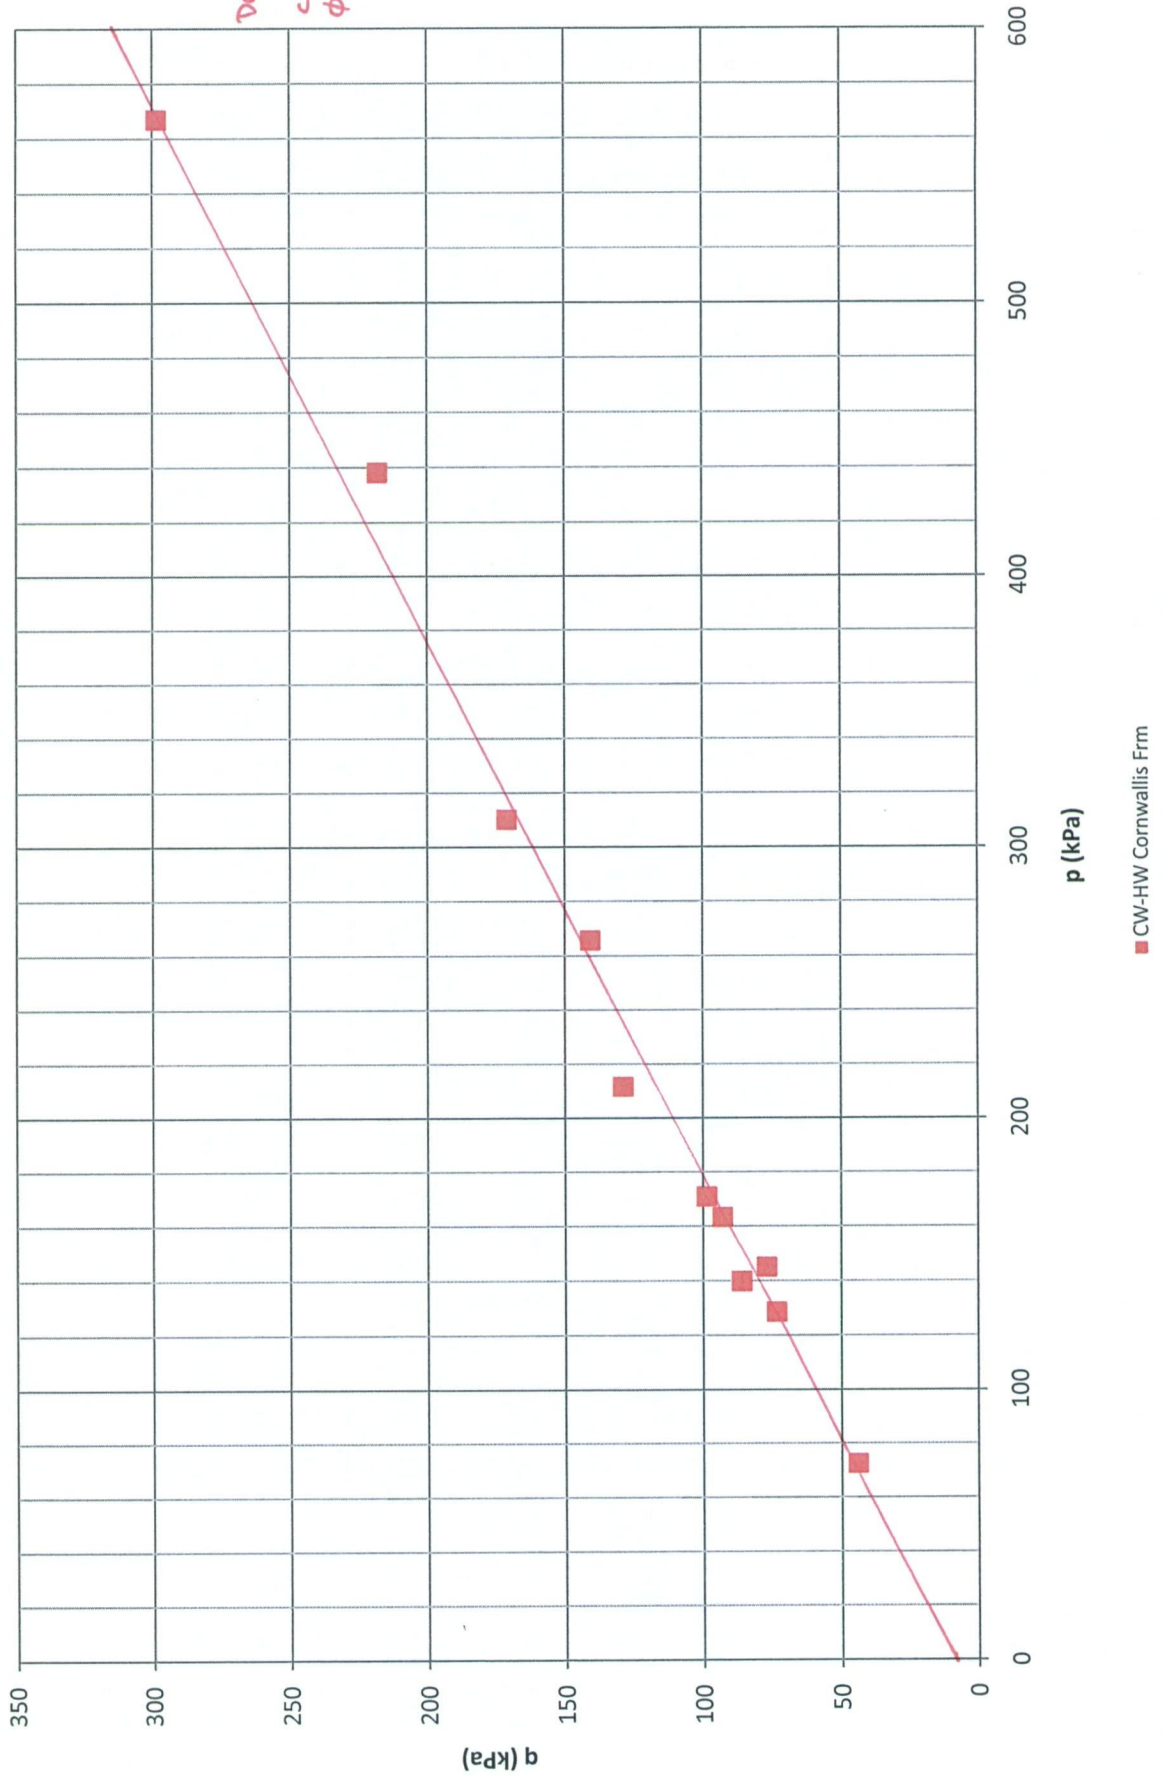
Watercare Huia Treatment Plant - Triaxial Test Results All Data Cornwallis

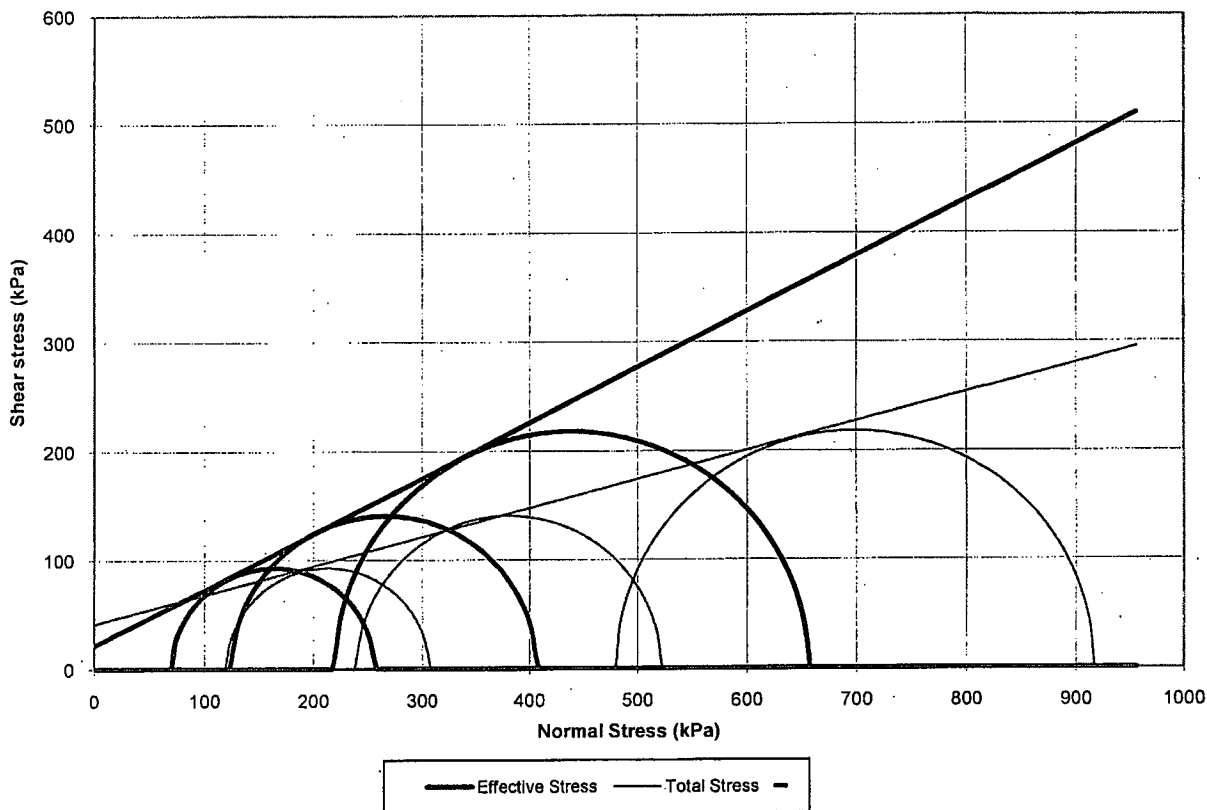
CONSOLIDATED-UNDRAINED TRIAXIAL COMPRESSION TEST (3 STAGES) MOHR CIRCLES OF TOTAL AND EFFECTIVE STRESSES

Initial Sample Height:	115.20	mm	Initial Water Content:	47.1	%
Initial Sample Diameter:	53.89	mm	Initial Bulk Density:	1.73	t/m ³
Initial B Value:	--	%	Initial Dry Density:	1.18	t/m ³
B Value before Consolidation:	96	%	Final Water Content:	43.4	%

Consolidation Stage			Failure Values				
	Cell Pressure (kPa)	Back Pressure (kPa)	Eff. Consol. Stress	Deviator Stress (kPa)	Pore Pressure Change During Shearing Δu (kPa)	Effective Principal Stress (kPa)		Vertical Strain (%)
						Major σ_1'	Minor σ_3'	
STAGE 1	470	350	120	186.01	49.7	256.31	70.30	3.37
STAGE 2	590	350	240	281.62	115.2	406.42	124.80	2.15
STAGE 3	830	350	480	436.35	260.1	656.25	219.90	2.37

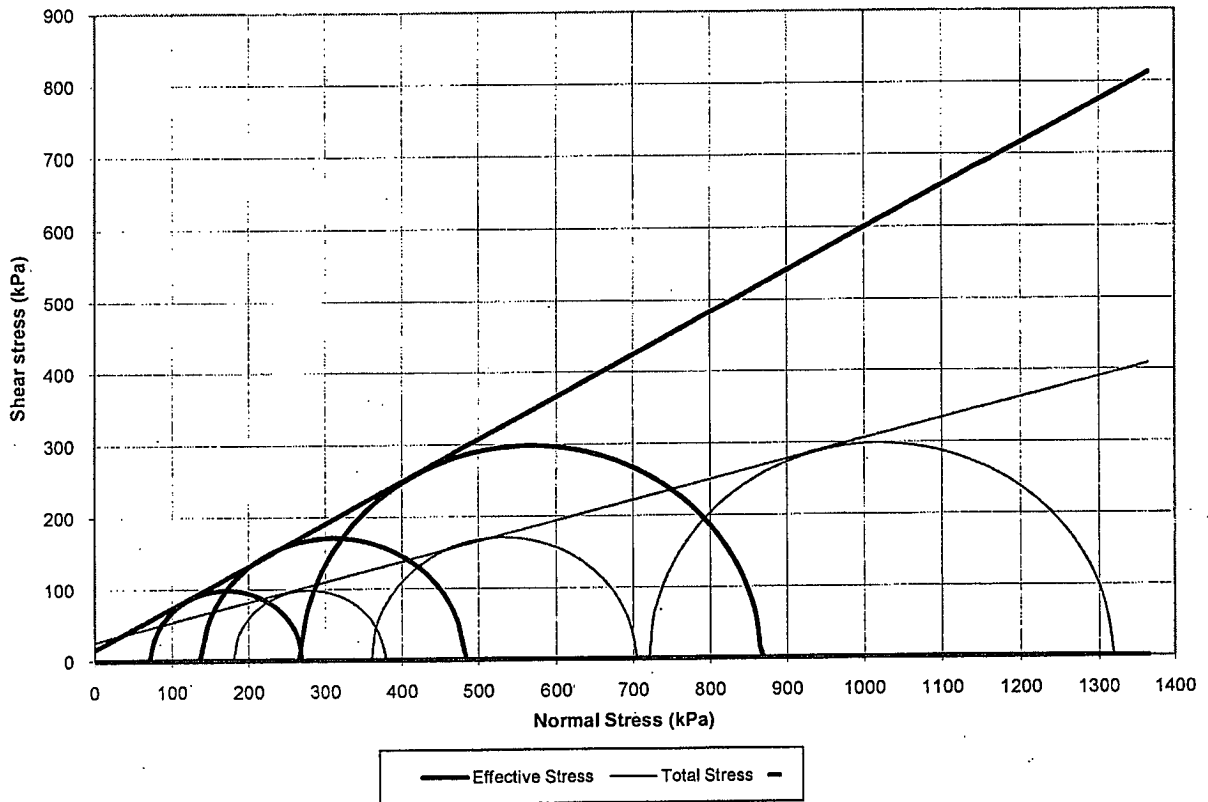
CONSOLIDATED-UNDRAINED TRIAXIAL COMPRESSION TEST (3 STAGES) MOHR CIRCLES OF TOTAL AND EFFECTIVE STRESSES

Initial Sample Height:	112.80	mm	Initial Water Content:	45.7	%
Initial Sample Diameter:	53.55	mm	Initial Bulk Density:	1.76	t/m ³
Initial B Value:	72	%	Initial Dry Density:	1.21	t/m ³
B Value before Consolidation:	98	%	Final Water Content:	36.5	%

Consolidation Stage			Failure Values				
	Cell Pressure (kPa)	Back Pressure (kPa)	Eff. Consol. Stress	Deviator Stress (kPa)	Pore Pressure Change During Shearing δu (kPa)	Effective Principal Stress (kPa)		Vertical Strain (%)
						Major σ_1'	Minor σ_3'	
STAGE 1	480	300	180	197.37	107.8	269.57	72.20	6.93
STAGE 2	660	300	360	342.54	221.2	481.34	138.80	4.77
STAGE 3	1020	300	720	597.15	451.8	865.35	268.20	3.21

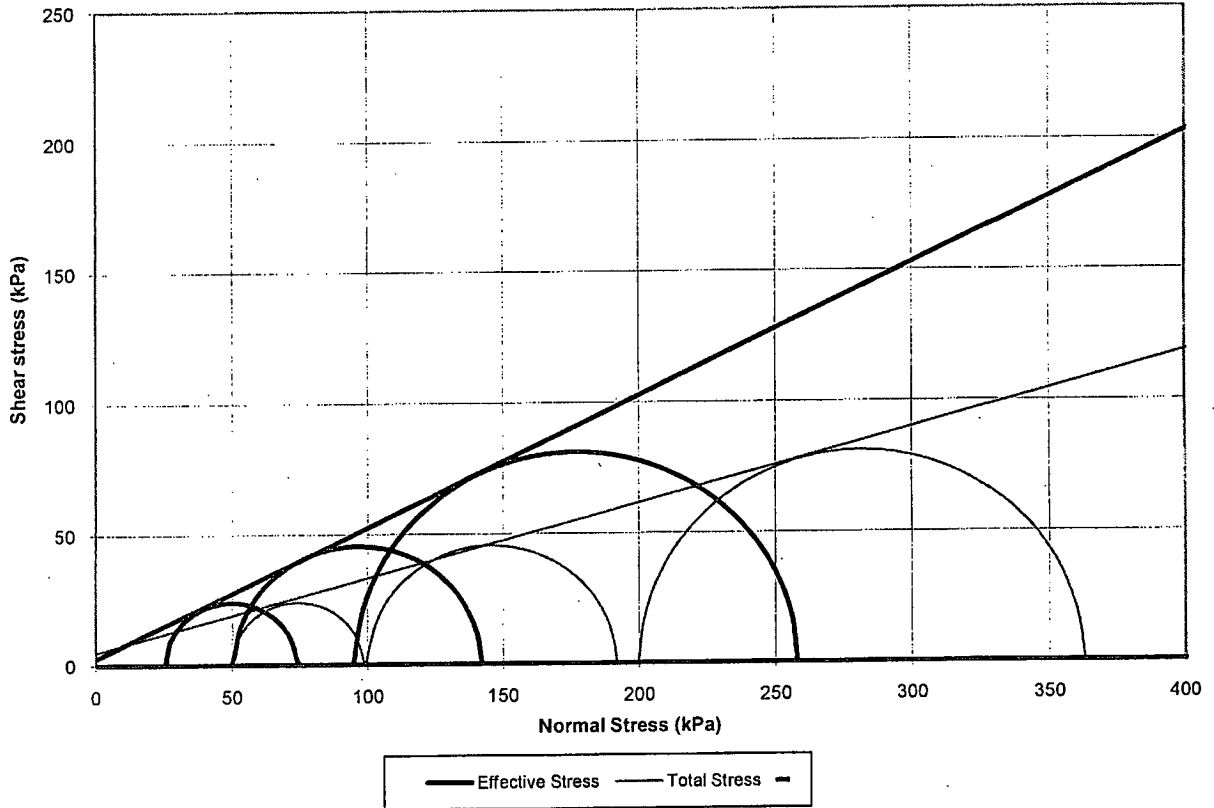
CONSOLIDATED-UNDRAINED TRIAXIAL COMPRESSION TEST (3 STAGES) MOHR CIRCLES OF TOTAL AND EFFECTIVE STRESSES

Initial Sample Height:	111.11	mm	Initial Water Content:	61.2	%
Initial Sample Diameter:	53.85	mm	Initial Bulk Density:	1.61	t/m ³
Initial B Value:	60	%	Initial Dry Density:	1.00	t/m ³
B Value before Consolidation:	96	%	Final Water Content:	52.5	%

Consolidation Stage			Failure Values				
	Cell Pressure (kPa)	Back Pressure (kPa)	Eff. Consol. Stress	Deviator Stress (kPa)	Pore Pressure Change During Shearing Δu (kPa)	Effective Principal Stress (kPa)		Vertical Strain (%)
						Major σ_1'	Minor σ_3'	
STAGE 1	350	300	50	48.06	24.4	73.66	25.60	4.46
STAGE 2	400	300	100	91.34	49.3	142.04	50.70	4.99
STAGE 3	500	300	200	162.41	104.6	257.81	95.40	6.06
