REPORT 7535

Watercare Services Ltd

**Huia Water Treatment Plant Rebuild
Geotechnical Investigation and
Assessment**

October 2010

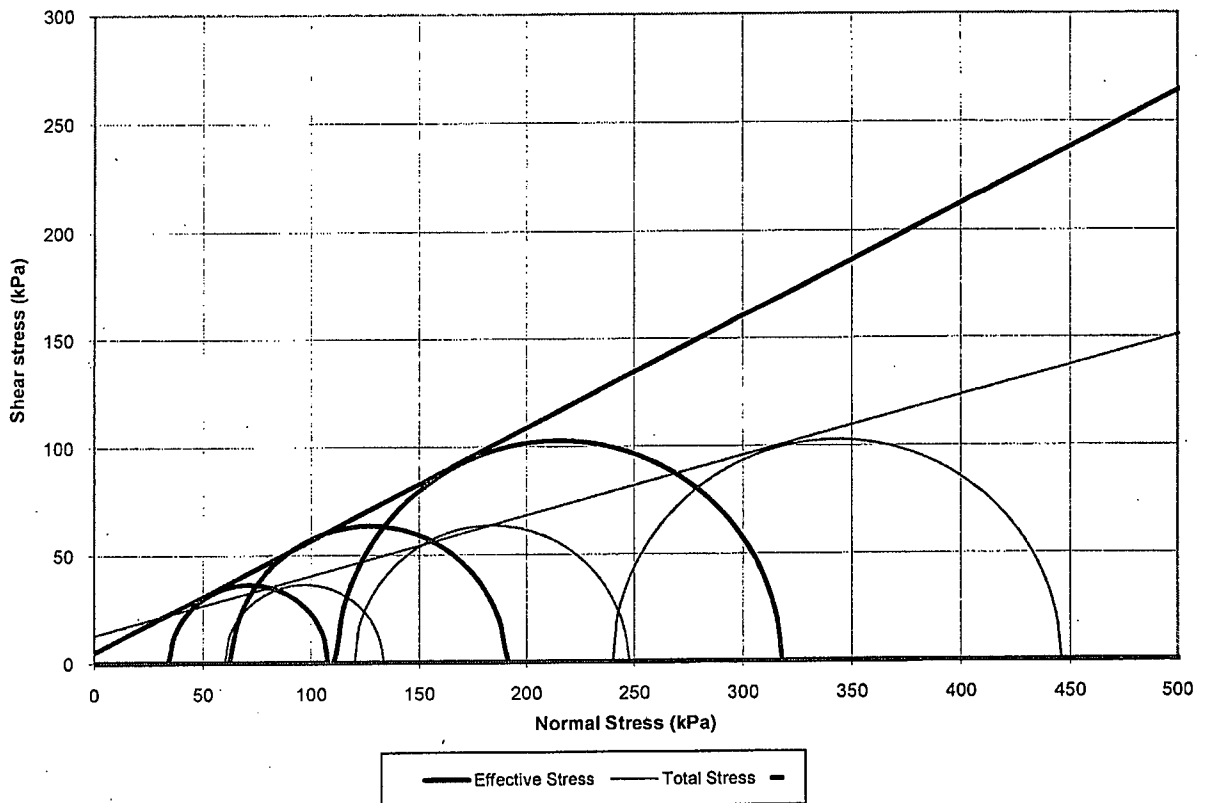
CONSOLIDATED-UNDRAINED TRIAXIAL COMPRESSION TEST (3 STAGES) MOHR CIRCLES OF TOTAL AND EFFECTIVE STRESSES

Initial Sample Height:	110.04	mm	Initial Water Content:	62.3	%
Initial Sample Diameter:	53.94	mm	Initial Bulk Density:	1.60	t/m ³
Initial B Value:	38	%	Initial Dry Density:	0.99	t/m ³
B Value before Consolidation:	98	%	Final Water Content:	60.1	%

Consolidation Stage			Failure Values				
	Cell Pressure (kPa)	Back Pressure (kPa)	Eff. Consol. Stress	Deviator Stress (kPa)	Pore Pressure Change During Shearing Δu (kPa)	Effective Principal Stress (kPa)		Vertical Strain (%)
						Major σ_1'	Minor σ_3'	
STAGE 1	360	300	60	73.33	25.5	107.83	34.50	3.52
STAGE 2	420	300	120	127.10	56.8	190.30	63.20	2.77
STAGE 3	540	300	240	205.58	128.2	317.38	111.80	3.42

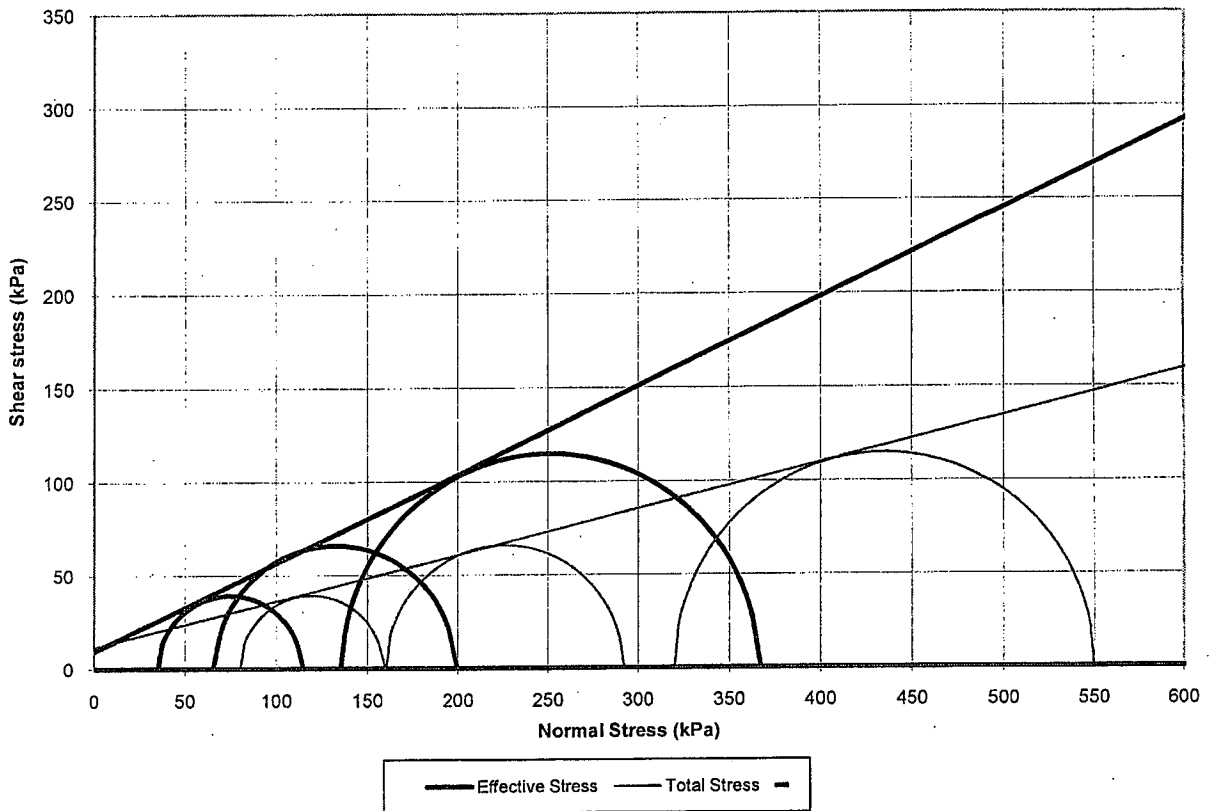
CONSOLIDATED-UNDRAINED TRIAXIAL COMPRESSION TEST (3 STAGES) MOHR CIRCLES OF TOTAL AND EFFECTIVE STRESSES

Initial Sample Height:	116.22	mm	Initial Water Content:	70.1	%
Initial Sample Diameter:	53.89	mm	Initial Bulk Density:	1.57	t/m ³
Initial B Value:	40	%	Initial Dry Density:	0.92	t/m ³
B Value before Consolidation:	96	%	Final Water Content:	64.6	%

Consolidation Stage			Failure Values				
	Cell Pressure (kPa)	Back Pressure (kPa)	Eff. Consol. Stress	Deviator Stress (kPa)	Pore Pressure Change During Shearing Δu (kPa)	Effective Principal Stress (kPa)		Vertical Strain (%)
						Major σ_1'	Minor σ_3'	
STAGE 1	380	300	80	78.53	44.8	113.73	35.20	3.24
STAGE 2	460	300	160	131.66	93.6	198.06	66.40	2.65
STAGE 3	620	300	320	229.75	184	365.75	136.00	2.78

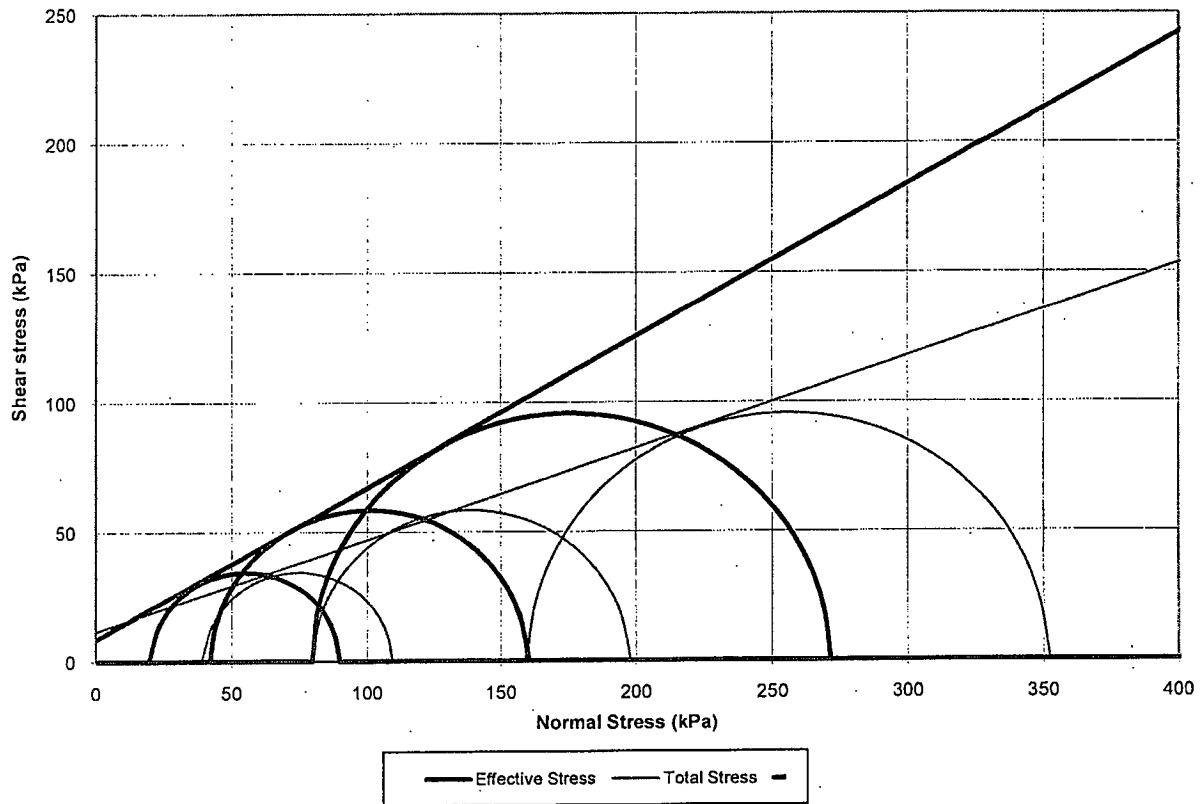
CONSOLIDATED-UNDRAINED TRIAXIAL COMPRESSION TEST (3 STAGES) MOHR CIRCLES OF TOTAL AND EFFECTIVE STRESSES

Initial Sample Height:	118.76	mm	Initial Water Content:	53.1	%
Initial Sample Diameter:	60.32	mm	Initial Bulk Density:	1.63	t/m ³
Initial B Value:	22	%	Initial Dry Density:	1.06	t/m ³
B Value before Consolidation:	96	%	Final Water Content:	53.2	%

Consolidation Stage			Failure Values				
	Cell Pressure (kPa)	Back Pressure (kPa)	Eff. Consol. Stress	Deviator Stress (kPa)	Pore Pressure Change During Shearing Δu (kPa)	Effective Principal Stress (kPa)		Vertical Strain (%)
						Major σ_1'	Minor σ_3'	
STAGE 1	490	450	40	68.97	19.5	89.47	20.50	3.55
STAGE 2	530	450	80	117.11	37.5	159.61	42.50	2.44
STAGE 3	610	450	160	191.47	80.5	270.97	79.50	3.21

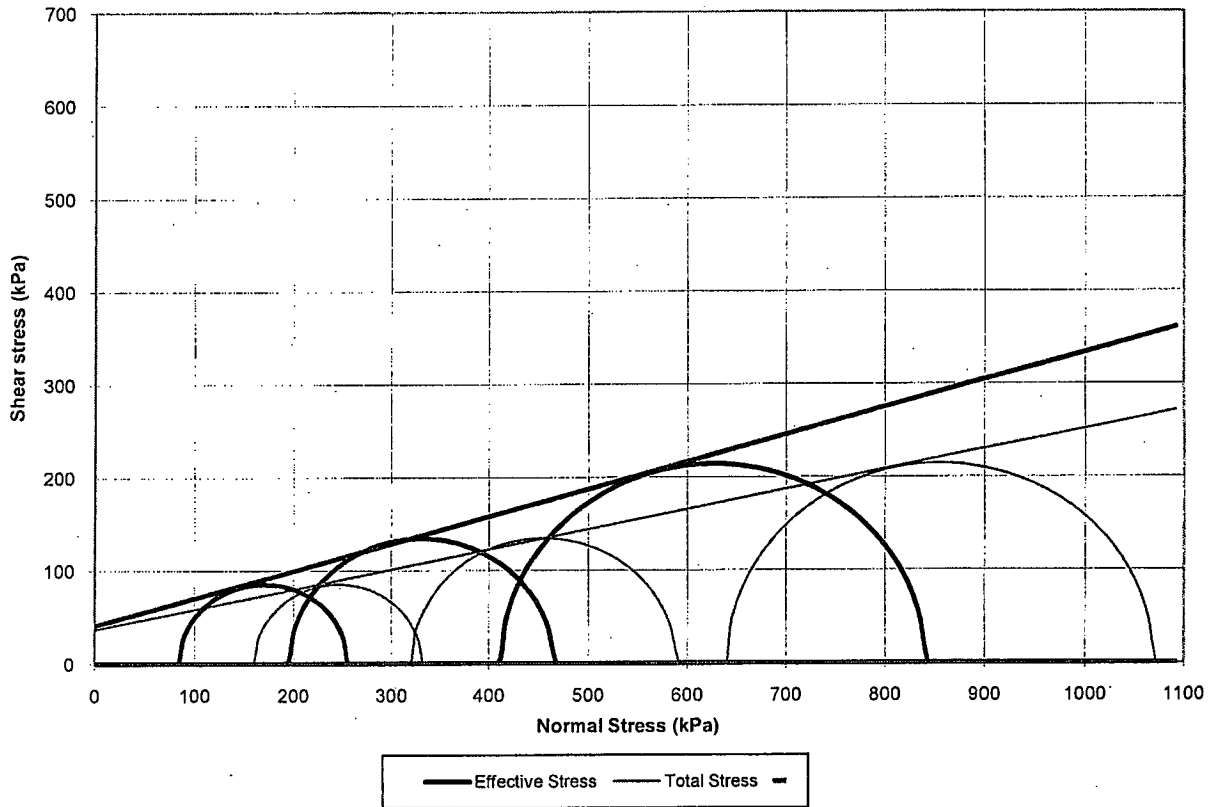
CONSOLIDATED-UNDRAINED TRIAXIAL COMPRESSION TEST (3 STAGES) MOHR CIRCLES OF TOTAL AND EFFECTIVE STRESSES

Initial Sample Height:	101.51	mm	Initial Water Content:	49.6	%
Initial Sample Diameter:	54.46	mm	Initial Bulk Density:	1.69	t/m ³
Initial B Value:	50	%	Initial Dry Density:	1.13	t/m ³
B Value before Consolidation:	100	%	Final Water Content:	43.6	%

Consolidation Stage			Failure Values				
	Cell Pressure (kPa)	Back Pressure (kPa)	Eff. Consol. Stress	Deviator Stress (kPa)	Pore Pressure Change During Shearing δu (kPa)	Effective Principal Stress (kPa)		Vertical Strain (%)
						Major σ_1'	Minor σ_3'	
STAGE 1	460	300	160	171.17	75.6	255.57	84.40	2.24
STAGE 2	620	300	320	268.95	124.1	464.85	195.90	1.72
STAGE 3	940	300	640	428.91	228.1	840.81	411.90	1.83

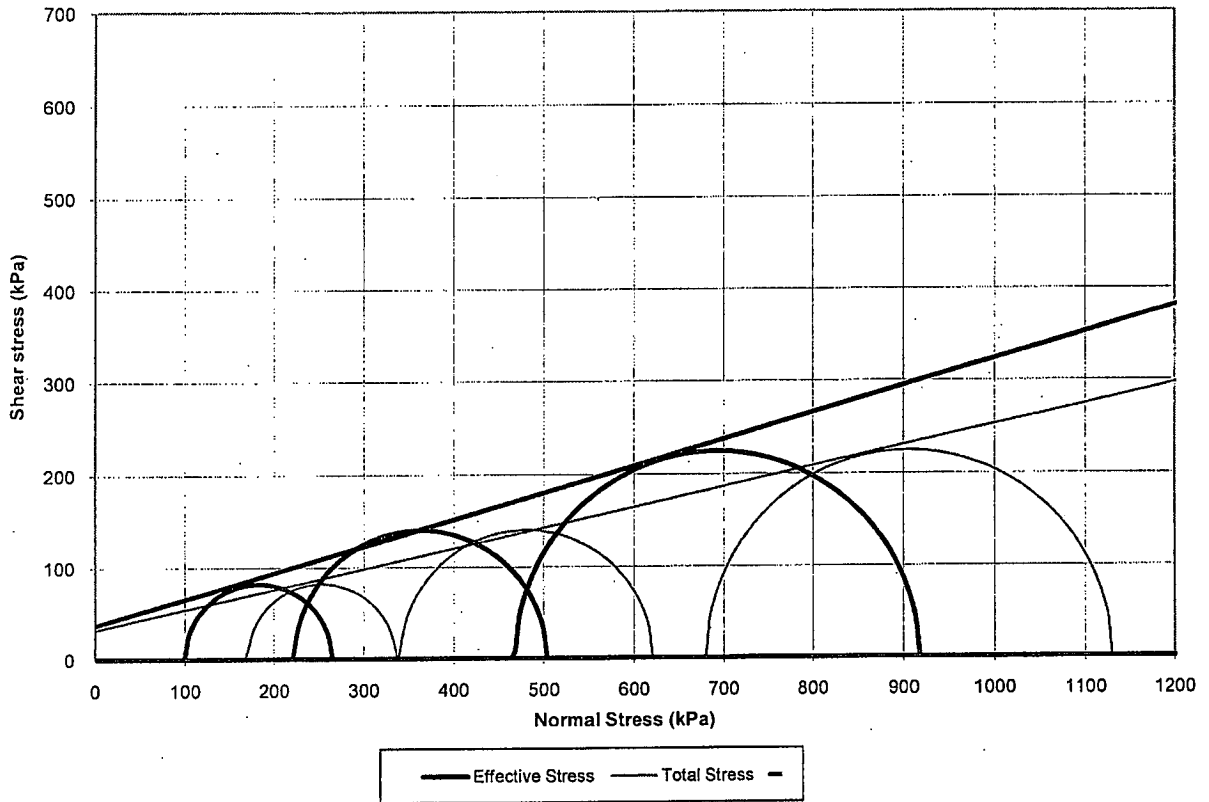
CONSOLIDATED-UNDRAINED TRIAXIAL COMPRESSION TEST (3 STAGES) MOHR CIRCLES OF TOTAL AND EFFECTIVE STRESSES

Initial Sample Height:	121.44	mm	Initial Water Content:	49.5	%
Initial Sample Diameter:	54.57	mm	Initial Bulk Density:	1.72	t/m ³
Initial B Value:	44	%	Initial Dry Density:	1.15	t/m ³
B Value before Consolidation:	100	%	Final Water Content:	45.2	%

Consolidation Stage			Failure Values				
	Cell Pressure (kPa)	Back Pressure (kPa)	Eff. Consol. Stress	Deviator Stress (kPa)	Pore Pressure Change During Shearing Δu (kPa)	Effective Principal Stress (kPa)		Vertical Strain (%)
						Major σ_1'	Minor σ_3'	
STAGE 1	470	300	170	164.89	70.4	264.49	99.60	2.13
STAGE 2	640	300	340	280.44	117.4	503.04	222.60	1.25
STAGE 3	980	300	680	449.25	212.2	917.05	467.80	1.96

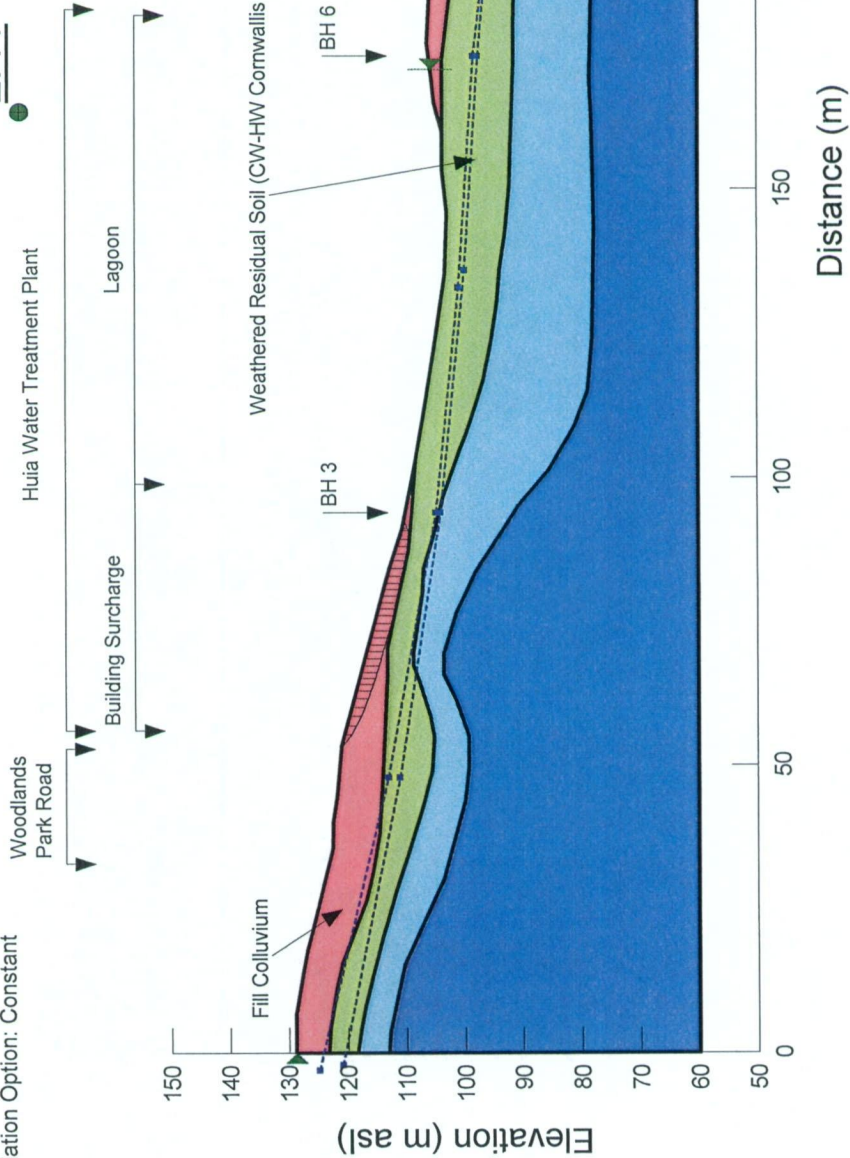
1. Method: Morgenstern-Price
2. Direction of movement: Left to Right
3. Optimization: Yes
4. Soil Strength Models: Mohr-Coulomb
5. PWP Conditions Source: Piezometric Line
6. Slip Surface Option: Auto-Search
7. C-Phi Correlation Coeff: 0 (All Soils)
8. Tension Crack Angle: 0
9. Horz Seismic Load:
10. FOS Calculation Option: Constant

Our analyses indicate that generally acceptable levels of stability are expected for the slope in static conditions (FoS > 2). For seismic conditions a minimum factor of safety (FoS) of 1.05 was calculated within the site and 0.97 in the slope below the site (beyond the property boundary). In all seismic assessments FoS values for slip circles that intersect the Huia WTP property boundary were >1.0.

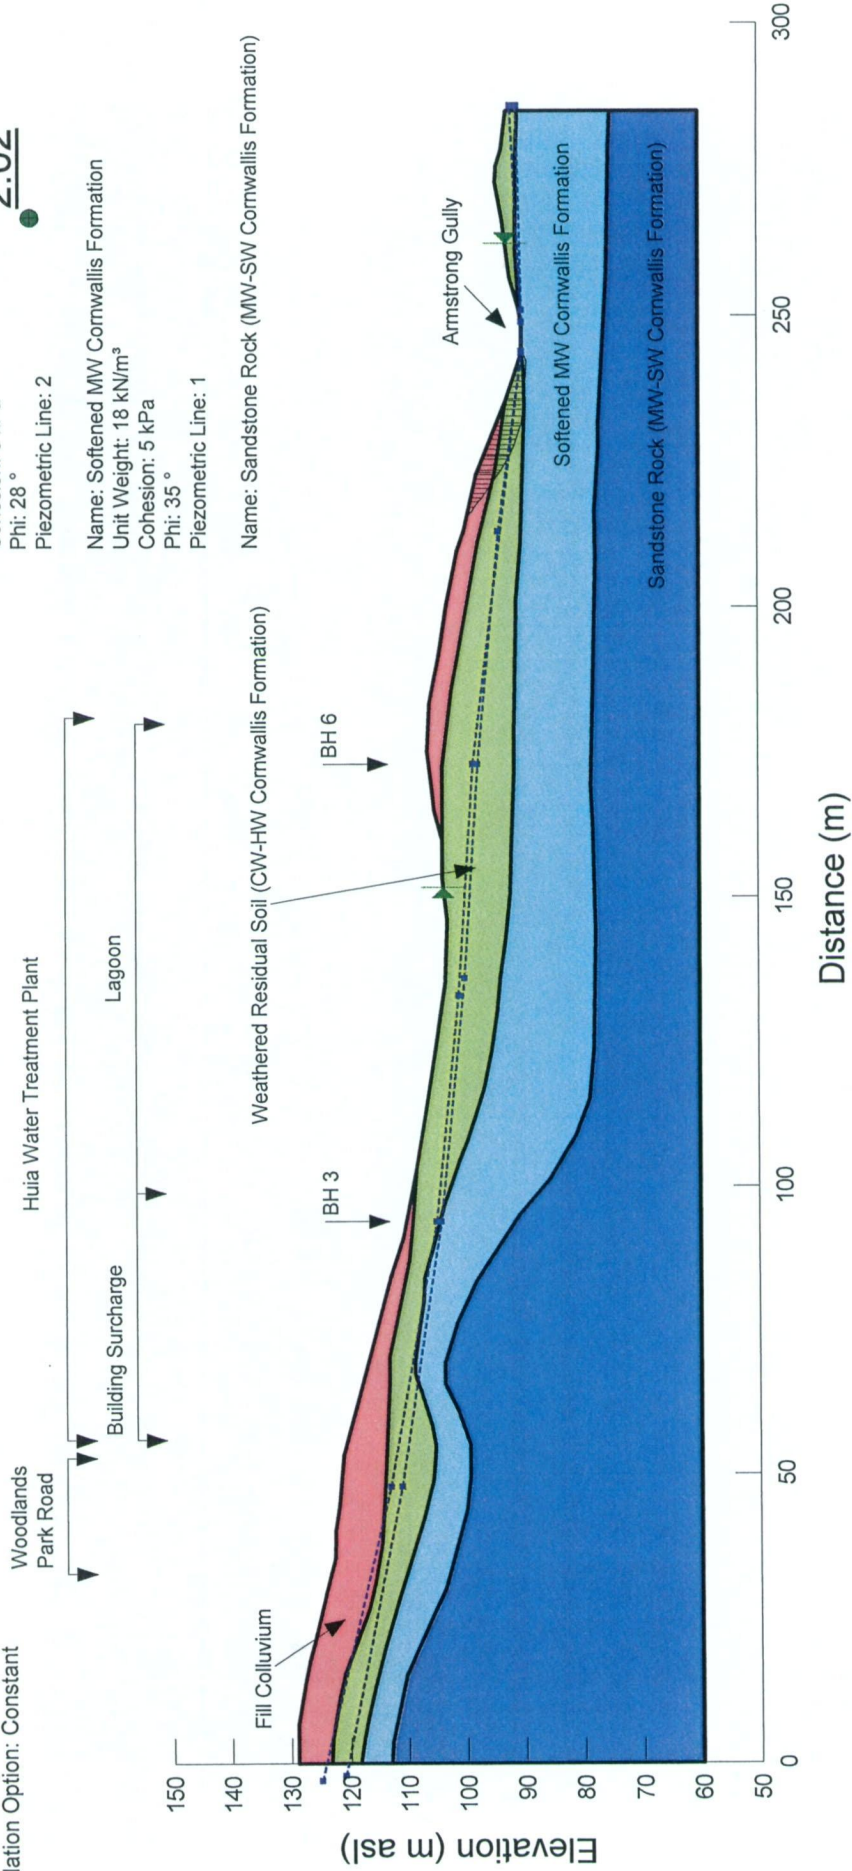
1. Method: Morgenstern-Price
2. Direction of movement: Left to Right
3. Optimization: Yes
4. Soil Strength Models: Mohr-Coulomb
5. PWP Conditions Source: Piezometric Line
6. Slip Surface Option: Auto-Search
7. C-Phi Correlation Coeff: 0 (All Soils)
8. Tension Crack Angle: 0
9. Horz Seismic Load: 0.31
10. FOS Calculation Option: Constant

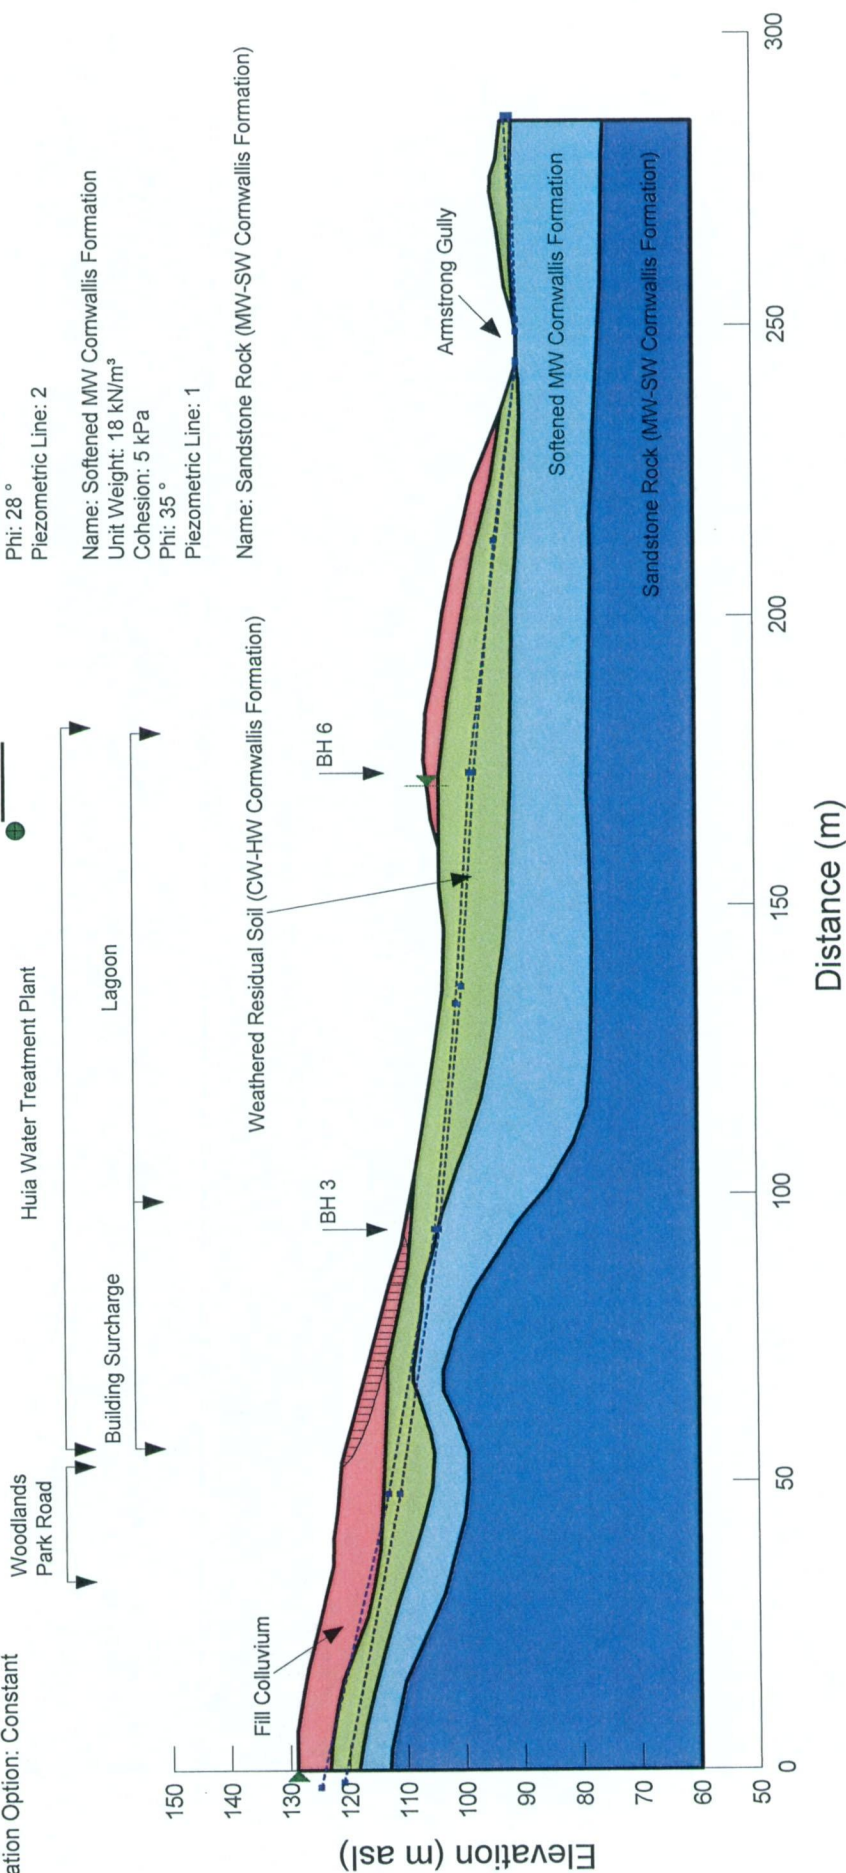
1. Method: Morgenstern-Price
2. Direction of movement: Left to Right
3. Optimization: Yes
4. Soil Strength Models: Mohr-Coulomb
5. PWP Conditions Source: Piezometric Line
6. Slip Surface Option: Auto-Search
7. C-Phi Correlation Coeff: 0 (All Soils)
8. Tension Crack Angle: 0
9. Horz Seismic Load: 0.31
10. FOS Calculation Option: Constant

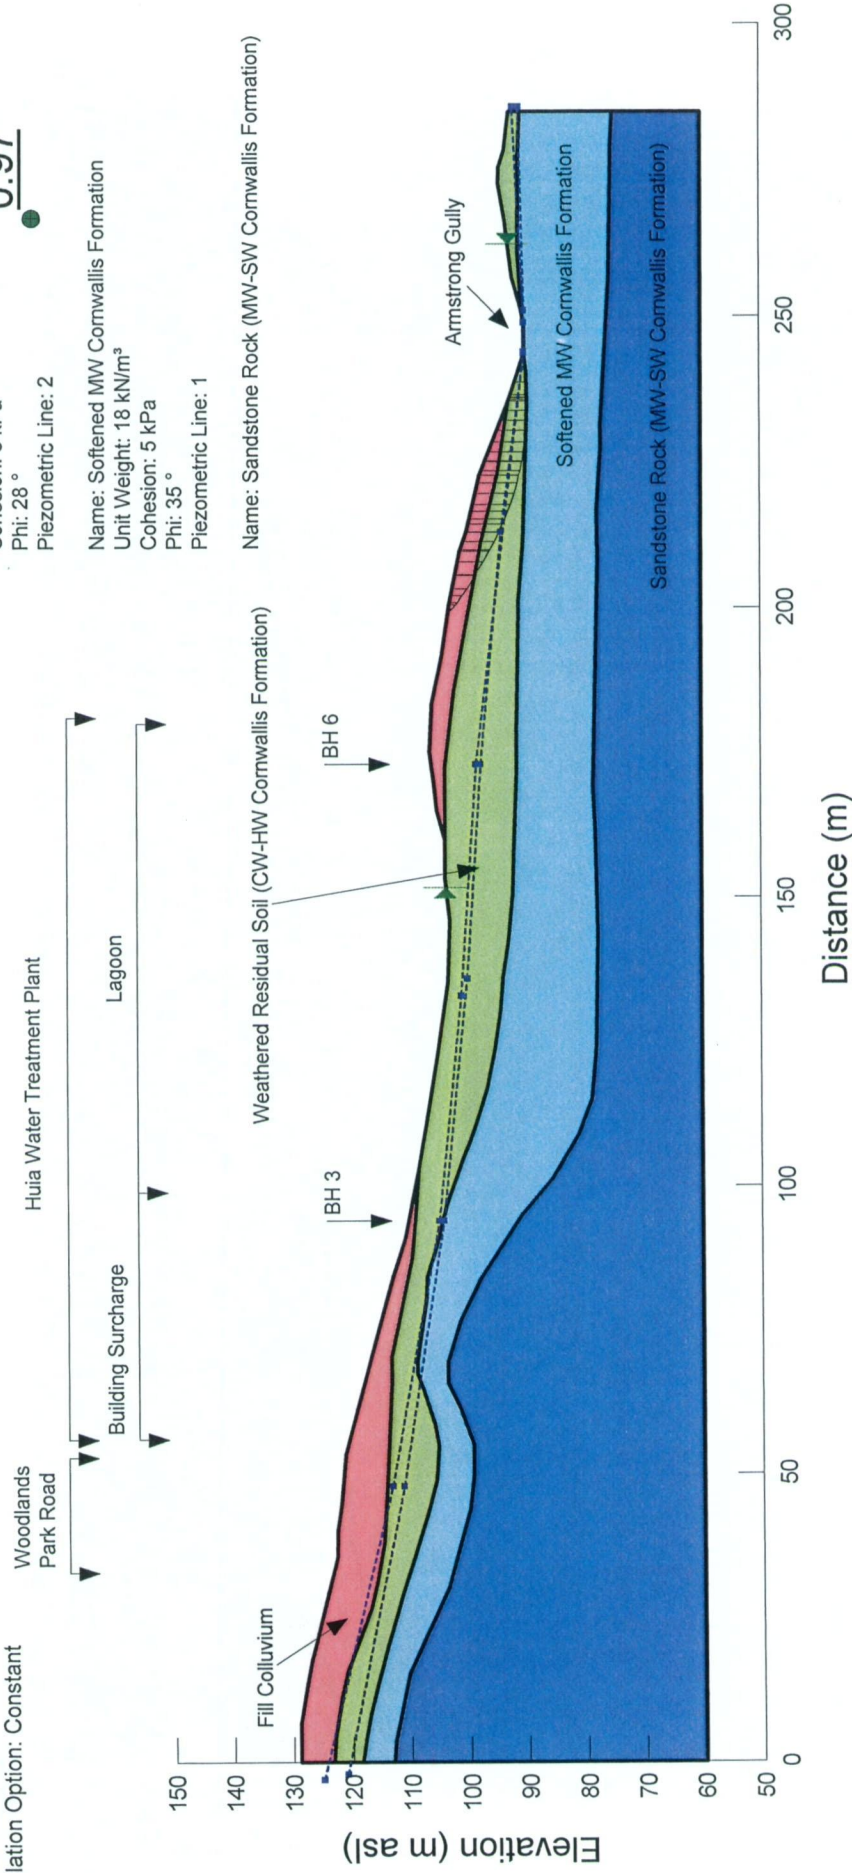
Name: Softened MW Cornwallis Formation
 Unit Weight: 18 kN/m³
 Cohesion: 5 kPa
 Phi: 35°
 Piezometric Line: 1

Name: Sandstone Rock (MW-SW Cornwallis Formation)
