# BOREHOLE LOG

North Harbour No 2 Watermain

1-C0935.46

Watercare Services Limited

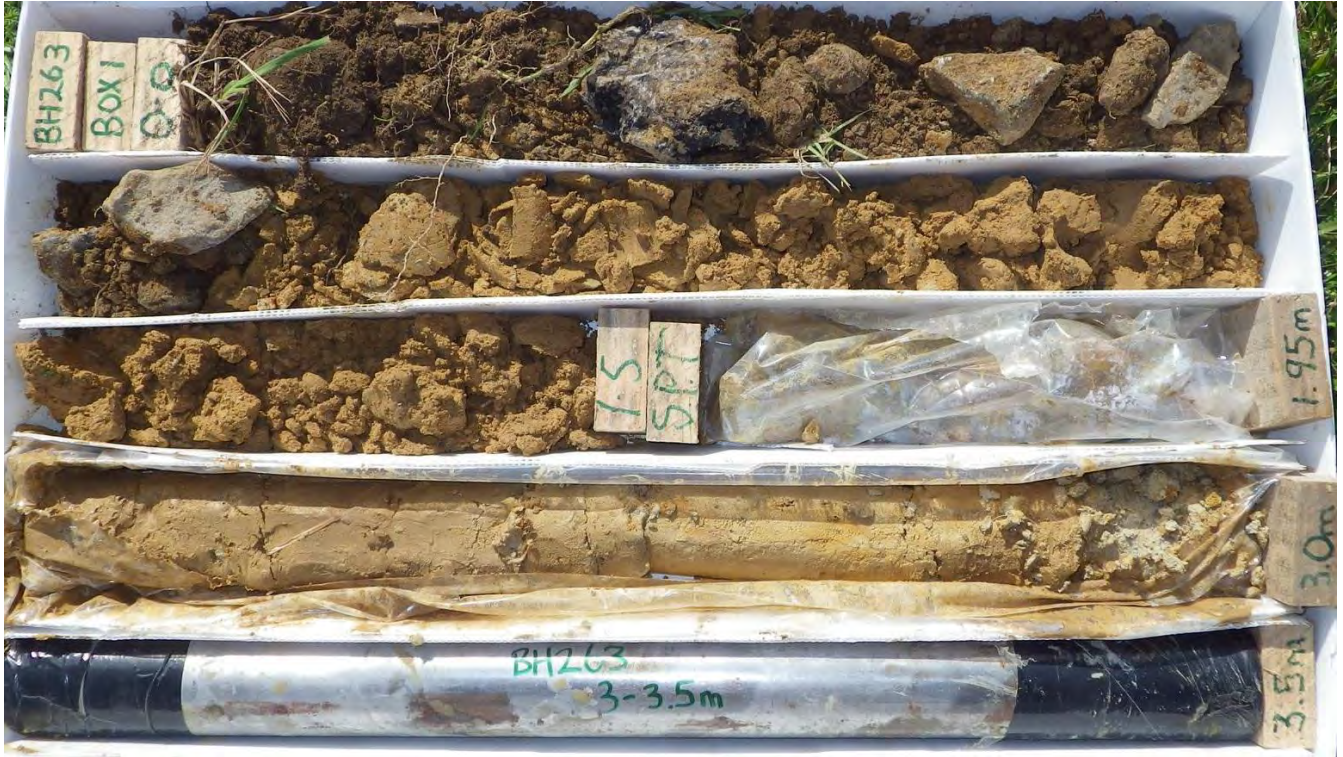
Box 1 of 4

0.00m – 3.50m

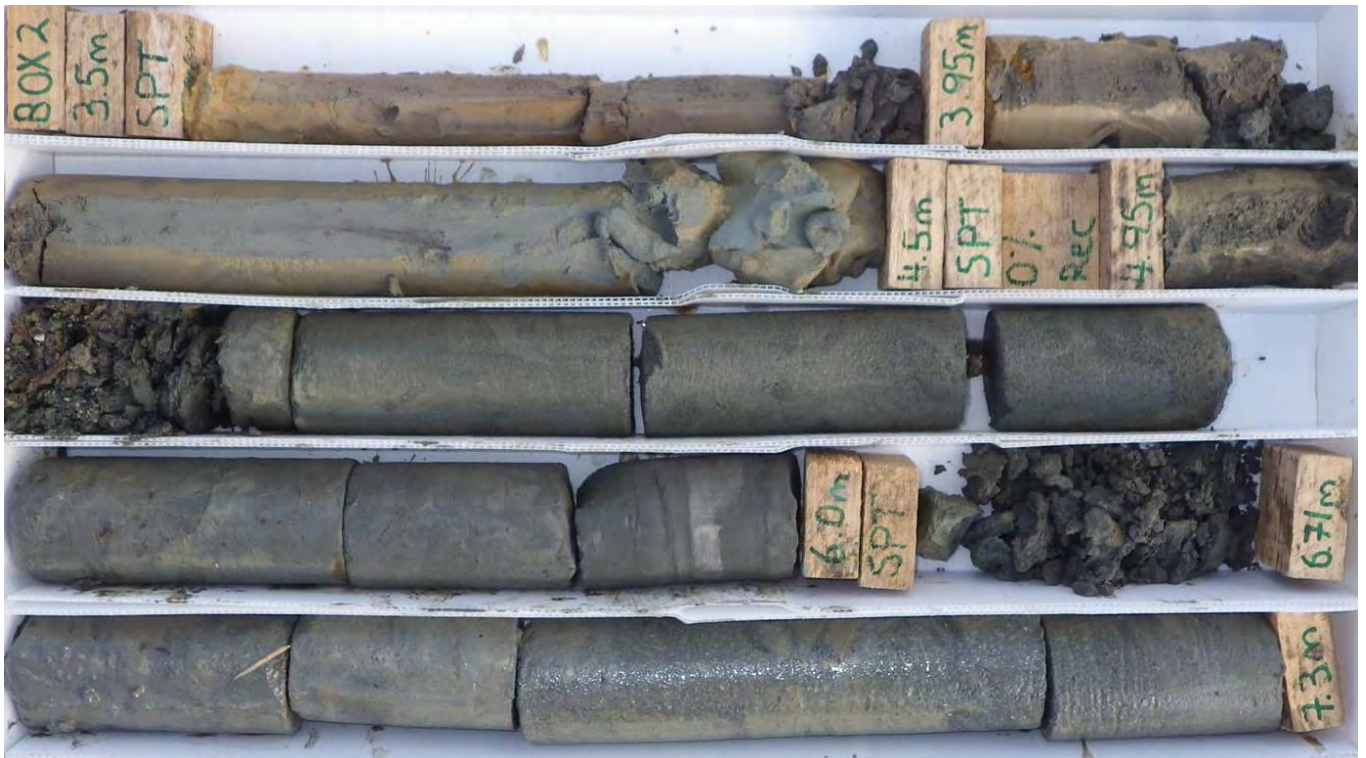
Box 2 of 4

3.50m – 6.90m

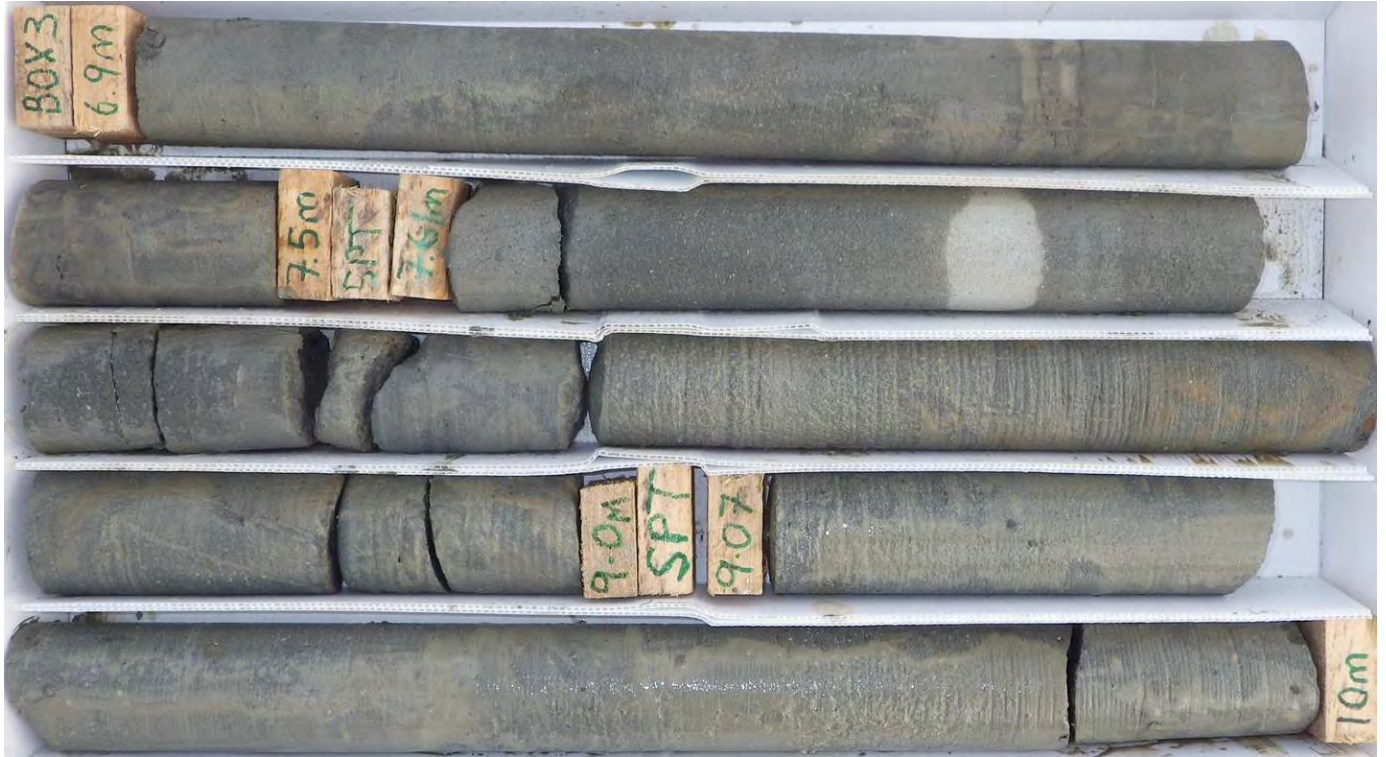
Box 3 of 4

6.90m – 10.00m

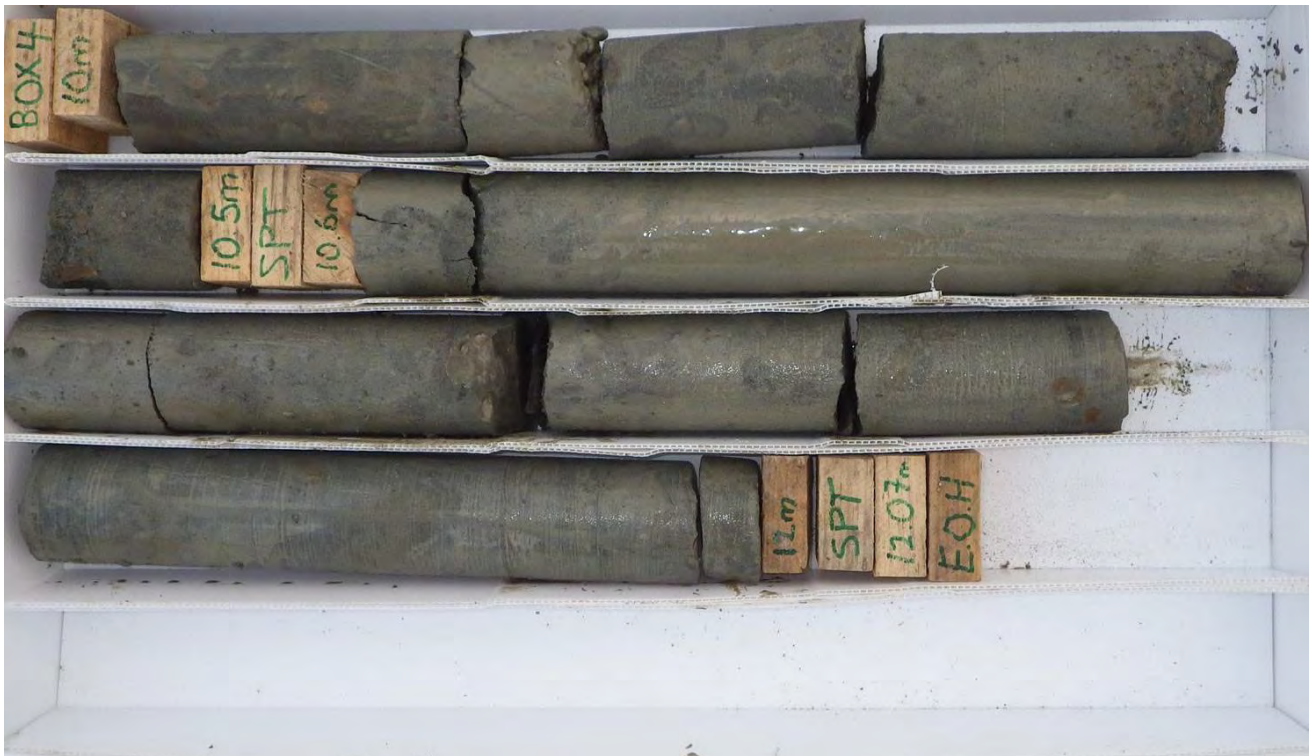
Box 4 of 4

10.00m – 12.07m EOH

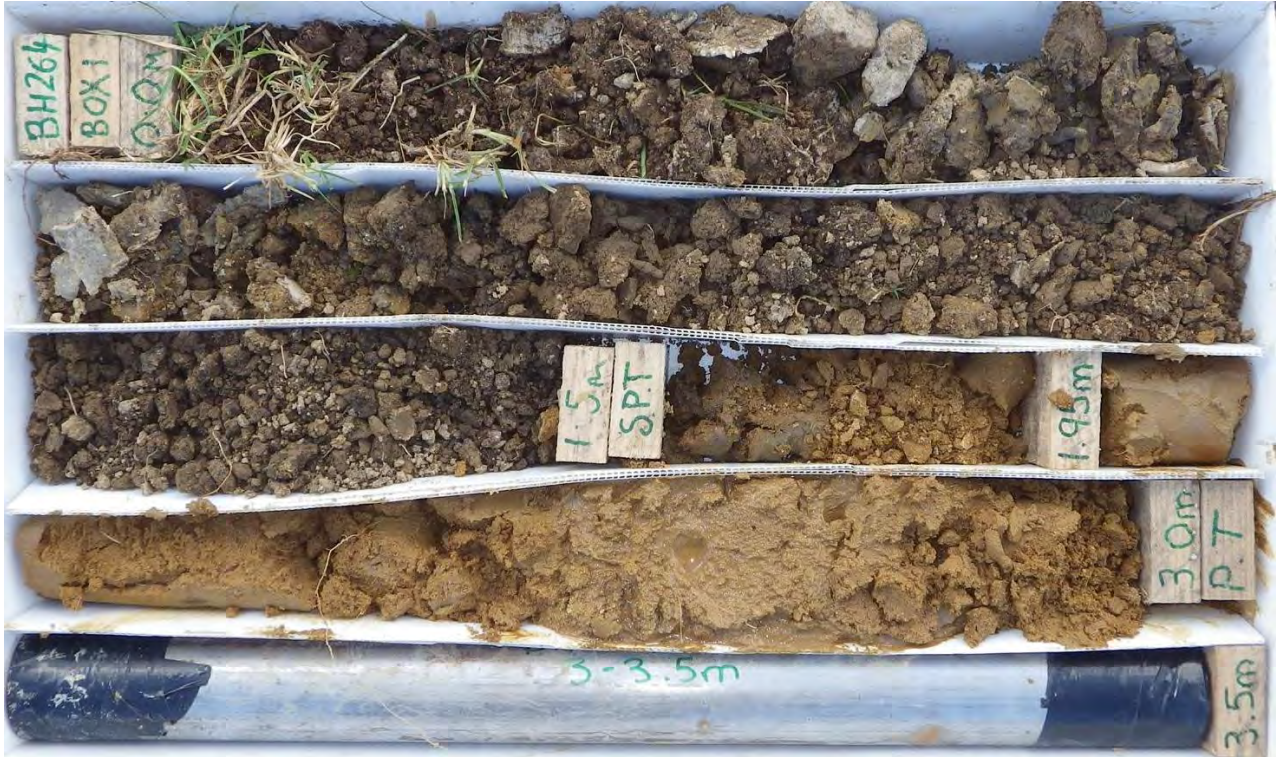
Box 1 of 4

0.00m – 3.50m

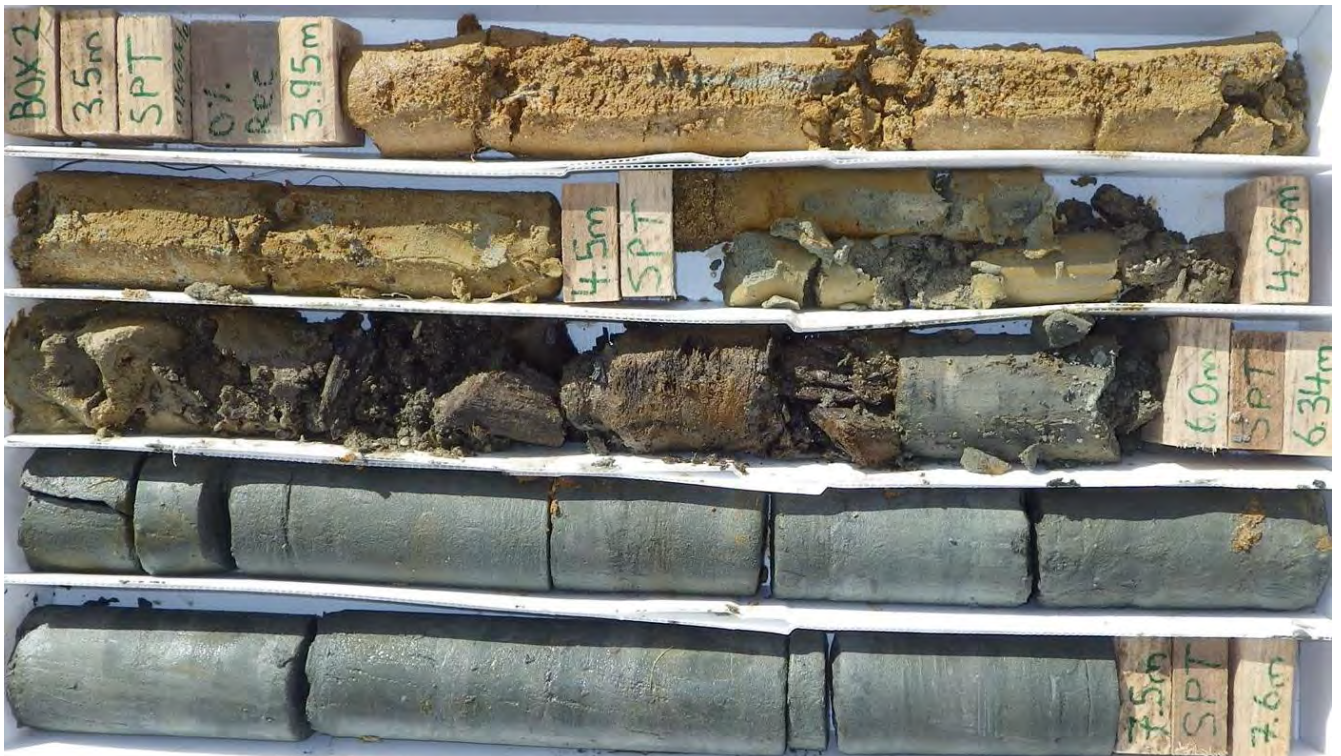
Box 2 of 4

3.50m – 7.60m

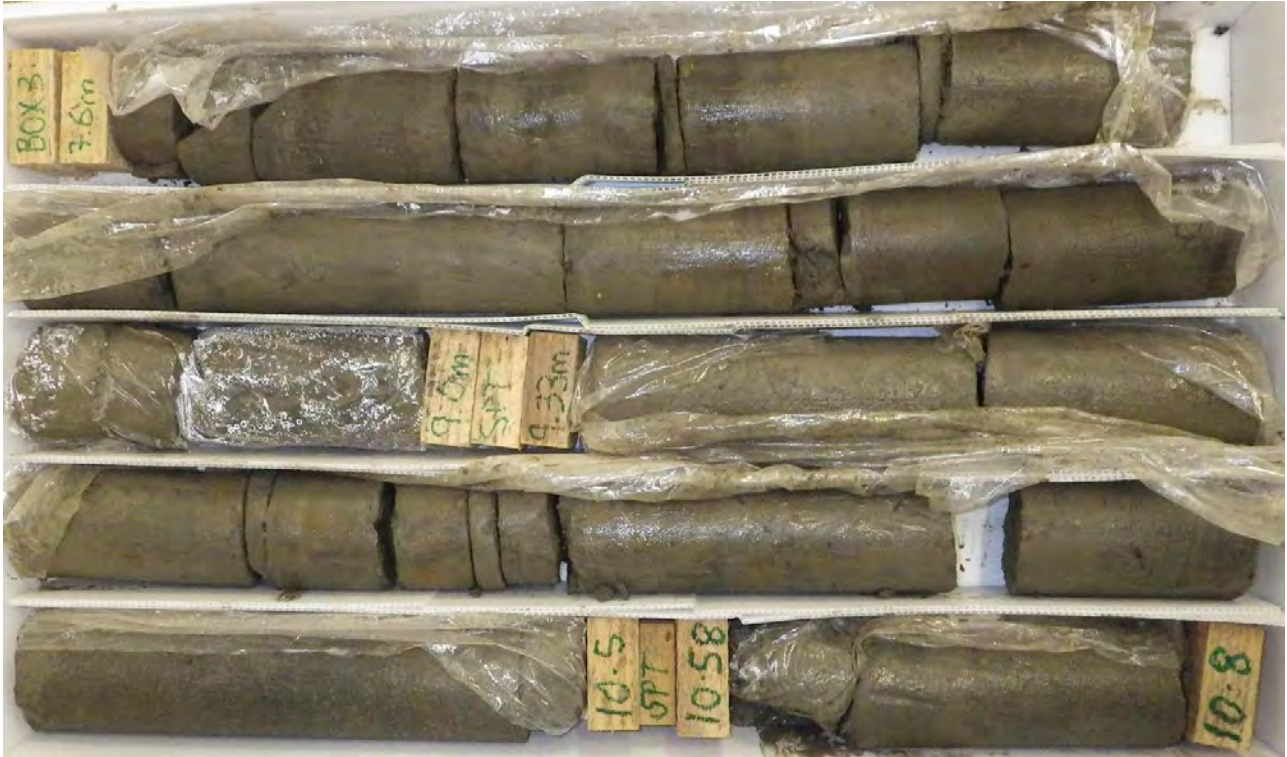
Box 3 of 4

7.60m – 10.80m

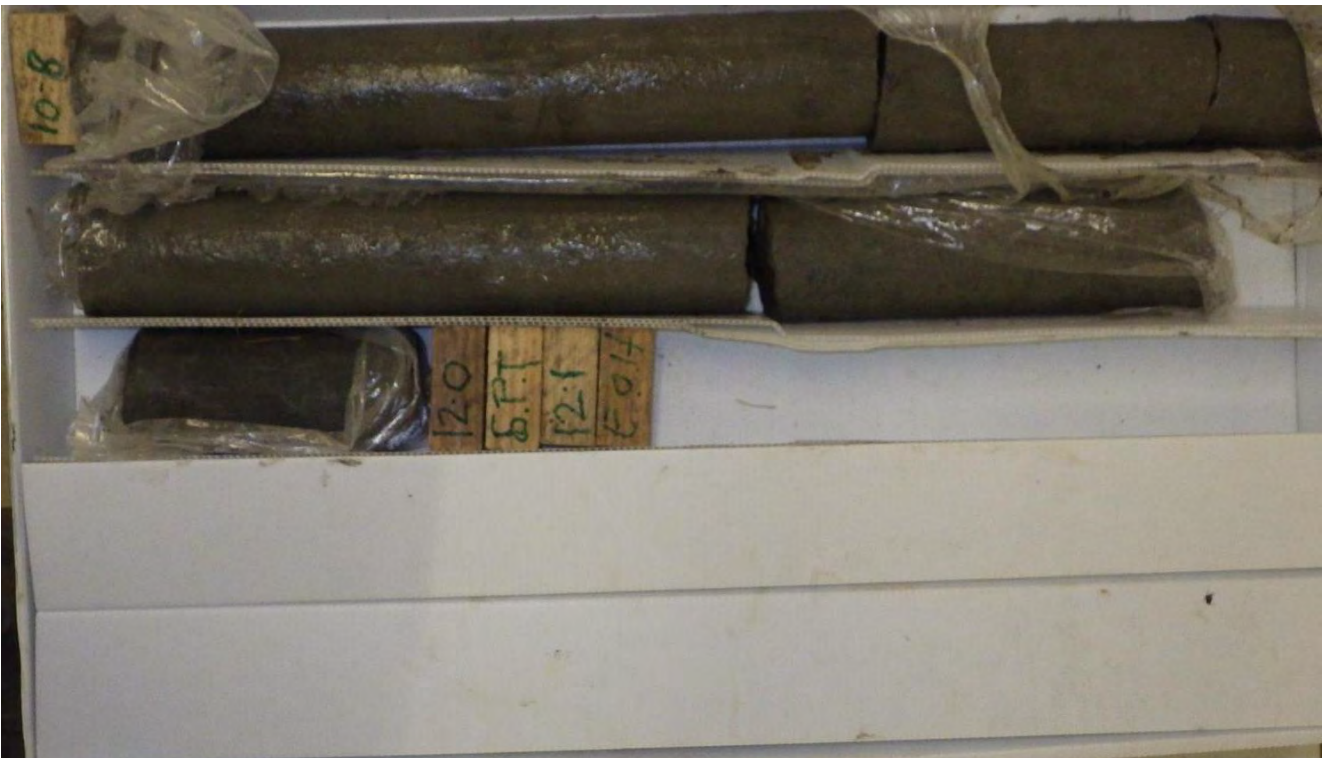
Box 4 of 4

10.80m – 12.10m EOH

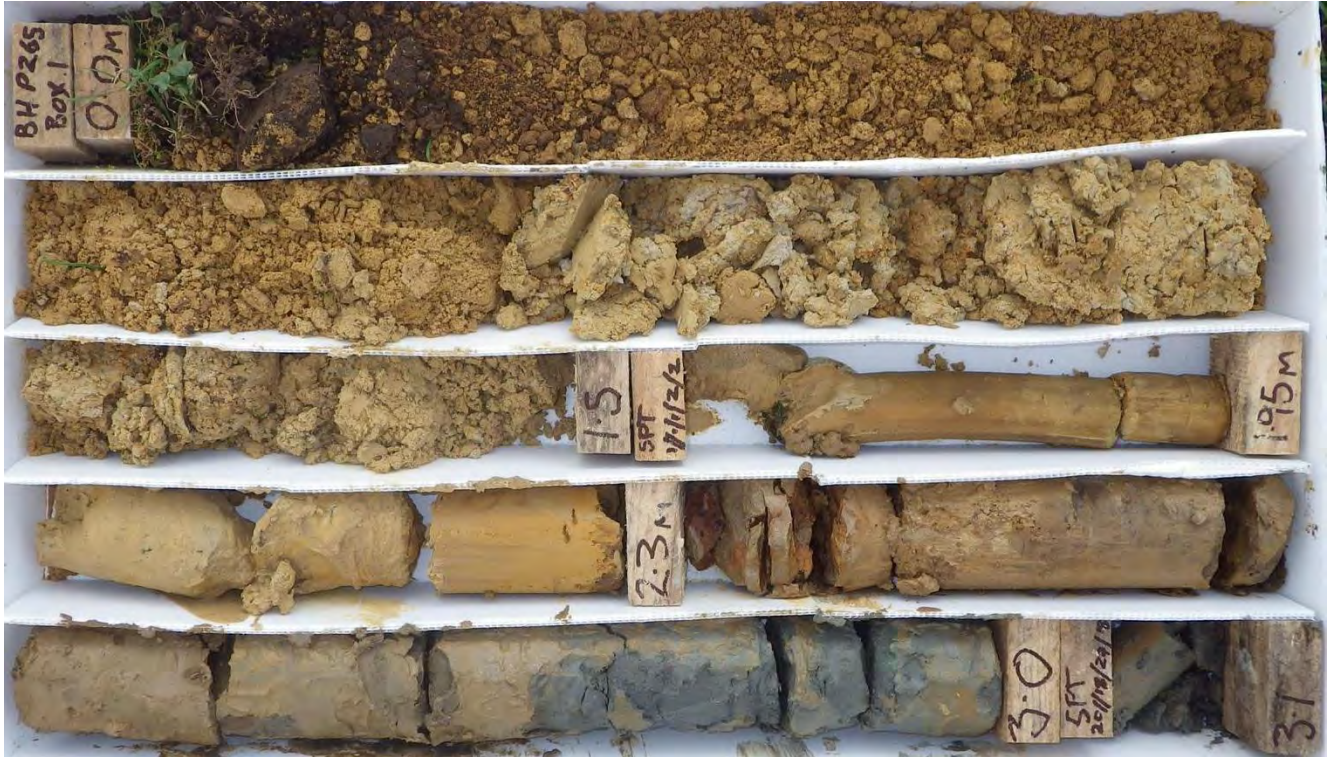
Box 1 of 3

0.00m – 3.10m

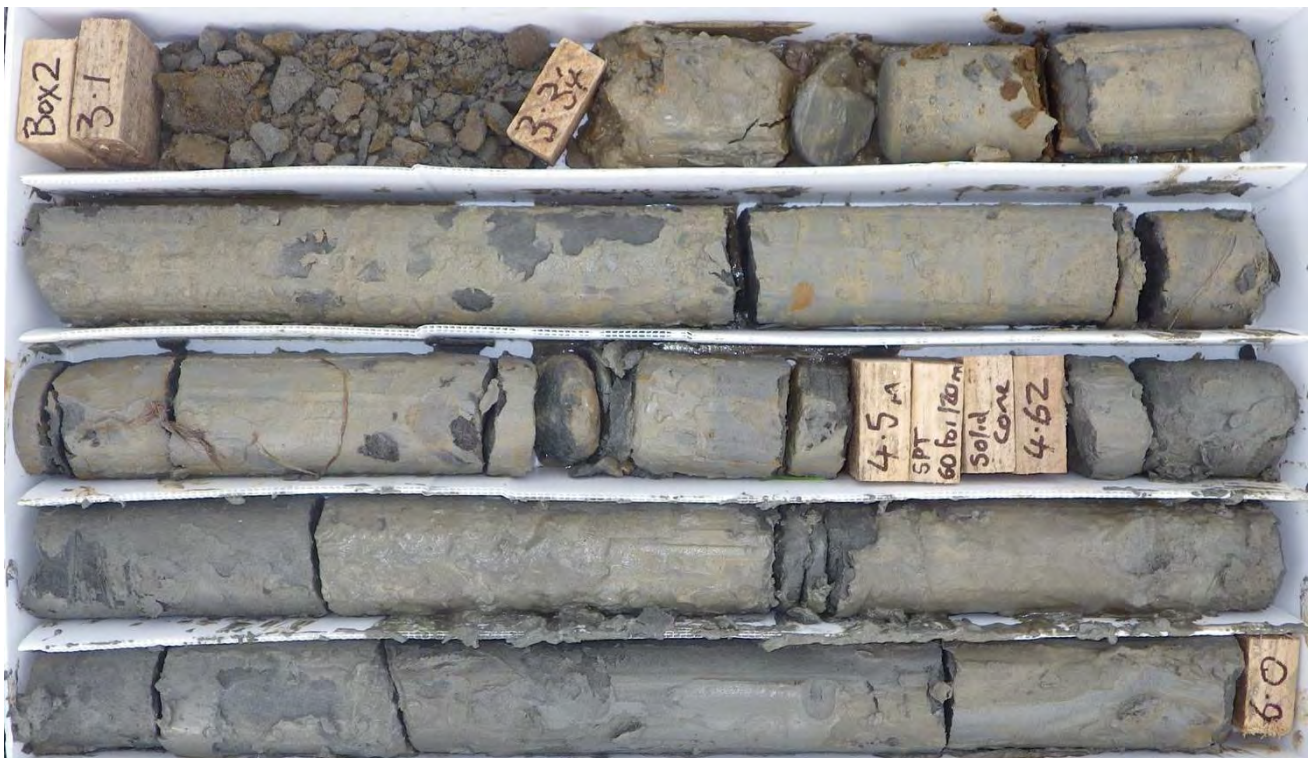
Box 2 of 3

3.10m – 6.00m

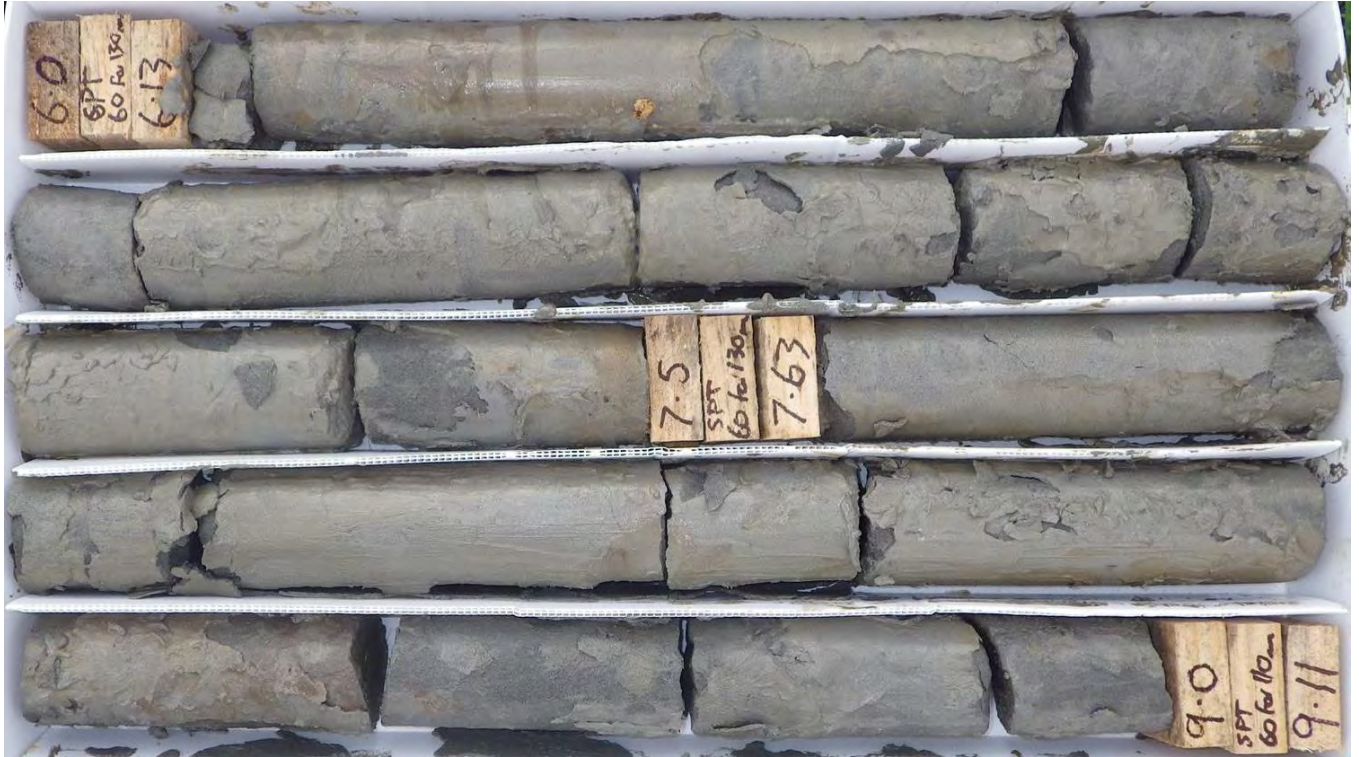
Box 3 of 3

6.00m – 9.11m EOH

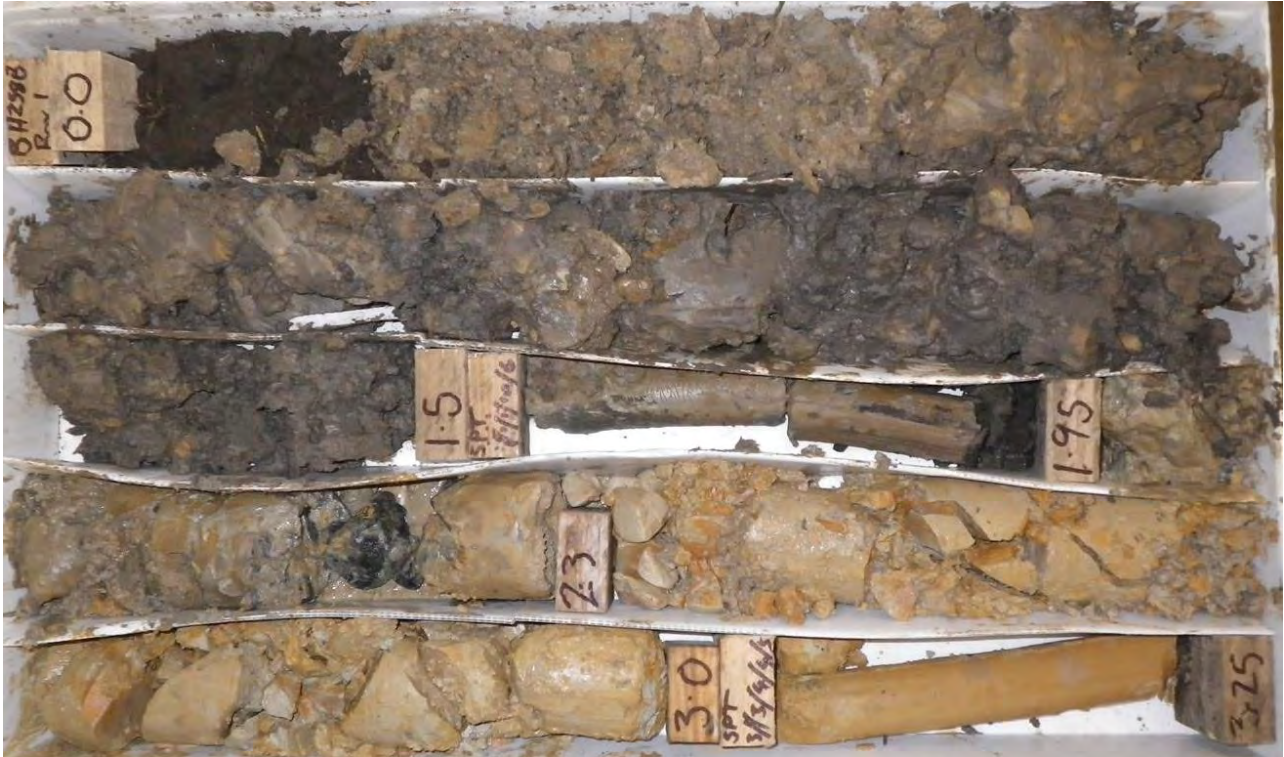
Box 1 of 4

0.00m – 3.25m

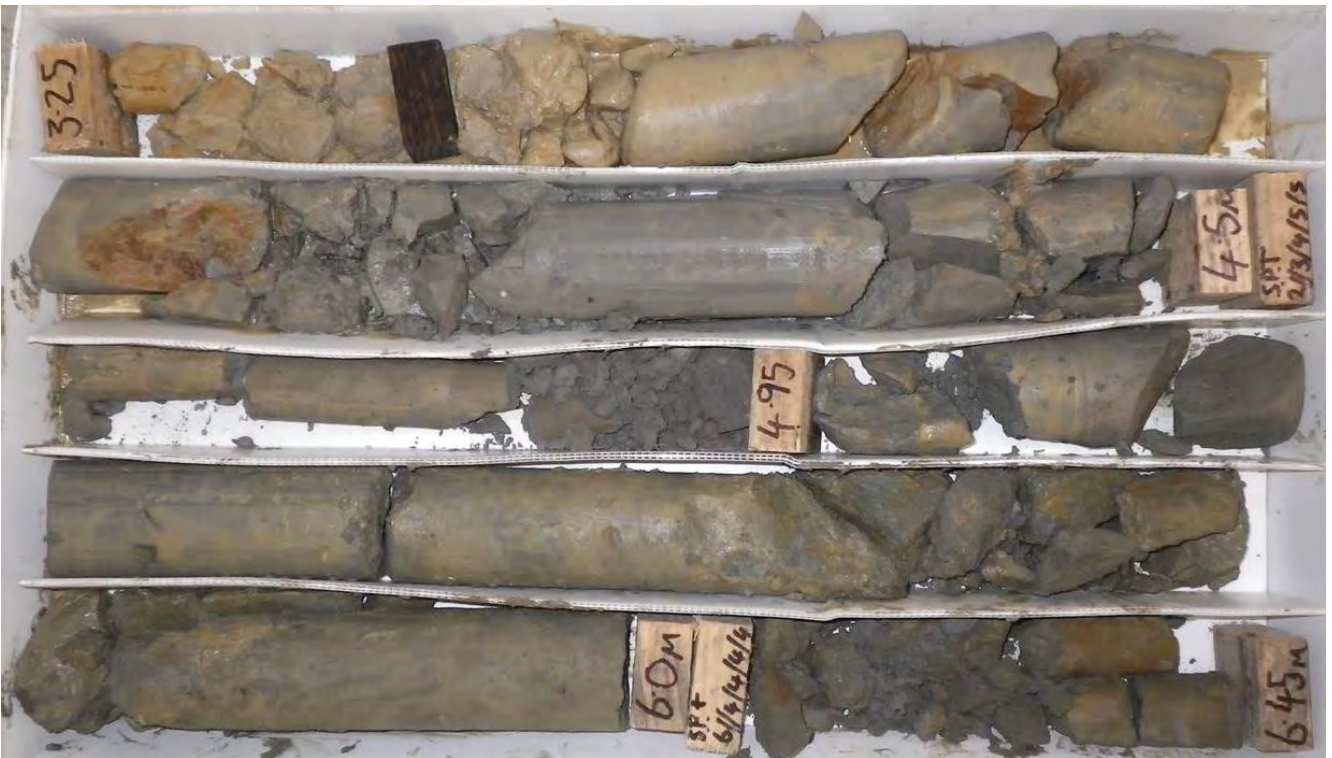
Box 2 of 4

3.25m – 6.45m

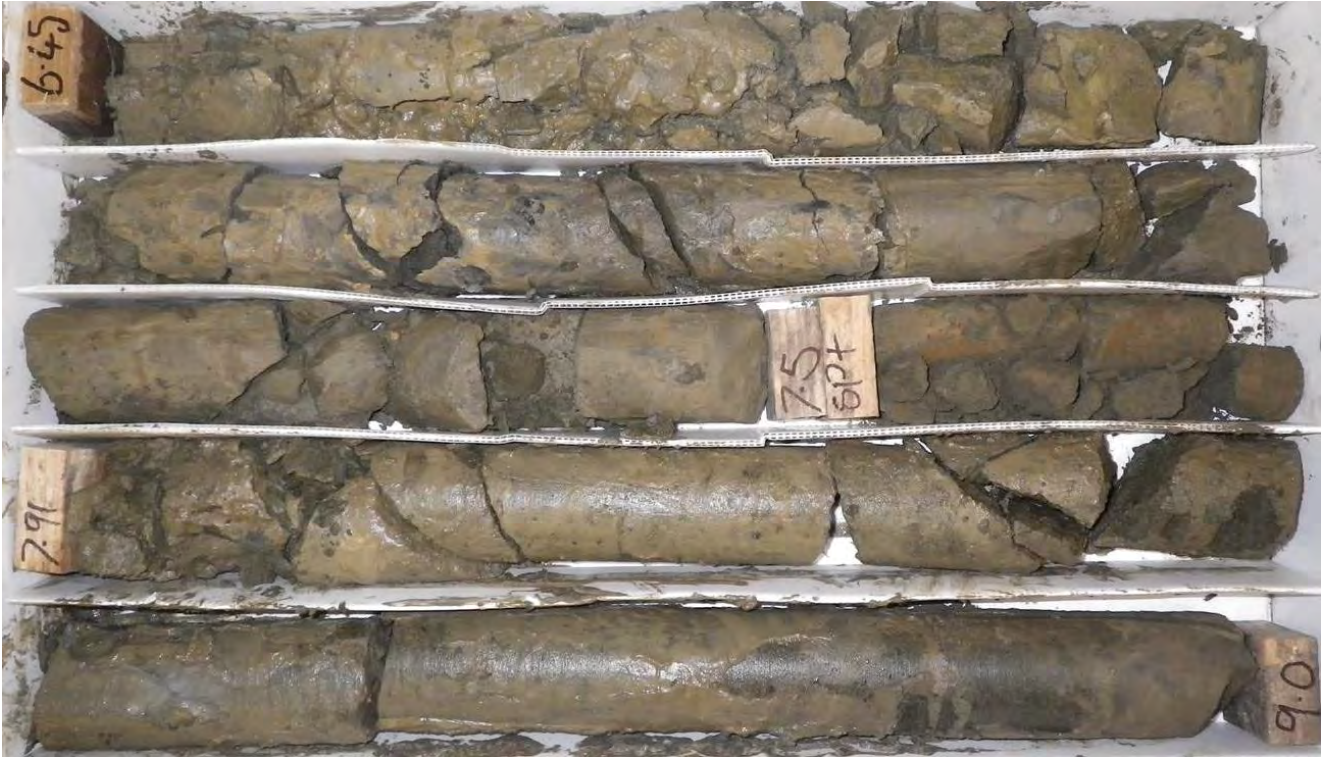
Box 3 of 4

6.45m – 9.00m

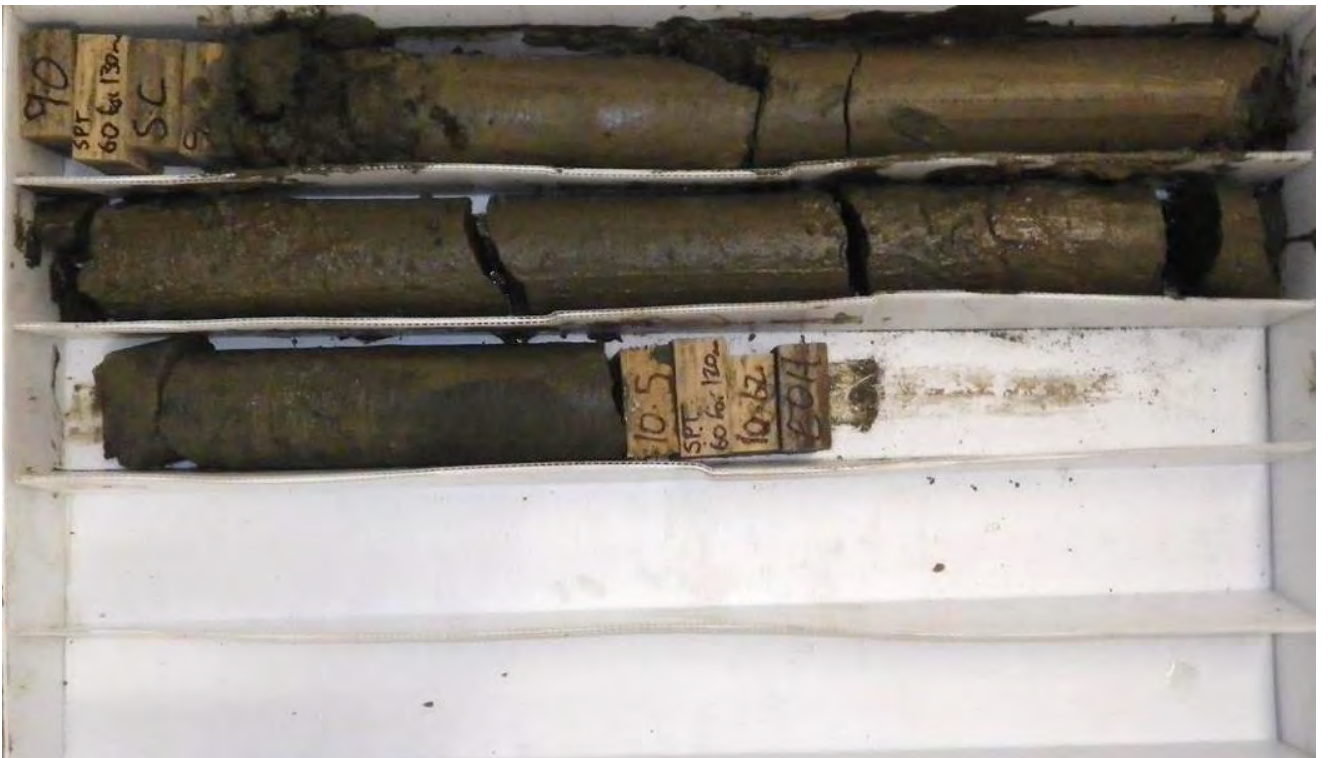
Box 4 of 4

9.00m – 10.62m EOH
