**NORTH HARBOUR 2 WATERMAIN
AND NORTHERN INTERCEPTOR IN SHARED CORRIDOR**

**TECHNICAL REPORT D
ASSESSMENT OF ECOLOGICAL EFFECTS**

May 2016

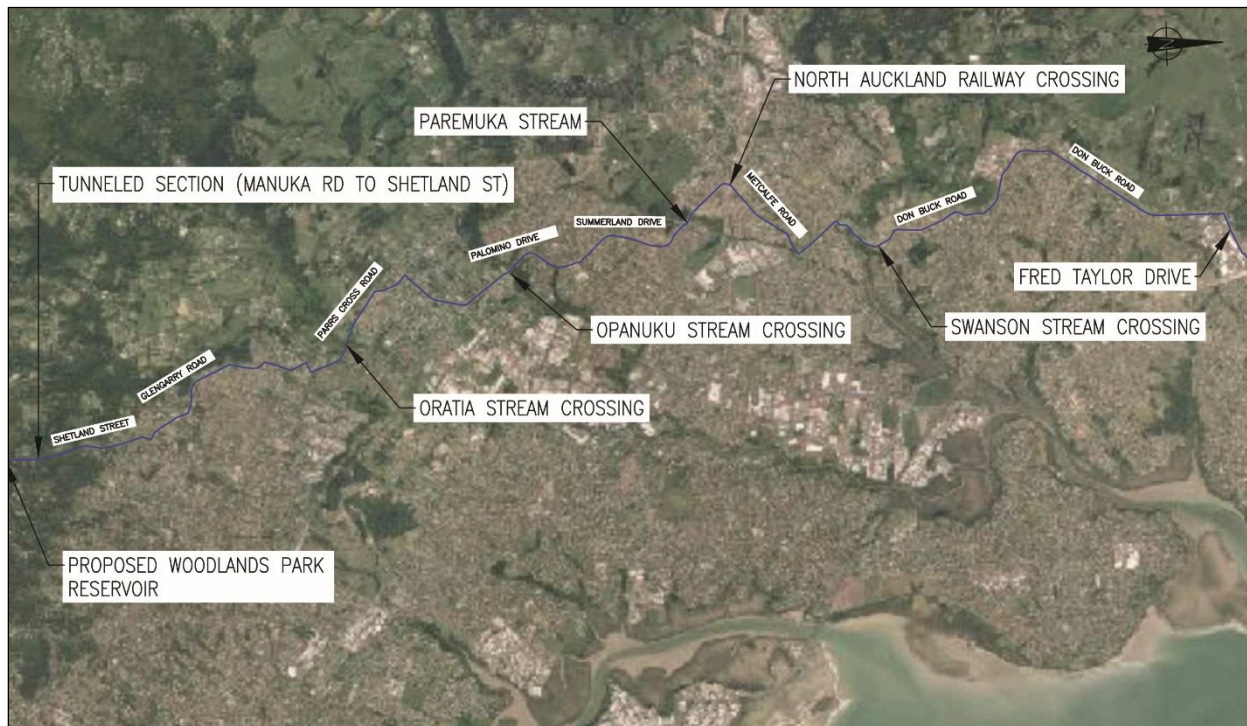
Figure 2. NOR1, Titirangi to Westgate.

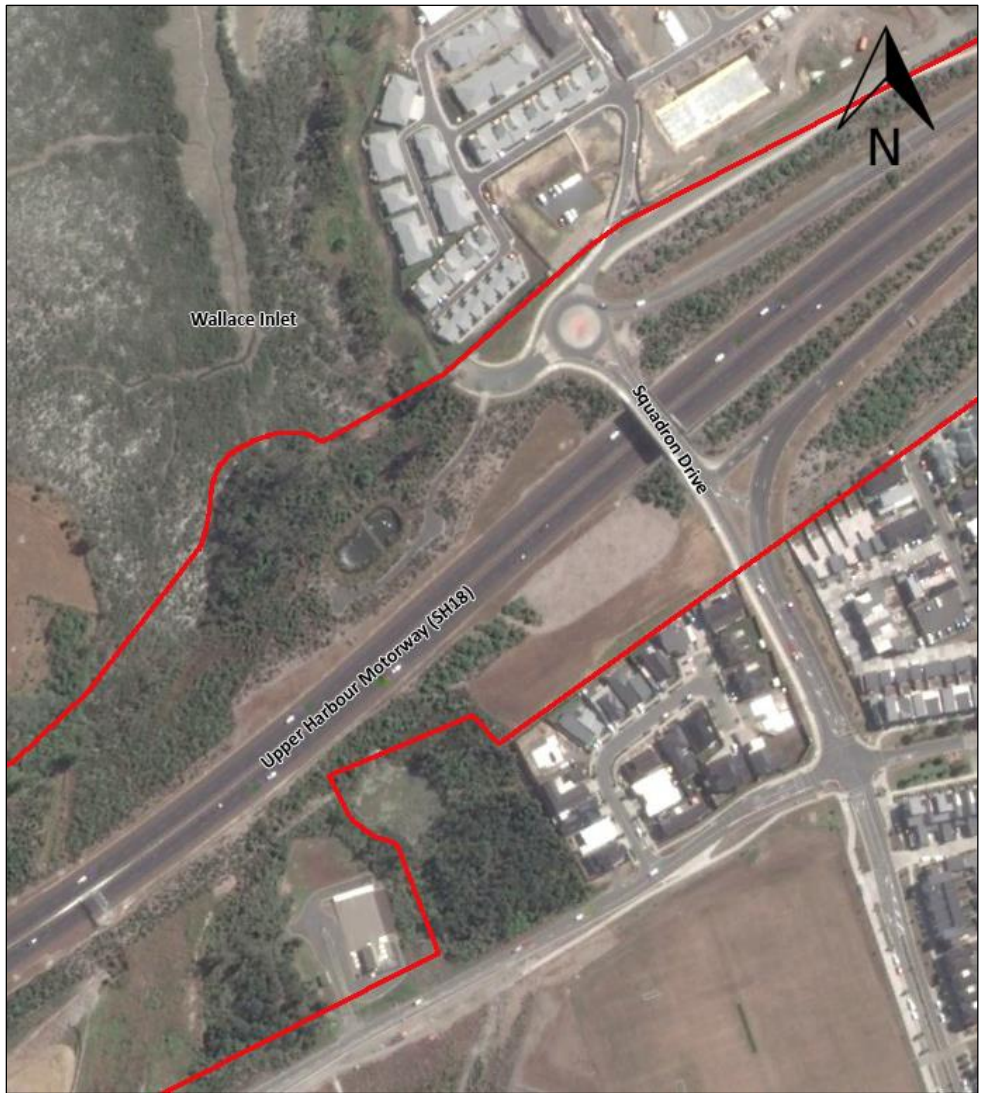
Figure 5. Designation boundary (red) within the vicinity of Wallace Inlet

Preclearance surveys for banded rail should be undertaken where any vegetation is required to be removed at Wallace Inlet (Figure 5). All vegetation that requires removal from within this area should be replaced. Where vegetation removal is required, there is an opportunity for a biodiversity gain through planting rush grass (*Apodasmia similis*) along the southern edge of the Wallace Inlet. Rush grass is an important nesting habitat for banded rail in estuarine areas. Where a banded rail nest is identified within affected vegetation, clearance should not be undertaken until nesting is complete (i.e. chicks have fledged).

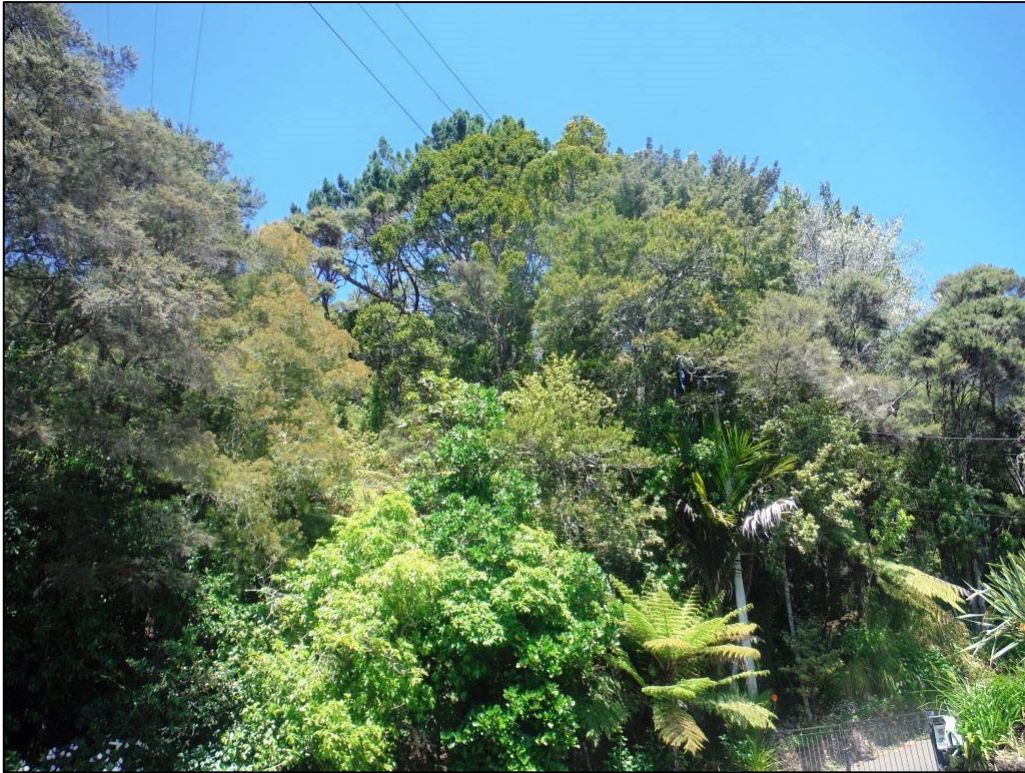
Plate 1 View of forest at the southern end of Shetland Street with hard beech trees in the middle background

At the southern end of Shetland Street (Plate 1) the vegetation is good quality secondary kauri podocarp broadleaved forest and includes two large specimens of hard beech (*Fuscospora truncata*), tawa (*Beilschmiedia tawa*), kahikatea (*Dacrycarpus dacrydioides*) and kanuka (*Kunzea spp.*). Some of this area is designated a SEA (SEA_T_5539). The botanical ecological values within this area are high.

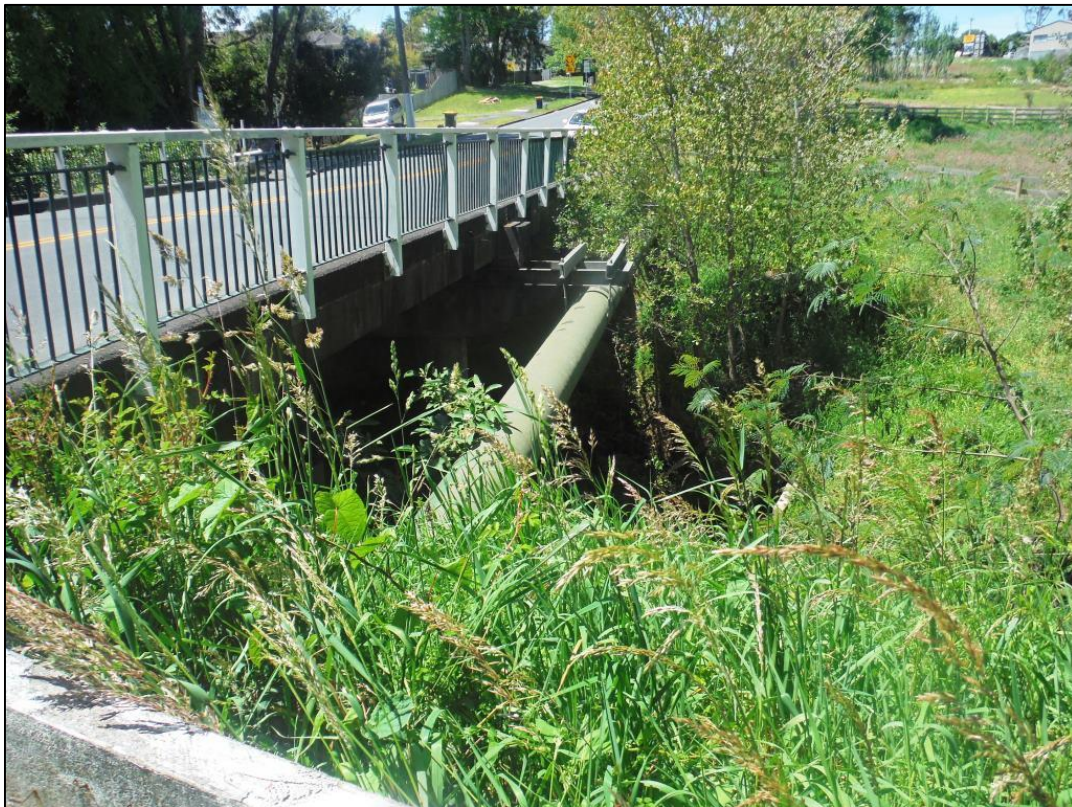
Plate 2 View of proposed stream crossing at the Oratia Stream

- The pipe bridge crossing at Oratia Stream will pass to the south of the road bridge outside the SEA where the riparian vegetation is mainly pasture with a few common poplar trees of no great size (Plate 2). Several large poplars are listed as heritage trees at 79 Parr's Cross Road (CHI 2186) and are shown as being along the riparian margin of stream, however no large trees were noted close to the NH2 designation. The botanical ecological values within this area are very low.

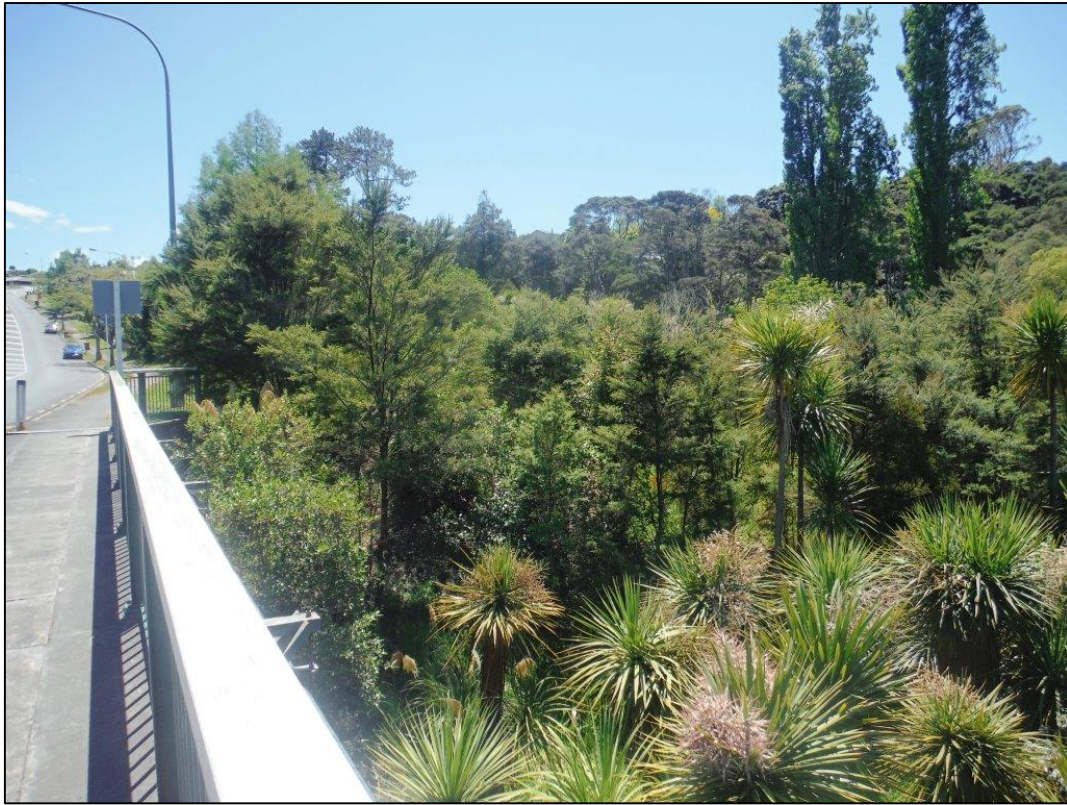
Plate 3 View of proposed stream crossing at the Opanuku Stream showing young planted natives

- The pipe bridge across the Opanuku Stream will pass to the east of the road bridge through SEA_T_4870. The riparian vegetation here is a well-established young native restoration planting with kanuka (*Kunzea robusta*), cabbage trees (*Cordyline australis*), houheria (*Houheria populnea*), puriri, rimu, titoki (*Alectryon excelsus*) and karamu (*Coprosma robusta*). Some of these trees are > 6m tall (Plate 3). The botanical ecological values within this area are low.

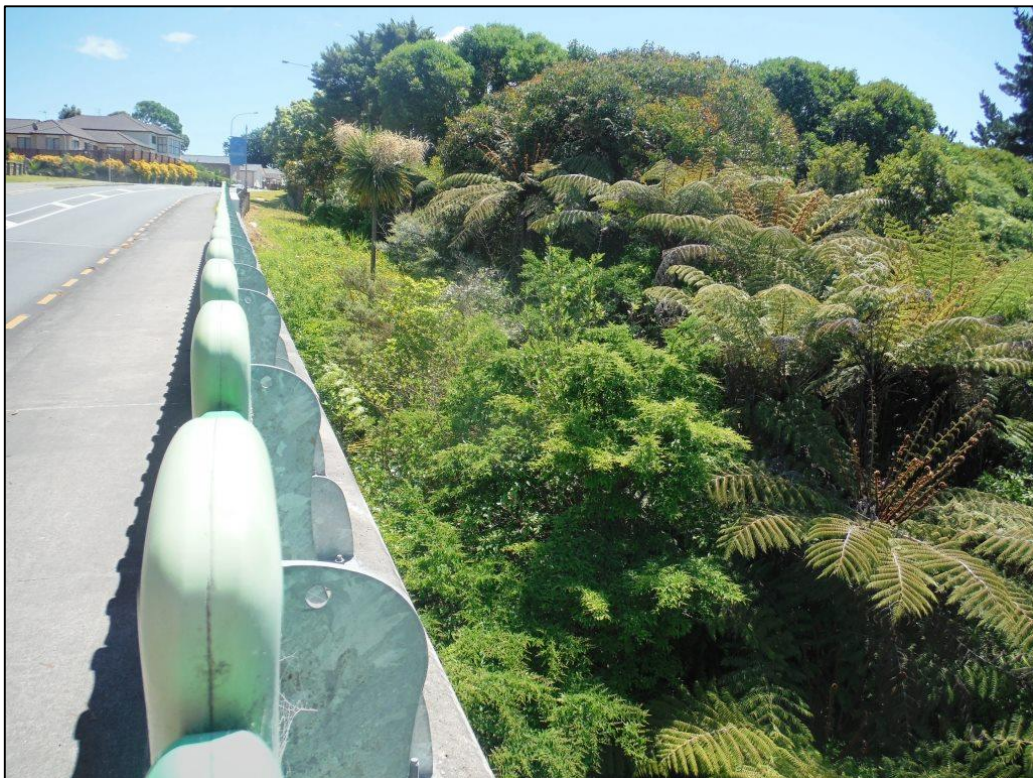
Plate 4 View of the stream crossing at the Paremuka Stream showing tree ferns and weedy area adjacent to the bridge

- The pipe bridge across the Paremuka Stream will pass to the south east of the road bridge through native restoration planting of the riparian corridor. The area is dominated by tree ferns (*Cyathea dealbata*) and other common native species of no great size. Close to the bridge the vegetation is weedy with privet (*Ligustrum lucidum* & *L. sinense*), wattle (*Acacia spp*) and Japanese honeysuckle (*Lonicera japonica*) being dominant (Plate 4). This area is not shown as part of an SEA, although SEA_T_4874 is located on the north western side of the road bridge. The botanical ecological values within this area are low.

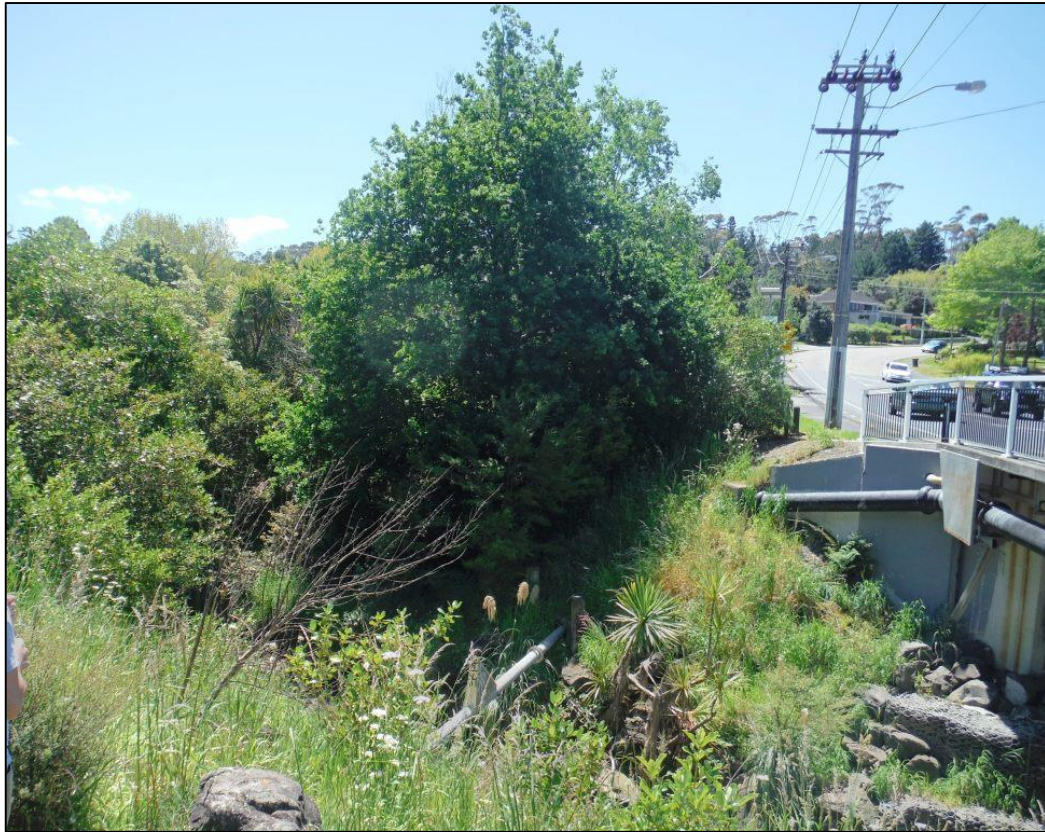
Plate 5 View of stream crossing at the Swanson Stream adjacent to the Don Buck Corner Reserve with a young oak tree on the northern (true left) bank

- The crossing of the Swanson Stream will pass to the west of the road bridge through SEA_T_4872. The key botanical features of the vegetation that may be affected at this site are a group of five European oaks (*Quercus robur*) in the Don Buck Corner Reserve which are > 10m tall, although they are not especially large or old. The proposed NH2 pipeline passes directly under the oak grove. Root depth of trees vary depending on many factors, including soil type. No adverse effects on tree roots are anticipated if the pipeline runs 7m or more below the ground. Otherwise the vegetation is a mixture of planted young natives such as kanuka up to 6m tall, flax (*Phormium tenax*), karo (*Pittosporum crassifolium*), kapuka (*Griselinia littoralis*), cabbage trees, karamu etc. and exotic trees such as birch (*Betula pendula*), privet, and Mexican white cedar (*Cupressus lusitanica*) (Plate 5). The botanical ecological values within this area are very low.

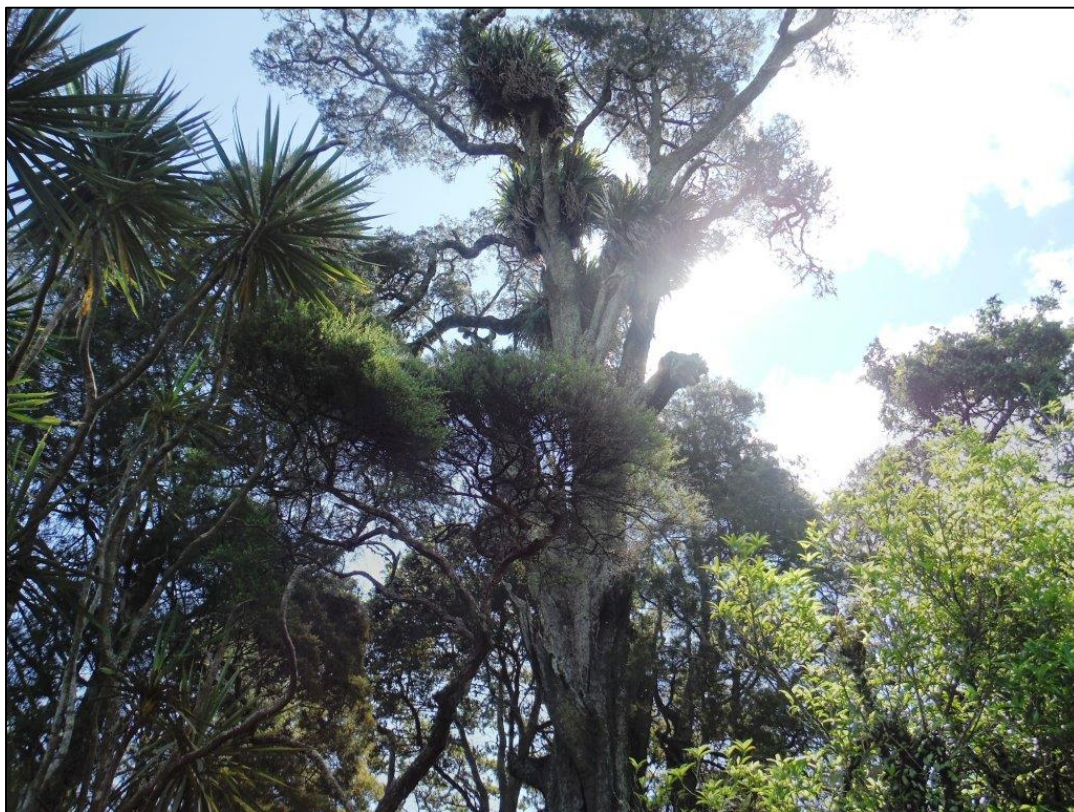
Plate 6 Large kahikatea tree close to the stream within the Fernhill Escarpment SEA

The key vegetation likely to be affected by the installation of NH2 is that within the Fernhill Escarpment Reserve to the north west of Bush Road. The NH2 designation takes in part of the steep south east facing escarpment above the Oteha Stream. The vegetation on the escarpment is mainly good quality kauri podocarp broadleaved forest with large totara (*Podocarpus totara*), kahikatea, tanekaha and kauri forming much of the canopy. There are some large totara and a very large kahikatea tree (Plate 6) near the stream. These riparian trees are generally 10 -12m away from the edge of the road, although further up Bush Road are two large totara that are right on the edge of the road. Other canopy trees include abundant kanuka and scattered titoki. The understorey is composed of kanono (*Coprosma grandifolia*), mahoe (*Meliclytus ramiflorus*), silver tree fern and other ground cover ferns and sedges. This is a good quality forest stand; however the best trees are generally more than 10m from the road and the roadside vegetation consists mainly of younger vegetation (Plate 7). Near the top of Bush Road the NH2 designation runs through an area of younger native vegetation and some mature pine trees on the upper edge of the reserve. The botanical ecological values within this area are high. Three options are proposed for the stream crossing and pipeline through the reserve and the effects of these are discussed below.

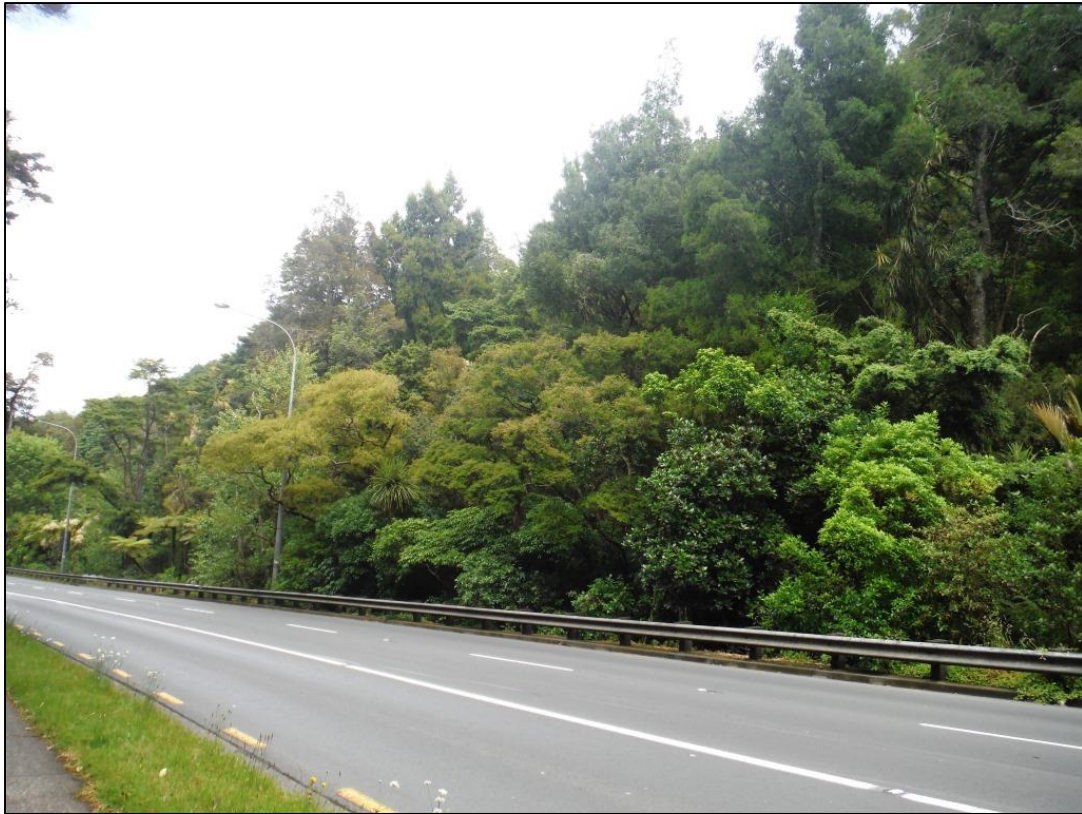
Plate 7 Vegetation along the edge of Bush Road within the Fernhill Escarpment SEA
