**Ground Contamination  
Assessment - Northern  
Interceptor Project:**

**Notices of Requirement**

**Prepared for**  
Watercare Services Limited

**Prepared by**  
Tonkin & Taylor Ltd

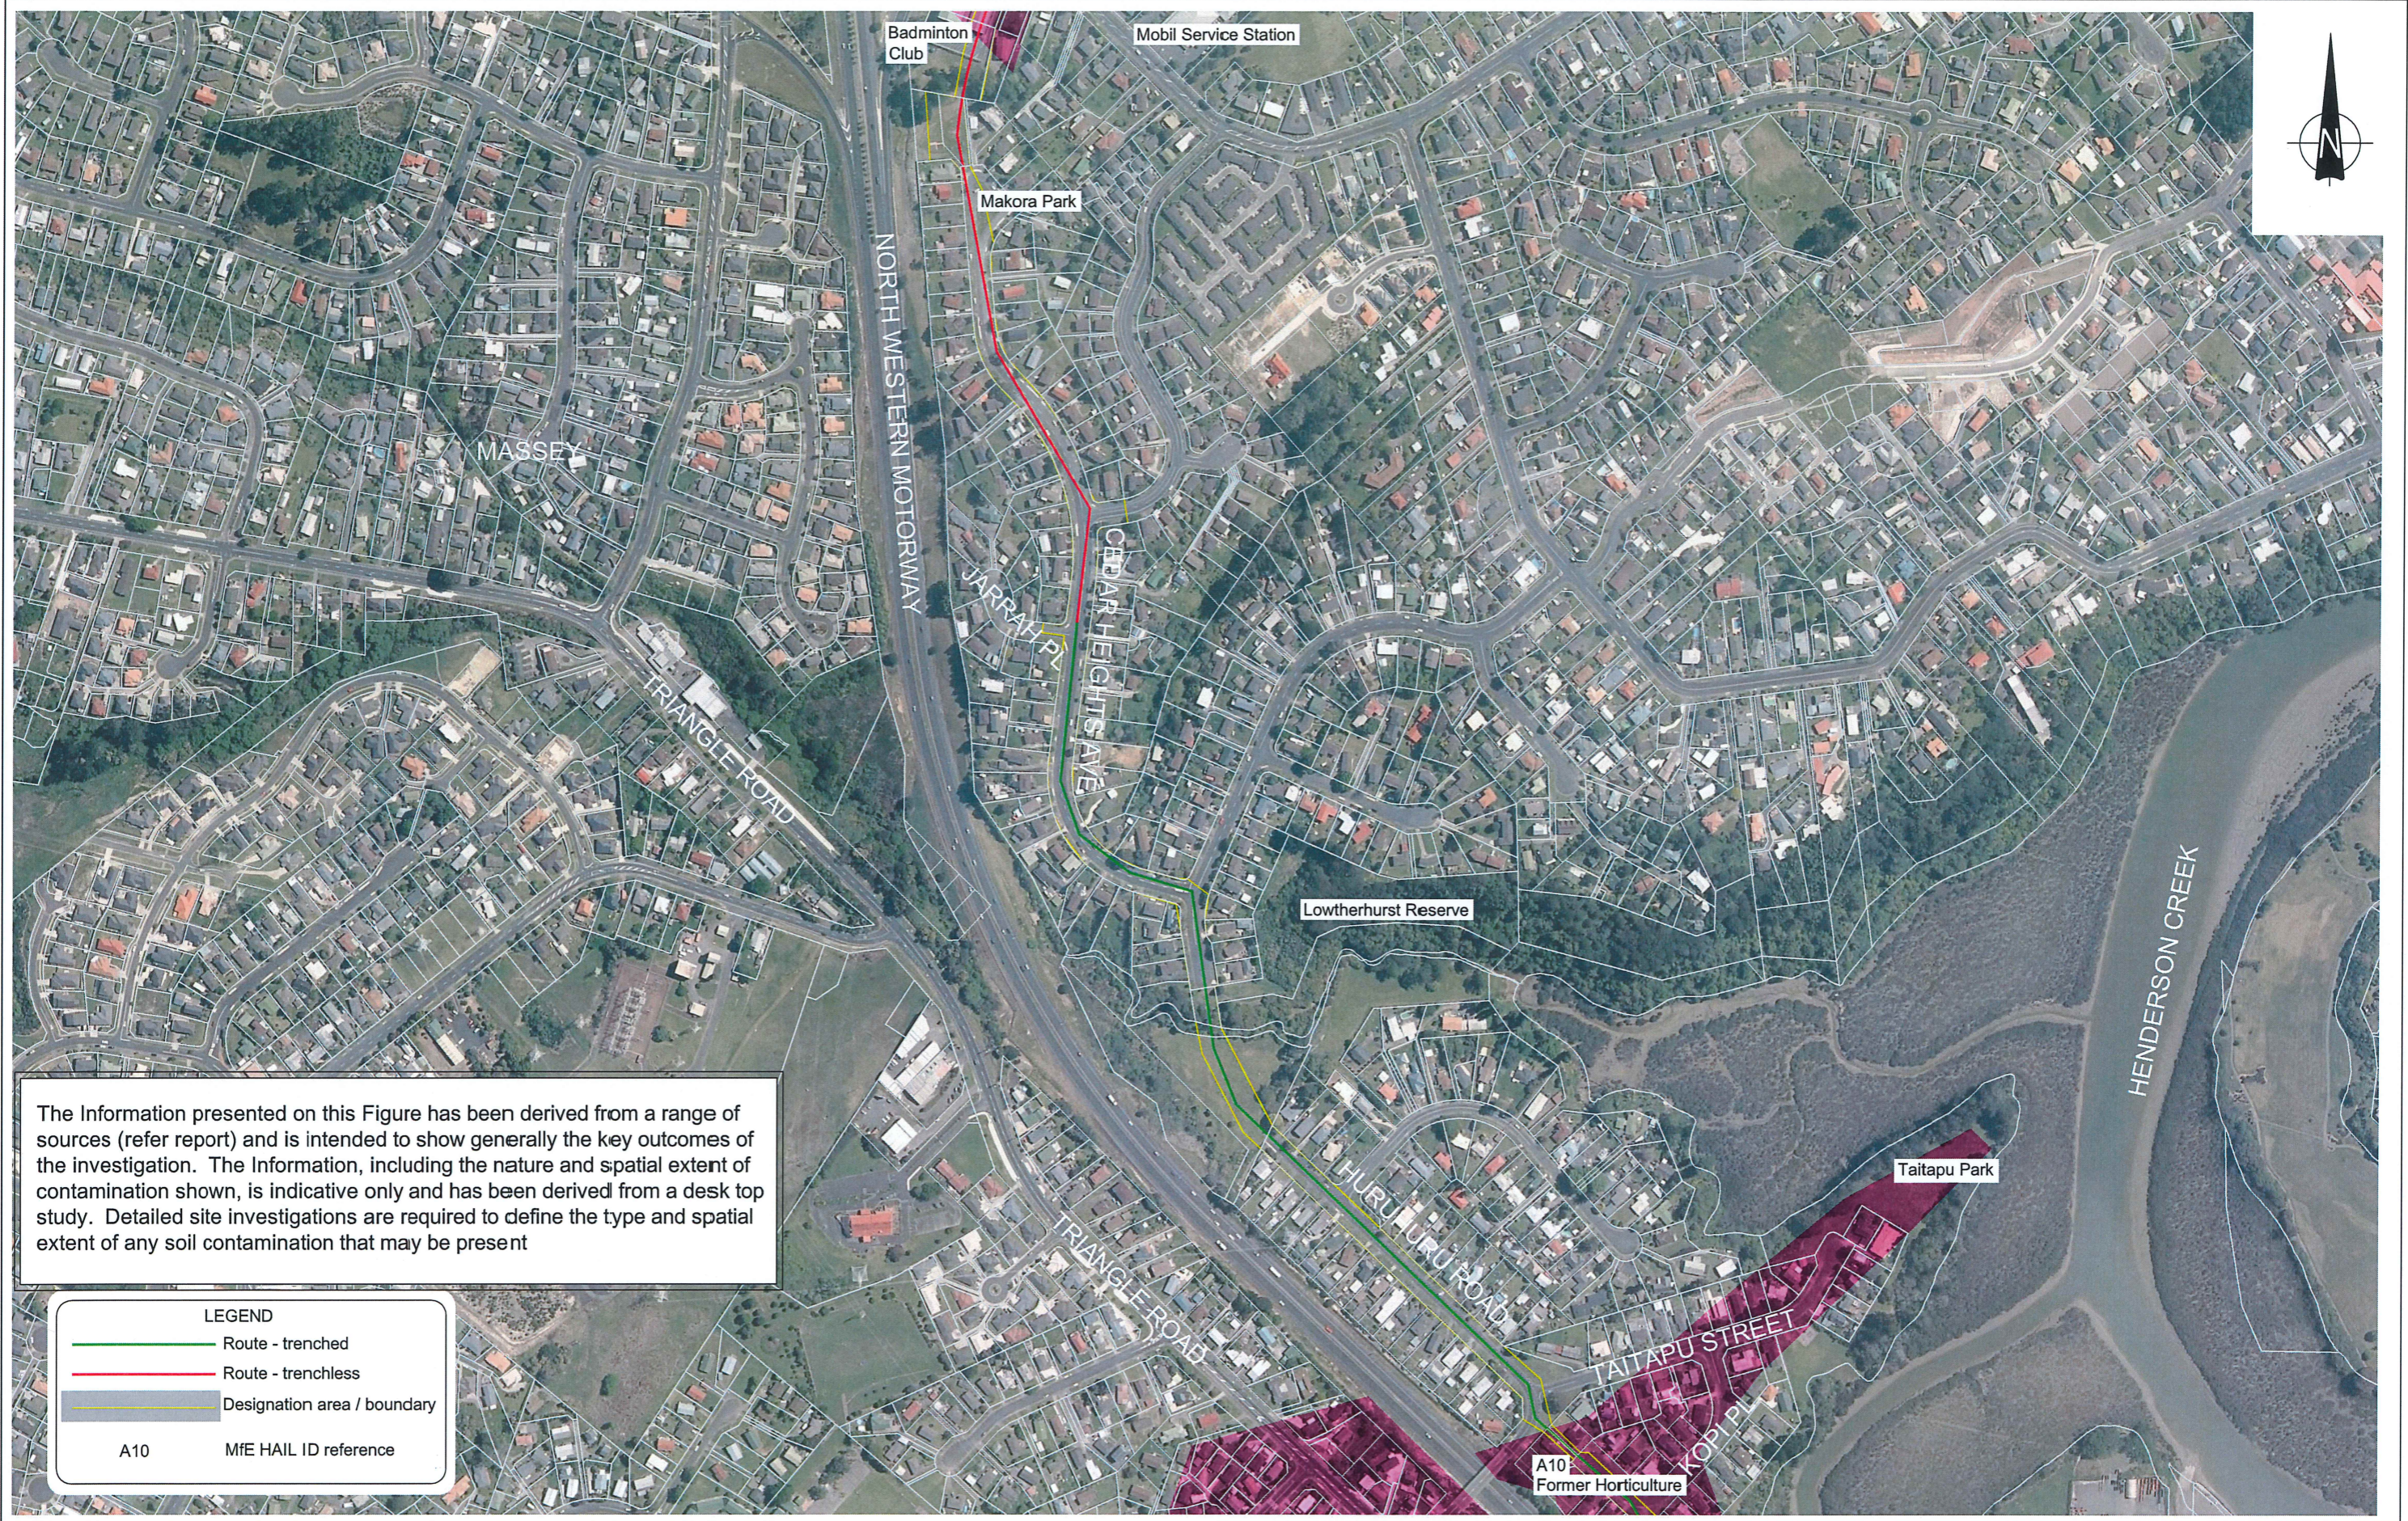
Bulk storage of chemicals at a drycleaning, swimming pool and powder coating/ painting facilities (refer Figure 3)	VOCs	<ul style="list-style-type: none"> <li>30 The Concourse</li> </ul>	<p>A drycleaners is located at 30 The Concourse. Spills and leaks of drycleaning fluid can affect soils and groundwater at the property. The property is located on the down-gradient side of the proposed designation.</p> <p>There are other potential industries which occupy properties on The Concourse may also store bulk chemicals. No significant spills have been recorded. Due to the distance, the likelihood for contaminant to extend to the road reserve is low.</p> <p><b>Potential for contamination: low</b></p>	None (Activity H - Contaminant migration to the designation is highly unlikely to have occurred)	None required

Land use/activity	Potential contaminants	Sections potentially affected	Likelihood, magnitude and possible extent of contamination	HAIL reference	Sampled locations
Refuse and Recycling Station (refer Figure 3)	Dependent on the type of waste: biological hazards, metals, PAHs, semi VOCs and solvents.	<ul style="list-style-type: none"> <li>The Concourse proposed pump station site</li> </ul>	<p>The refuse and recycling centre is a transfer station located adjacent to the Watercare pump station on The Concourse. Landfilling does not appear to currently occur on the site, although a consent for historic filling using municipal wastes exists for the site. As the project area is located down-gradient and approximately 90 m away from the designation, the potential for contamination of the soil underlying the road reserve is low.</p> <p><b>Potential for contamination: low</b></p>	None (Activity H - Contaminant migration to the designation is highly unlikely to have occurred)	Not required

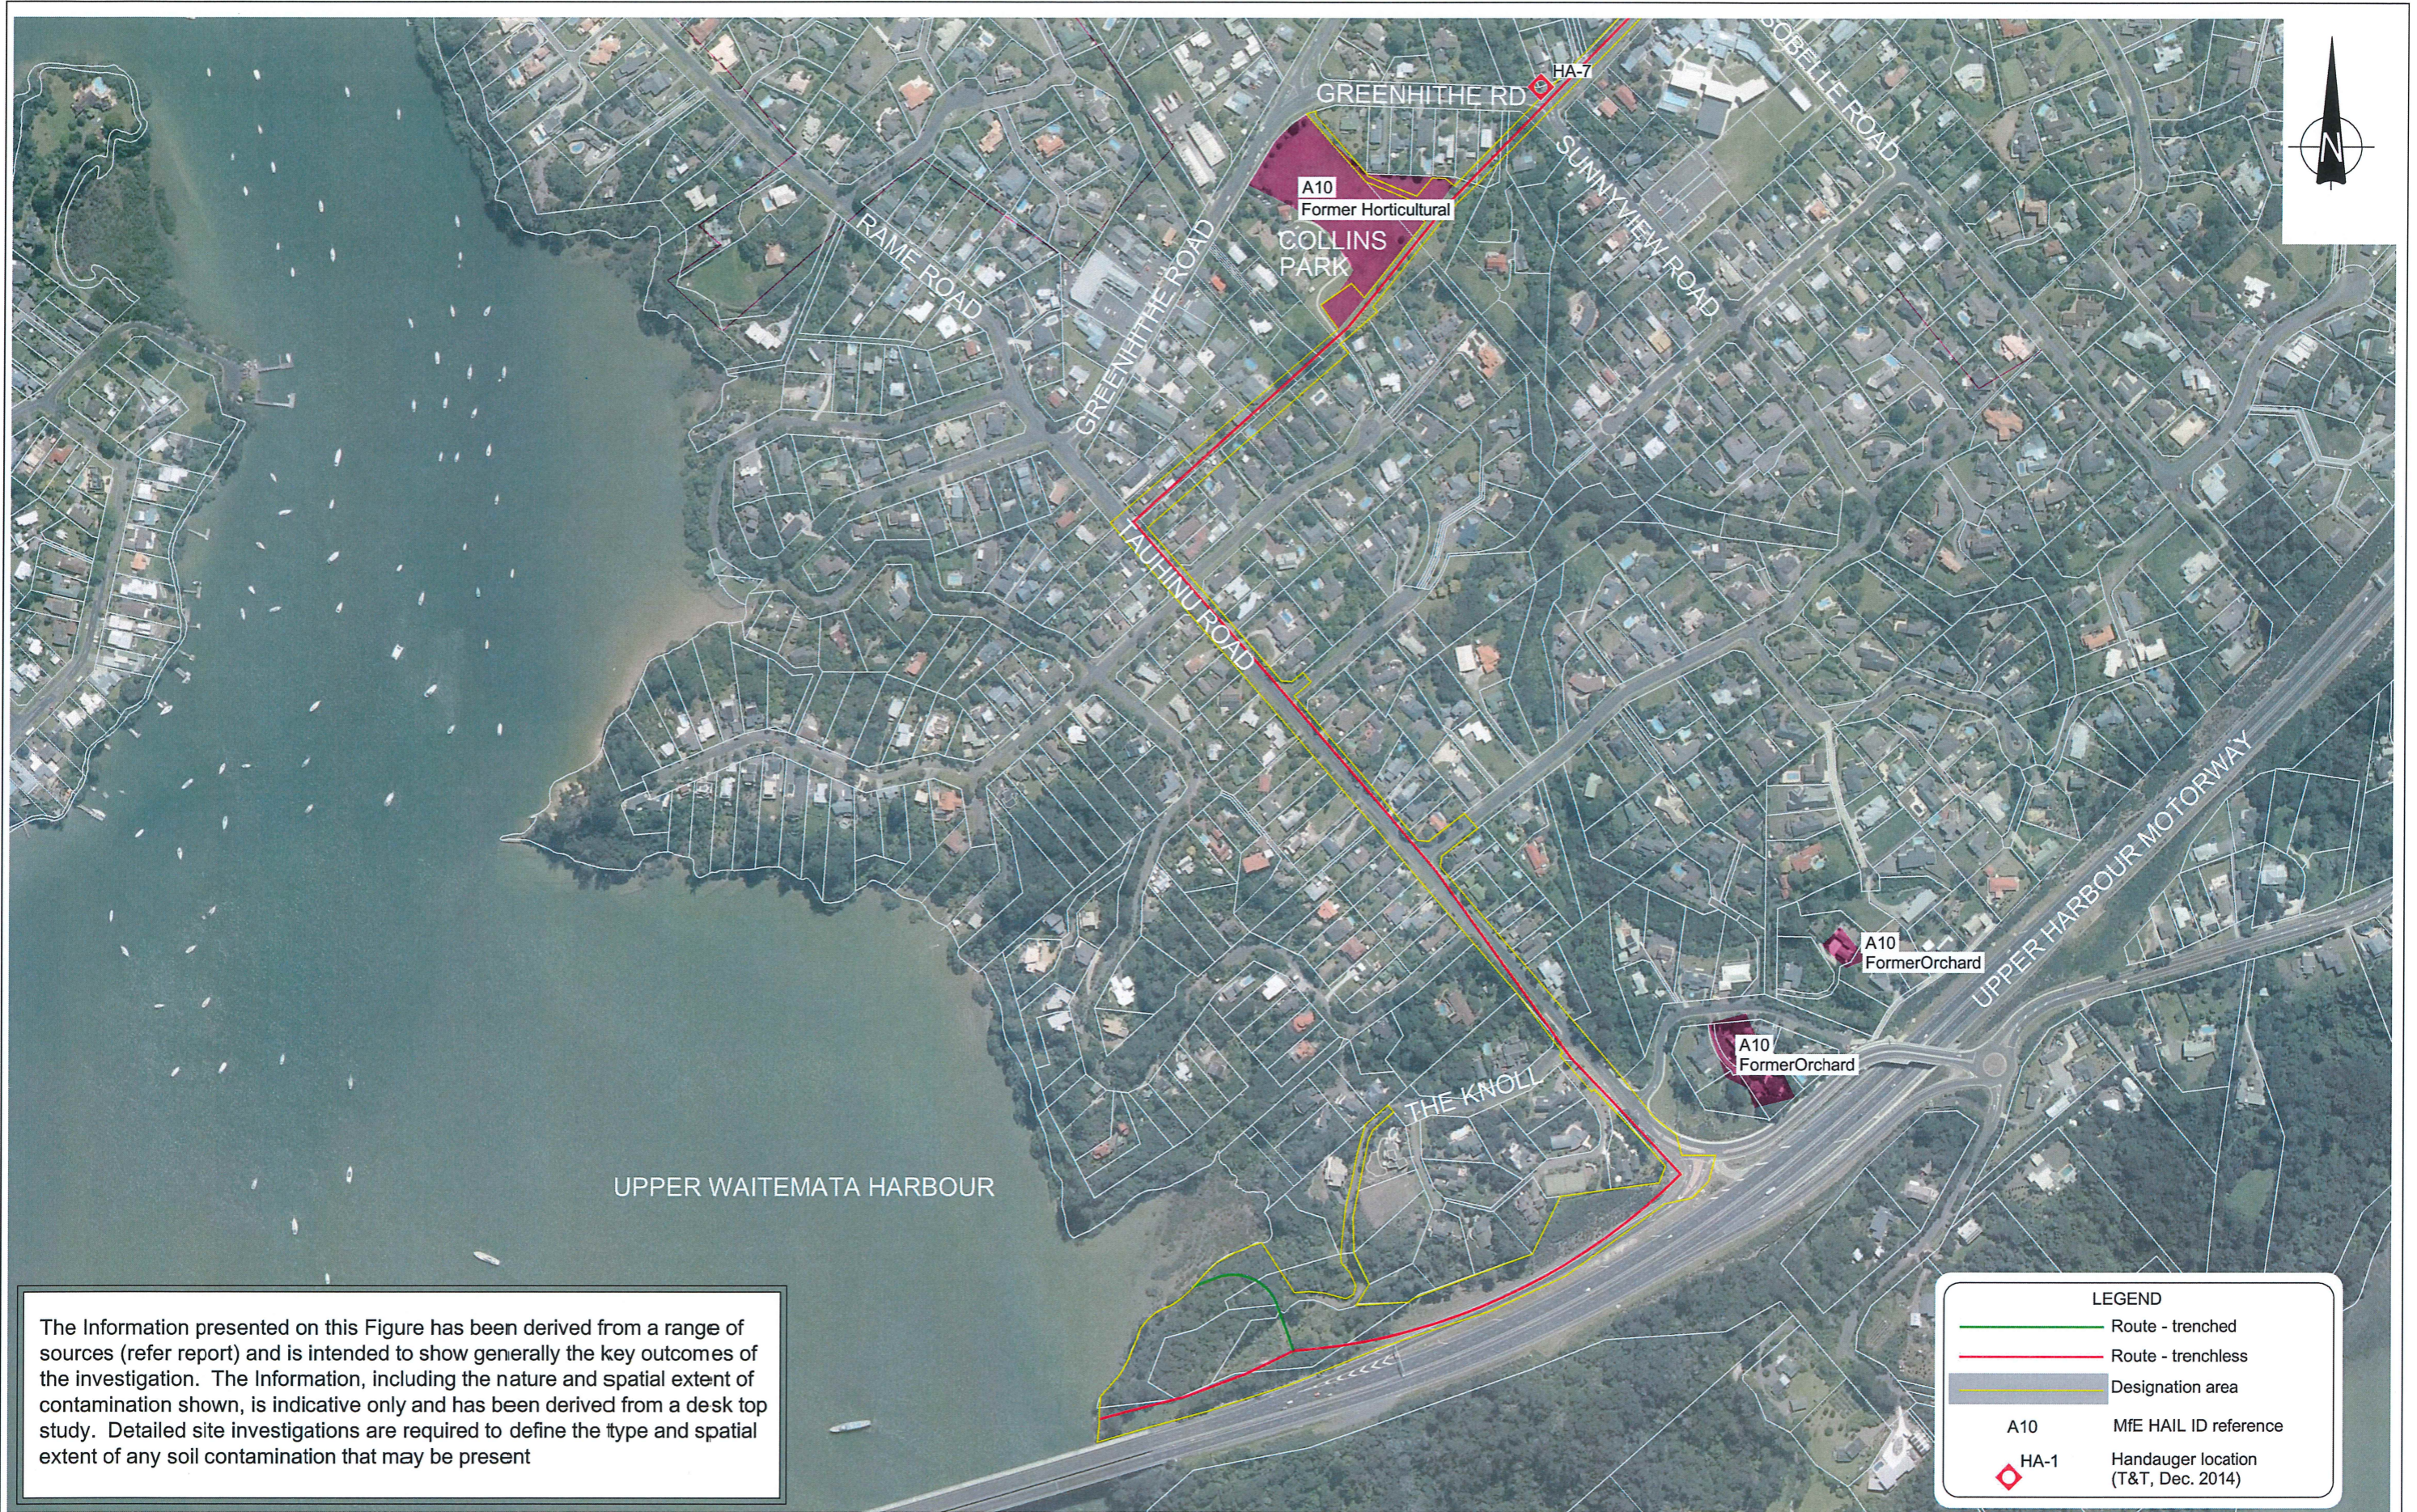
FIG. No. **Figure 6** REV. **0**

**NORTHERN INTERCEPTOR NoR-NI WAITAKERE & NORTH SHORE**  
Potential HAIL Activities – Hobsonville Road

The Information presented on this Figure has been derived from a range of sources (refer report) and is intended to show generally the key outcomes of the investigation. The Information, including the nature and spatial extent of contamination shown, is indicative only and has been derived from a desk top study. Detailed site investigations are required to define the type and spatial extent of any soil contamination that may be present
