Ecological Assessment - Northern Interceptor Project

Prepared for Watercare Services Limited
10 June 2016

Document title: Ecological Assessment - Northern Interceptor Project: Notices of Requirement

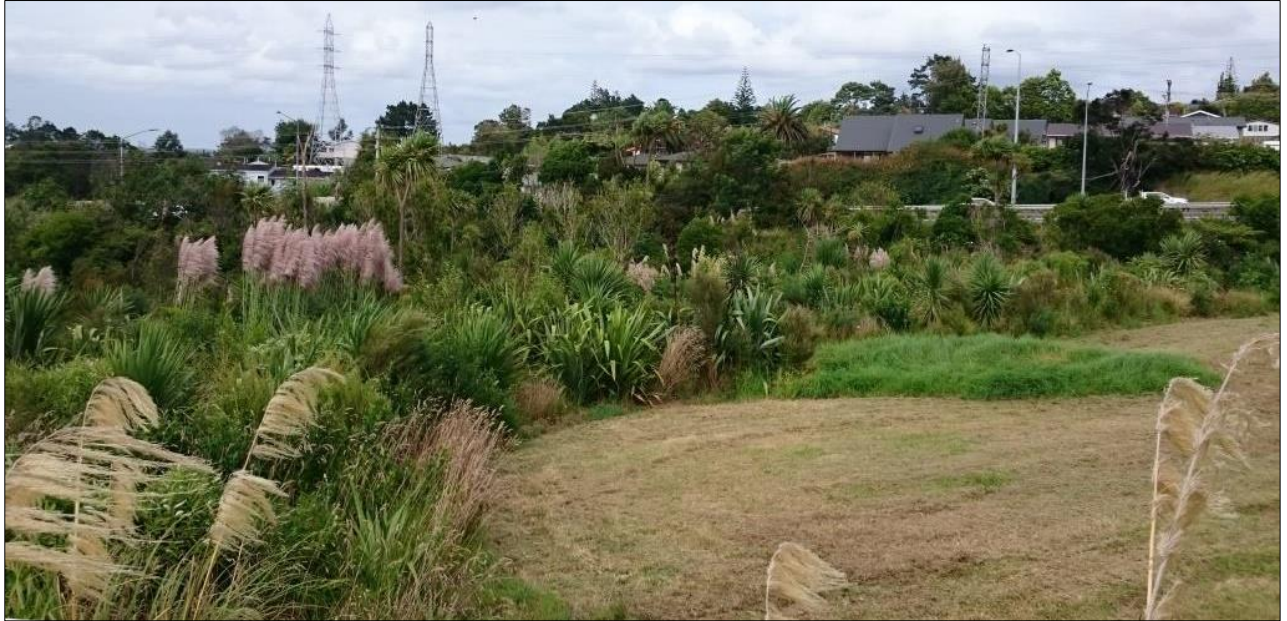
The concept design indicates trenched construction from Selwood Road to Huruhuru Road through Taitapu Park. Taitapu Park supports some planted vegetation along the western bank of the Henderson Creek. The designation boundary abuts the coastal area on either side of the Henderson Creek.

Figure 1. Vegetation at Taitapu Park

Young planted native vegetation along the coastal fringe within Taitapu Park will have matured over the next 20 years and should have established a closed canopy of trees with some natural regeneration occurring (depending on the way in which it is managed). The vegetation buffers the upper tributary of Henderson Creek. The installation of the open trenched pipeline would necessitate the removal of a small section of this vegetation with the potential loss of several medium sized native trees such as kanuka, tarata etc. This would have generally minor effects on the overall botanical values of the site although it will temporarily fragment the coastal band of vegetation at this point.

Planted vegetation at Taitapu Park supports indigenous copper skinks (NZTA 2010) and may also support other native lizard species, as well as nesting or roosting habitat for native birds. Fauna habitat values at Taitapu Park are likely to increase slightly as the vegetation matures.

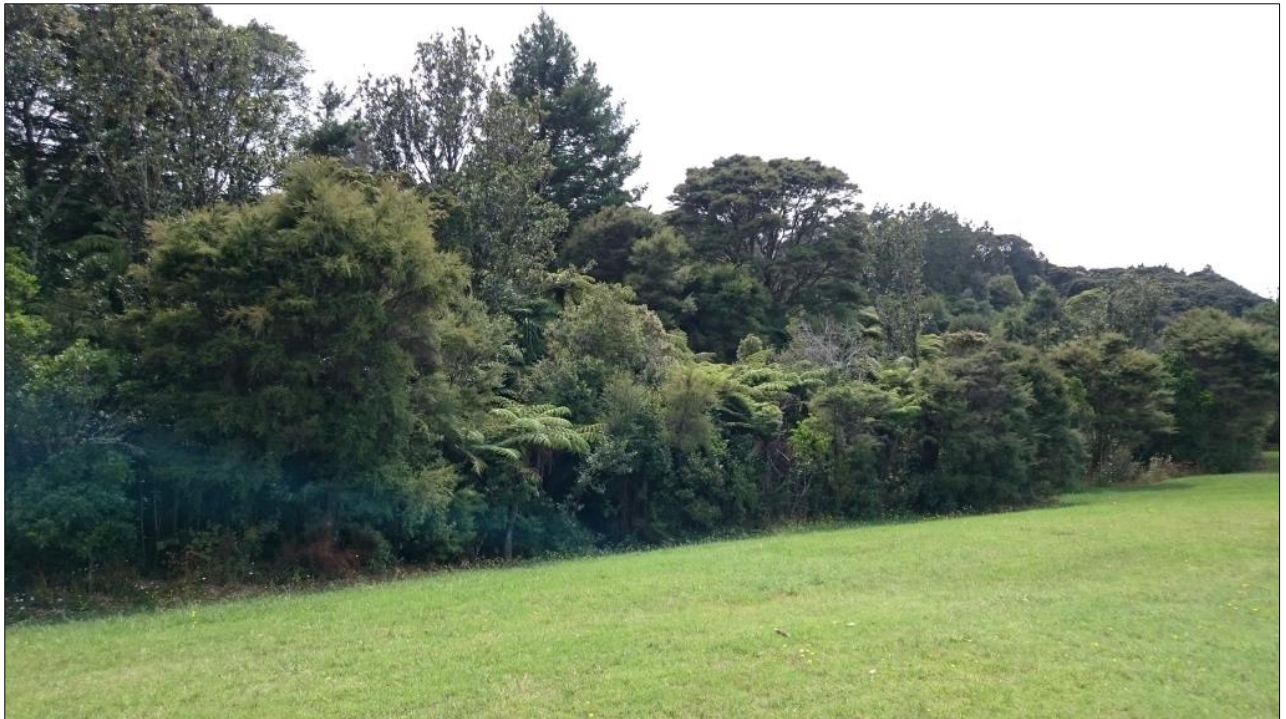
Much of the pipeline designation through Lowtherhurst Reserve is in mown grass, however the native vegetation surrounding Rarawaru stream within the SEA where the pipeline bridge will cross into Cedar Heights Avenue is of moderate quality. It includes tall rewarewa (*Knightsia excelsa*) 15 – 20m tall, towai (*Weinmannia silvicola*), and tall kanuka with typical understorey shrubs and tree ferns. The Rarawaru stream flows over a rock substrate.

Figure 2. Vegetation at Lowtherhurst Reserve (SEA).

The native vegetation surrounding the stream at the proposed trench crossing point is of good quality although it constitutes a fairly narrow band along both sides of the stream. Loss of a section of the vegetation on each side of the stream would fragment the riparian vegetation and result in edge effects on the remaining vegetation on each side. Loss of mature flowering and fruiting canopy trees would also have moderate effects on the botanical values of the site.

Vegetation within SEA_T_4654 at Lowtherhurst Reserve supports suitable potential habitat for at least five indigenous lizard species, four of which have a National threat classification of 'At Risk'. Threat rankings for some of these species, particularly those 'At Risk', may increase over the next 20 years.

For Lowtherhurst Reserve, a mitigation plan should be developed well ahead of construction and replacement planting of the canopy and understorey species that will be lost carried out well ahead of this time. This will reduce the time between loss of mature trees and their replacement. Mitigation planting should occur at suitable sites within the affected reserve and be contiguous with existing similar native vegetation. The mitigation plan should also include replacement planting at the impact site post construction.

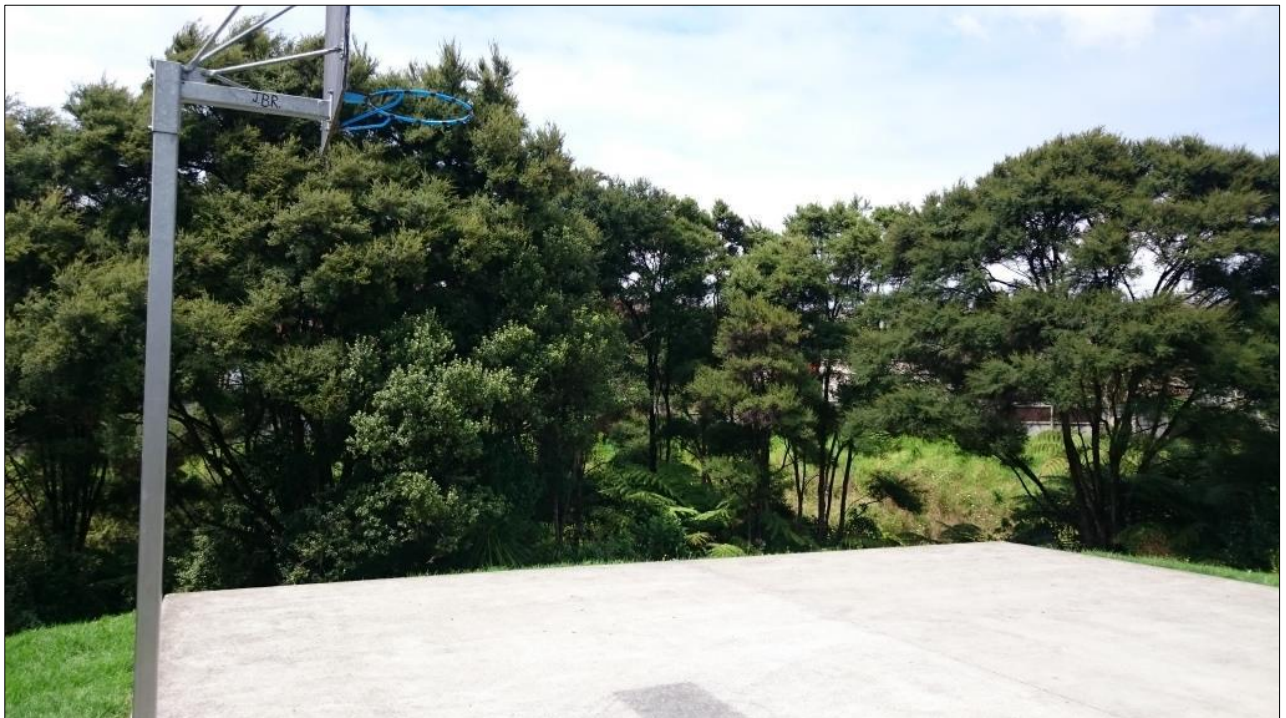
Trenched construction is proposed from Manutewhau Reserve to Holmes Drive. The trenched construction crosses over an overland flow path, of less than minor ecological value, within the Manutewhau Reserve. An indicative pipe bridge would cross Tihema Stream, which flows through native vegetation at 113A Oreil Avenue (Manutewhau walk). This riparian corridor is designated SEA_T_4866 and SEA_T_2040. The vegetation within these areas is predominantly native and provides suitable habitat for at least five native lizard species, four of which have a threat classification of "At Risk" (Hitchmough et al. 2013). The Tihema Stream is of moderate ecological value.

Figure 3. Riparian vegetation along Tihema Stream (SEA).

The native vegetation along the Tihema Stream in the vicinity of the proposed pipeline crossing is designated SEA _T_4866 and SEA_T_2040. It is regenerating kanuka scrub with common shrubs and tree ferns. The pipe crossing would fragment the riparian vegetation, however the botanical effects would be minor and could be mitigated with replacement planting post construction.

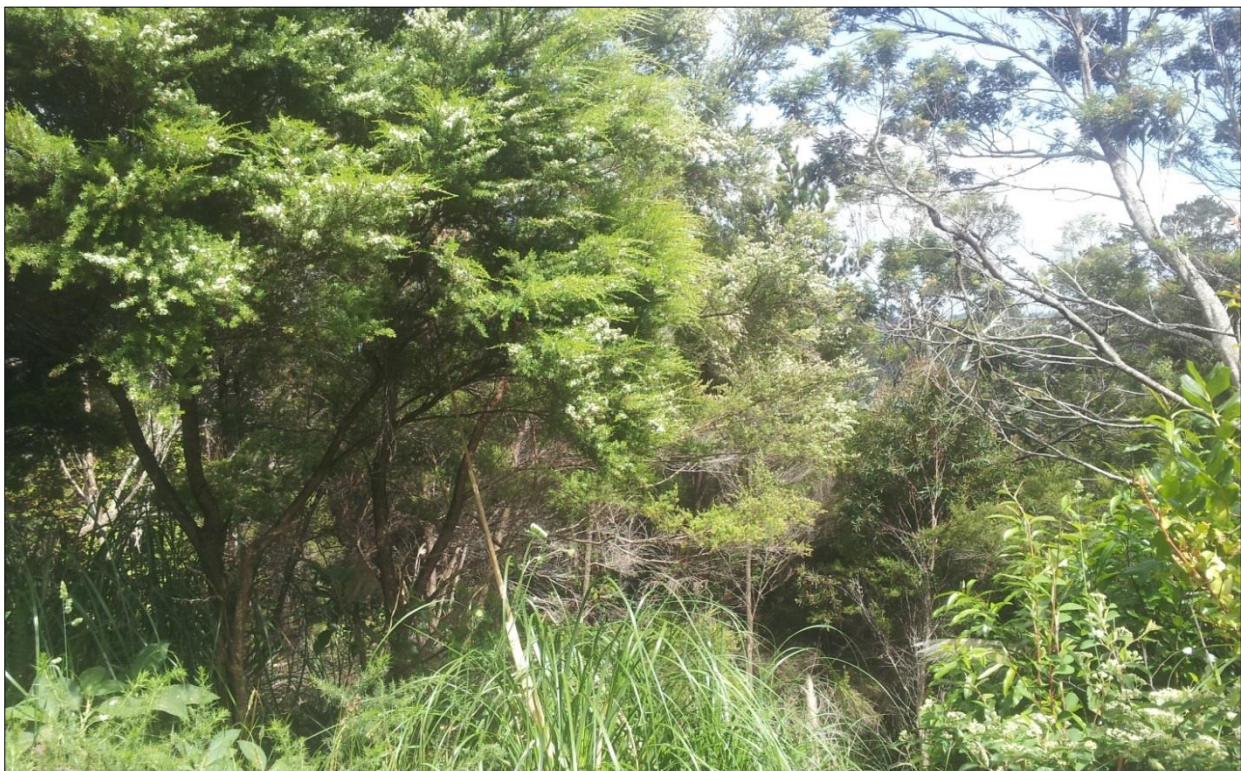
The vegetation within 15 The Eastern Abutment of the Greenhithe Bridge is a mixture of open ground with kikuyu (*Pennisetum clandestinum*), a gravel driveway and kanuka scrub under a broken canopy of black wattle (*Acacia mearnsii*). Understorey plants include tauhinu (*Pomaderris amoena*), kumerahou (*P. kumeraho*), mingimingi (*Leptocophylla juniperina*) and corokia (*Corokia buddleioides*). Several large kahikatea trees (*Dacrycarpus dacrydioides*) were noted in the gully between 15 and 9 The Eastern Abutment of the Greenhithe Bridge.

Figure 4. Vegetation at The Eastern Abutment of the Greenhithe Bridge (SEA).

Vegetation within SEA_T_SEA_T_8319 at The Eastern Abutment of the Greenhithe Bridge supports suitable potential habitat for at least five indigenous lizard species, four of which have a National threat classification of 'At Risk'. Threat rankings for some of these species, particularly those 'At Risk', may increase over the next 20 years. It is noted that the forest gecko, copper skink and ornate skink have been recorded from SEA_T_8319. The vegetation also has the potential to support roosting and nesting habitat for a range of common native bird species.
