# Investigation Plan for the Omaha WWTP – Stage 2 update

Dr Mark James, Aquatic Environmental Sciences Ltd

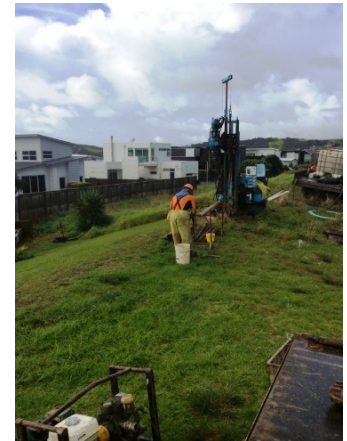
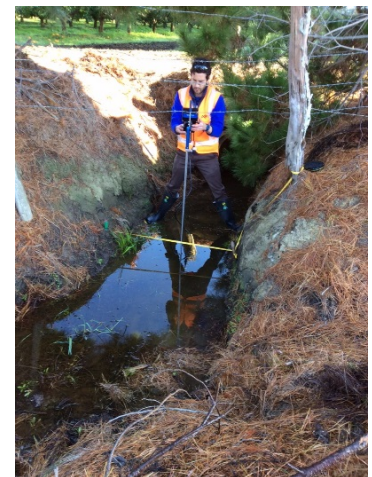
FIGURE 1: PROPOSED & MARKED/CLEARED GROUNDWATER MONITORING BORE SITES

WHITE SHADED AREAS INDICATE APPROXIMATE TWW IRRIGATION EXTENT - EXISTING SYSTEM

MARKED & CLEARED BORE LOCATIONS - black

EXISTING GROUNDWATER MONITORING BORES - white

PROPOSED BORE LOCATIONS - blue

APPROXIMATE LOCATIONS OF GROUNDWATER MONITORING BORES & DRAIN FLOW SURVEYS

- Log geological information from bore locations
- Install 13 new bores (1/3 through @8th June)
- Hydraulic testing of existing and new bores
- Collate rainfall and irrigation data
- Map and survey drainage system  
(completed but not written up yet)
- Water quality sampling of bores

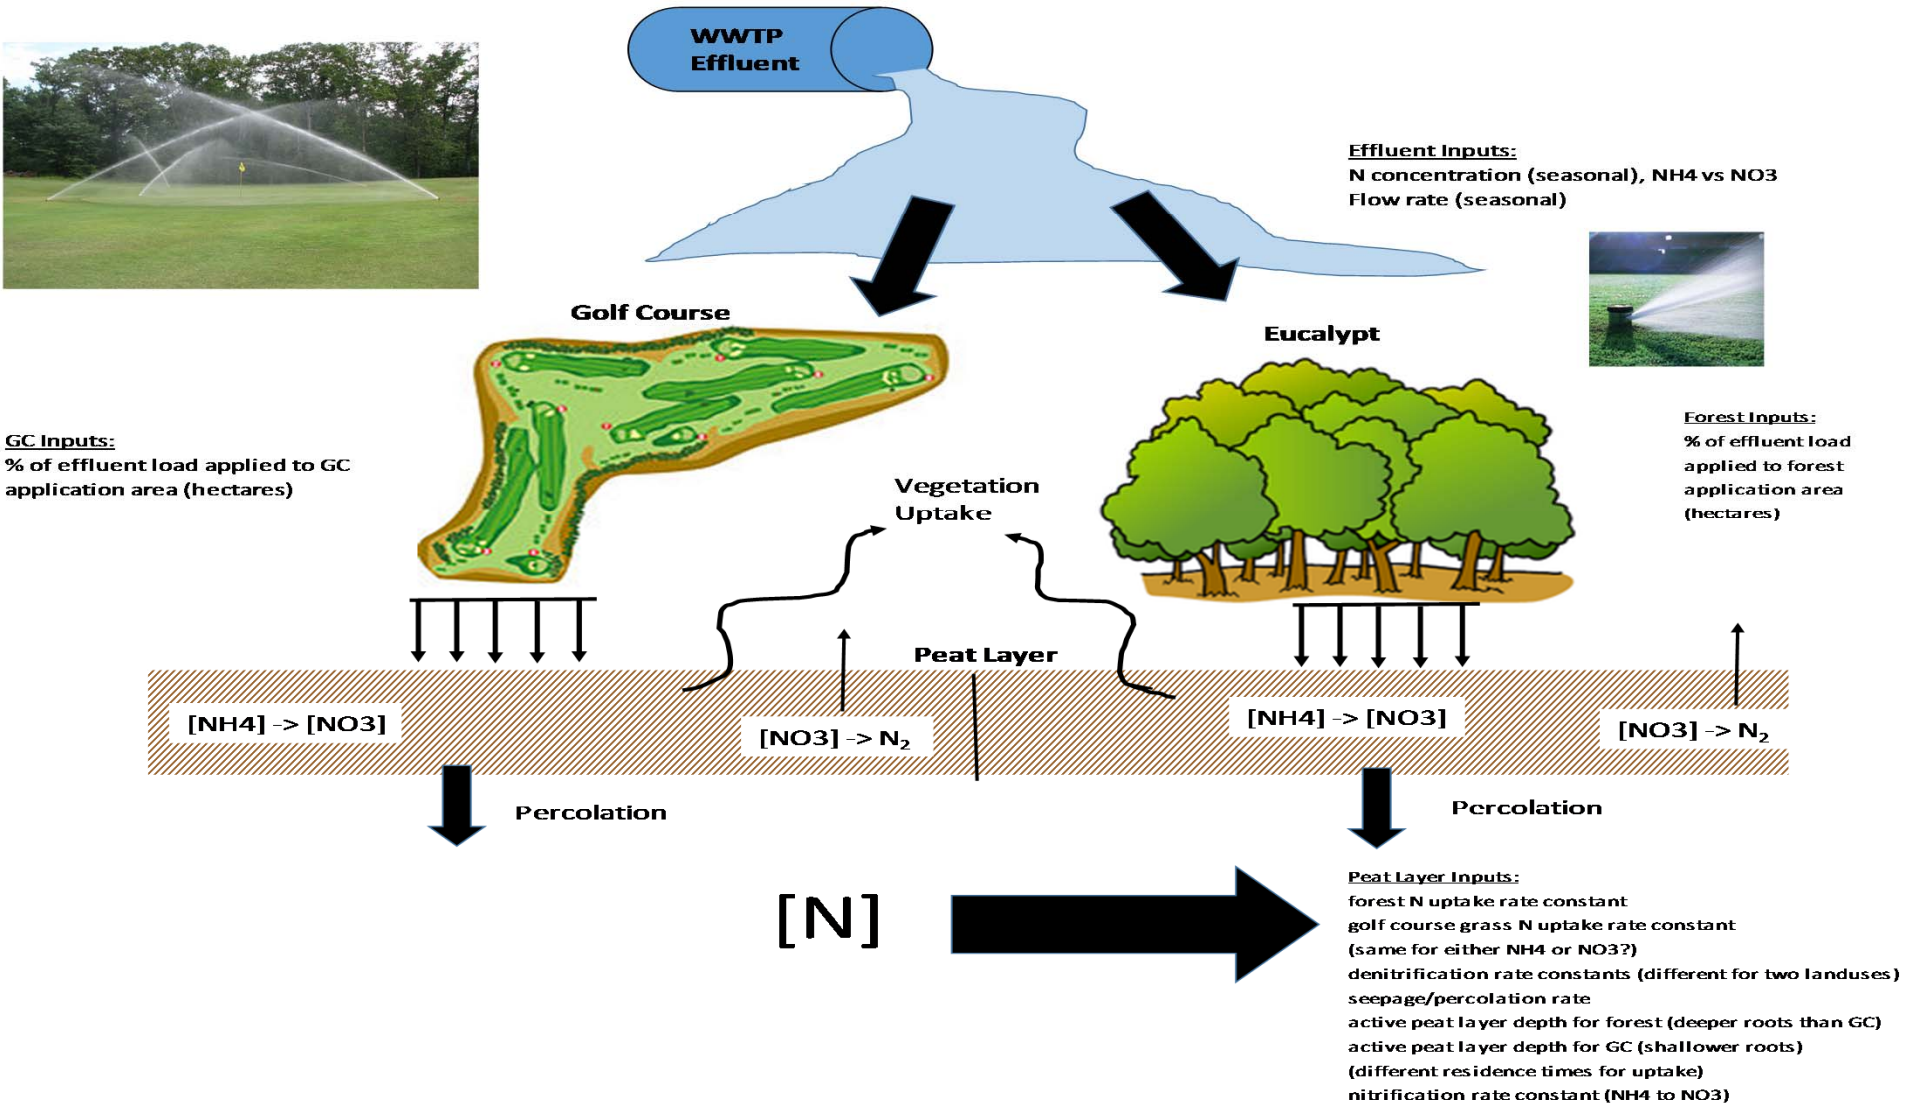
# Omaha Beach Nitrogen Accounting Model

- Field work completed, most of lab analyses completed, waiting for samples from new bores
- Background review and schematic plan for model completed
- Model concept:
  - Nitrifying and denitrifying rates, soil data (carbon and nutrients)
  - Uptake rates on golf course and forest
  - Flow paths from irrigation areas – harbour
  - Input from turf specialist (golf course) and Scion (Eucalypts), initial estimate of leaching from GC is 40 kgN/ha/y
  - Will be used to predict fate of nutrients and can illustrate effect of management changes

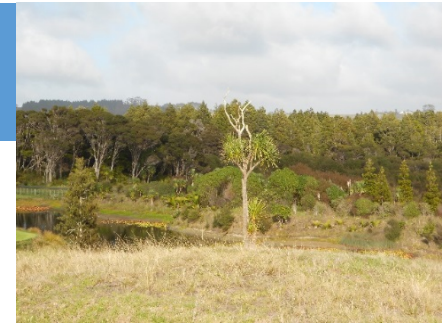
- No indications of poor plant health, likely N limited
- No surface water in forest/wetlands (summer)
- Eels and mosquito fish and 16 bird species including fernbird recorded
- Need more information on groundwater/nutrients to assess effects (still to come)
- Site visit during winter (surface water?)

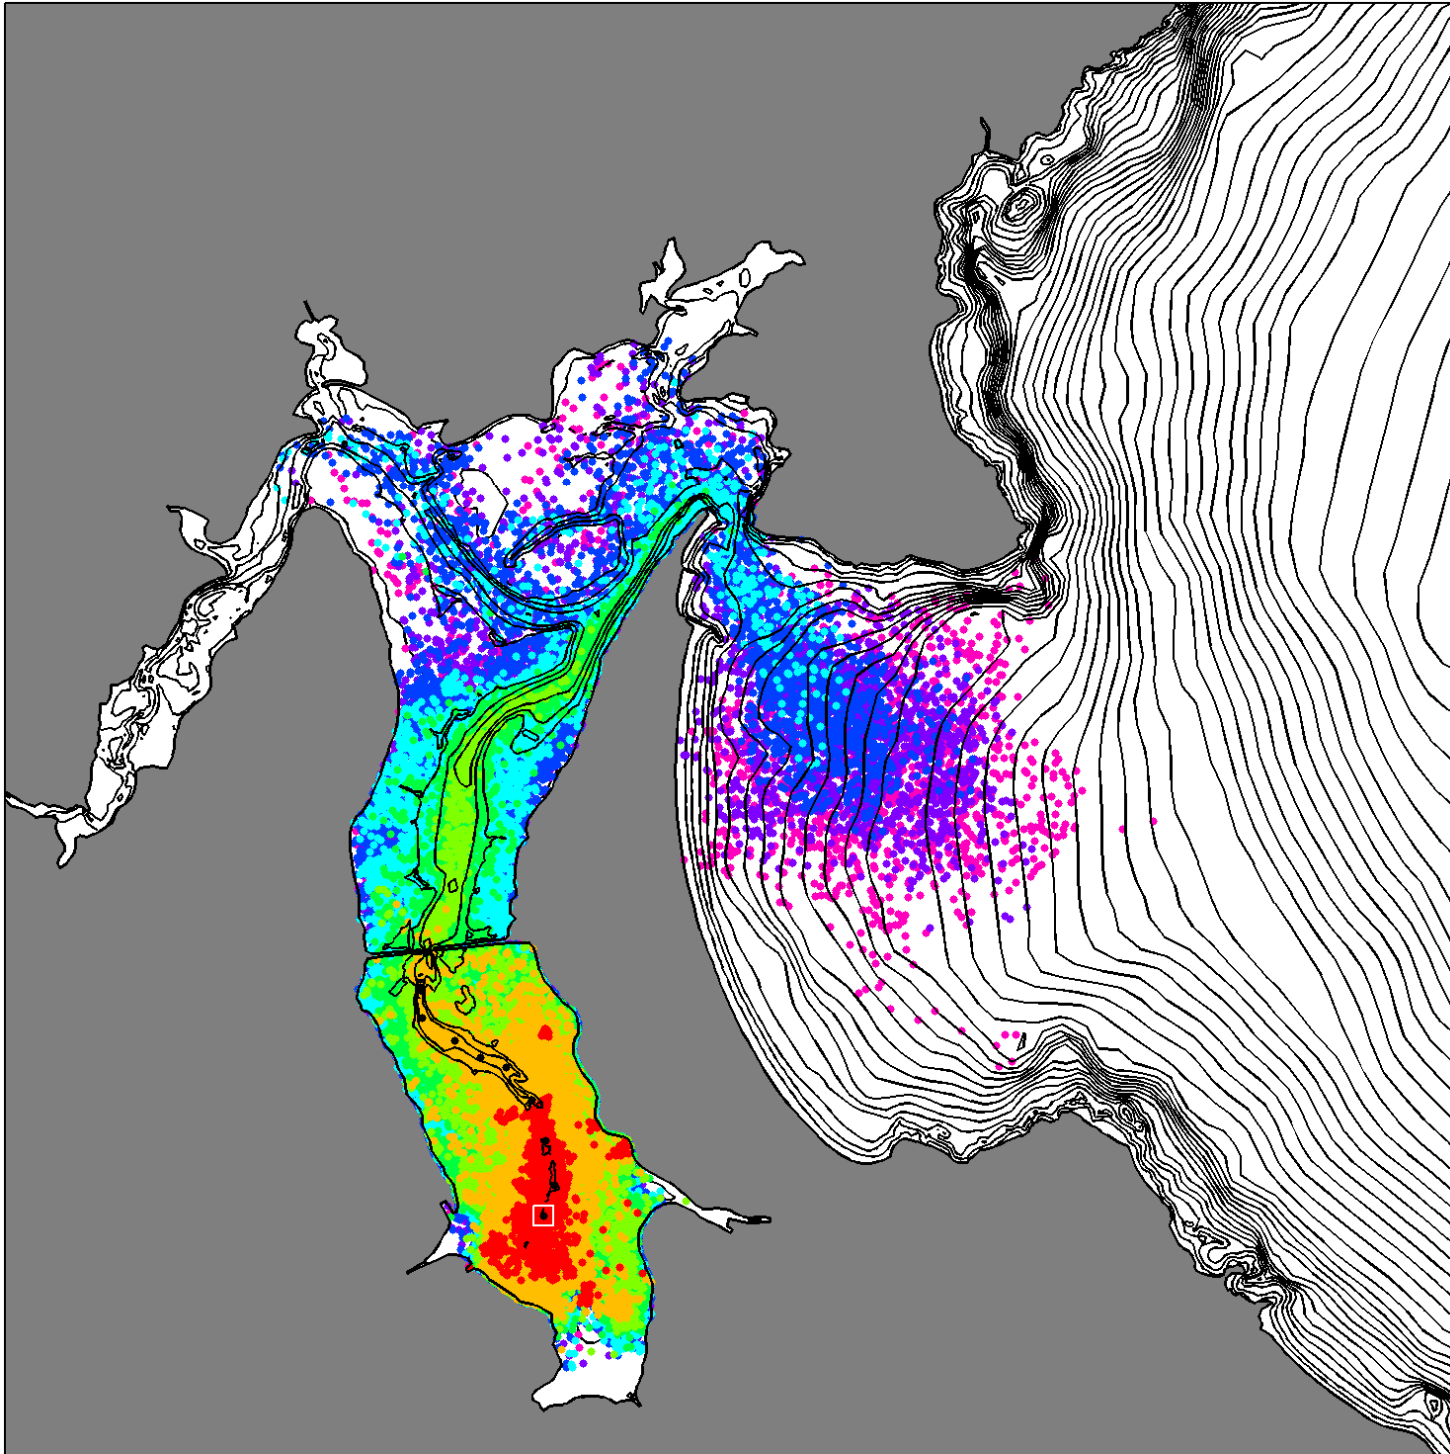
Dispersion of particles at different ages with tide and stream flows over 7 days – release from head of Arm

Red <1 hr

Purple <96 hr

- Hydrodynamic model completed
- Particles in upper Waikokopu Arm potentially take several tidal cycles to flush out of harbour
- Tidally driven dispersion depends on release site in Arm, excursions greater during spring tide
- Inclusion of stream inputs – increase flows on ebb to north and out of Harbour and reduce flows on flood phase

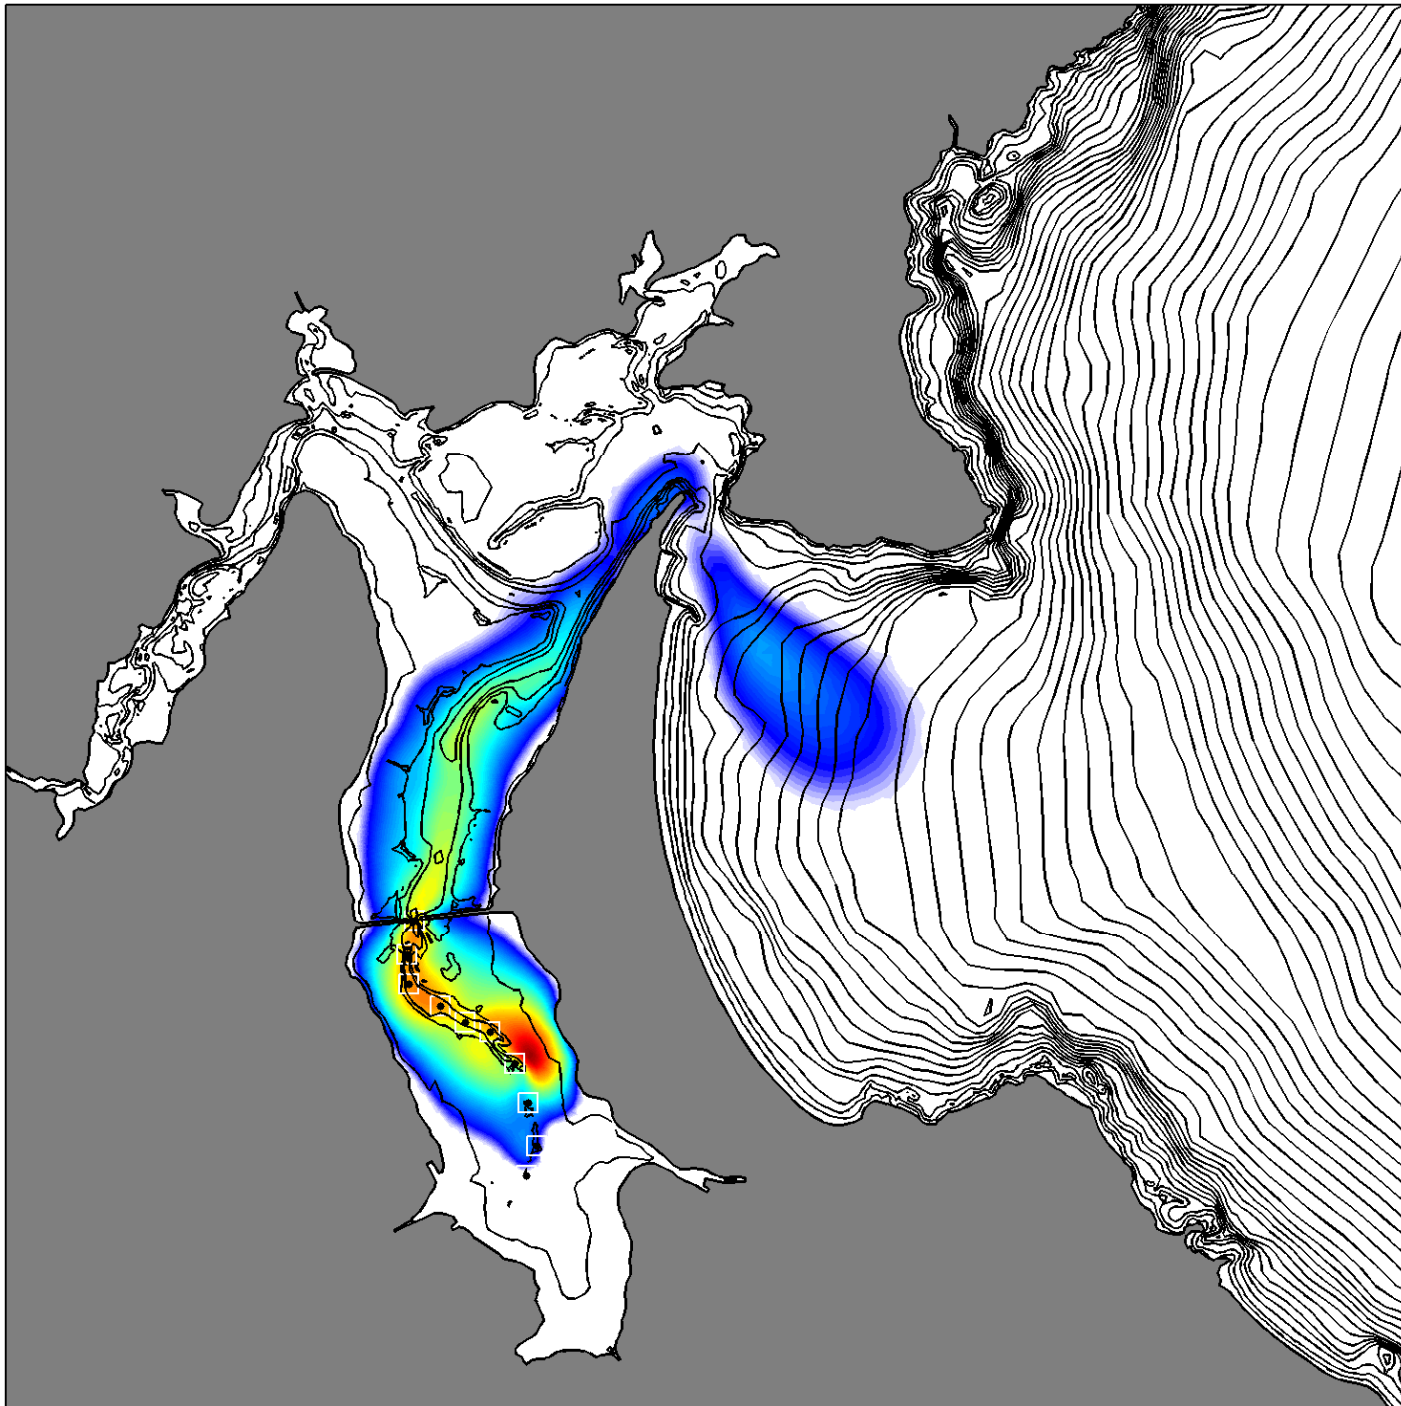
Particle concentrations  
during 7 day period

Red = 1  
Dark blue =  
significantly diluted

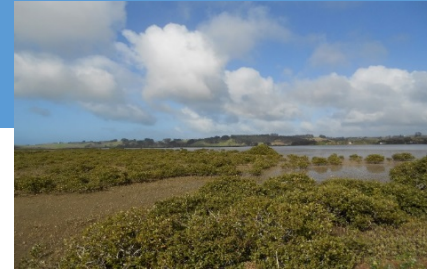
Changes in habitat and communities mapped (presented in Feb)

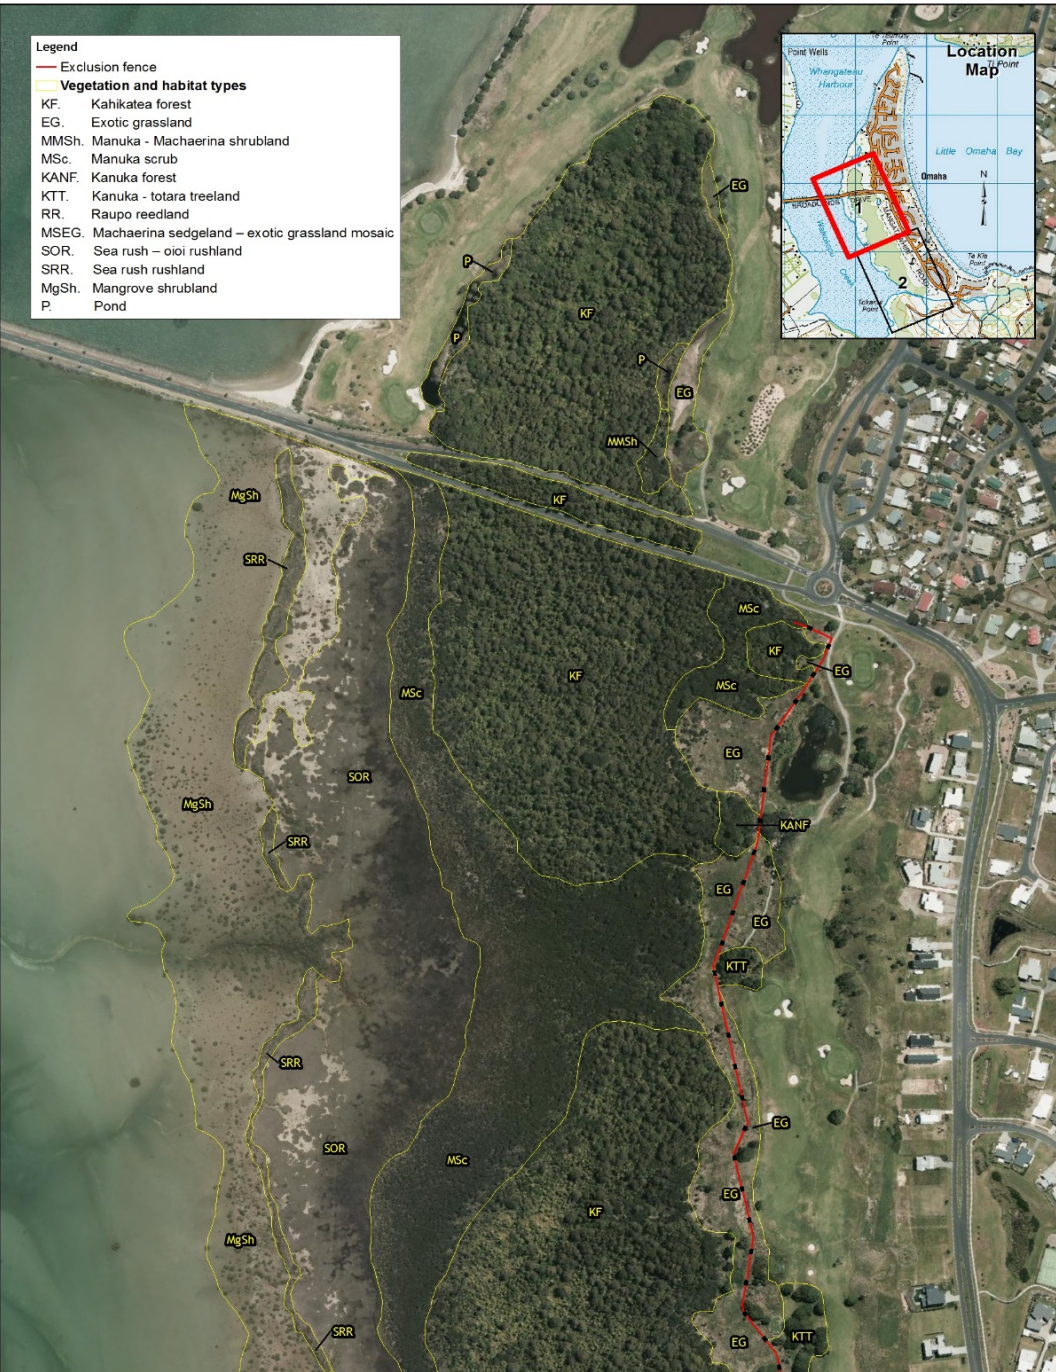
(Sheet 1 of 2)

Figure 1. Vegetation and habitat types of the receiving environment for the Omaha Wastewater Treatment Plant discharge, Omaha.

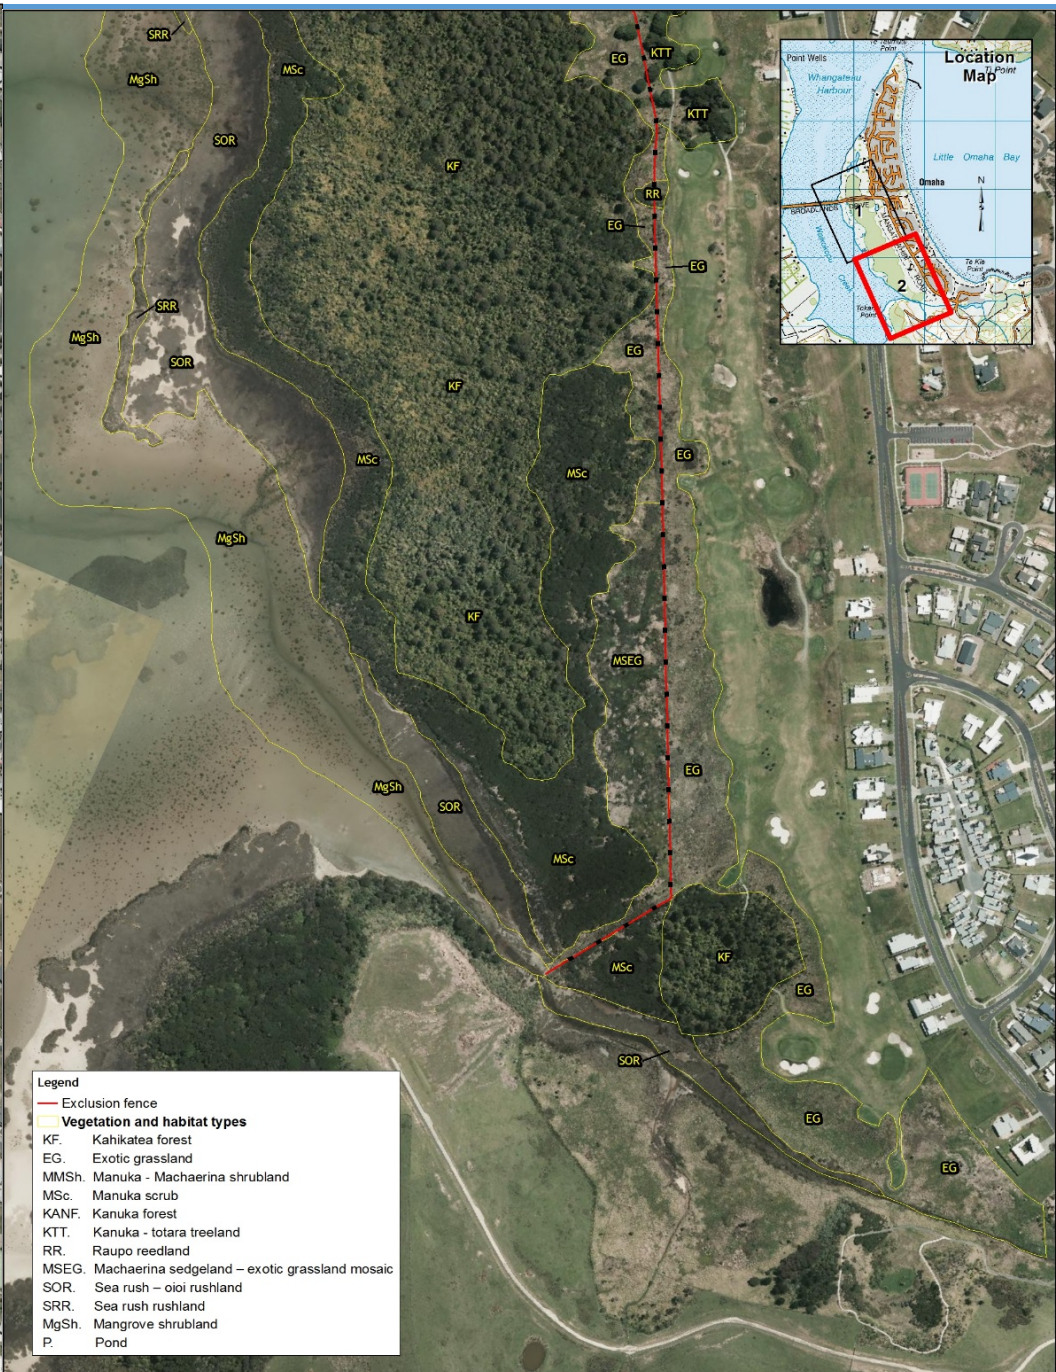
(Sheet 2 of 2)

Figure 1. Vegetation and habitat types of the receiving environment for the Omaha Wastewater Treatment Plant discharge, Omaha.

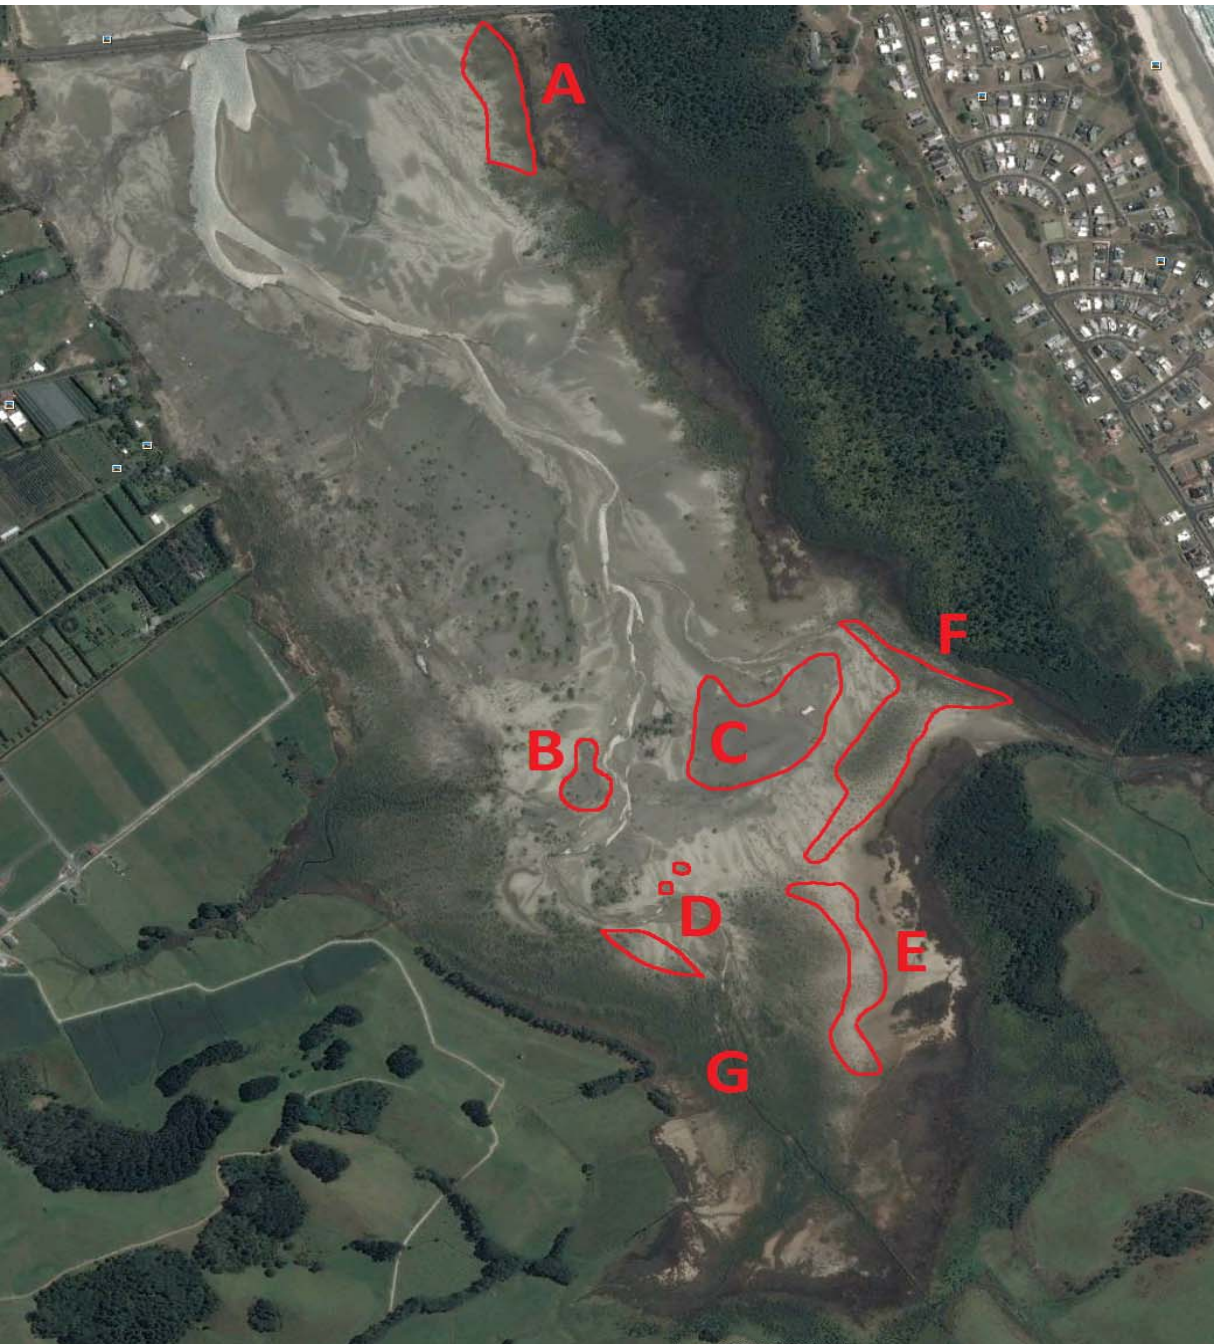
A - Backfilling by mangroves

B – Seagrass expanding northwards

C – Expansion of seagrass patches

D – Seagrass patches expanded, mangroves expanding seaward

E – Backfilling with scattered mangroves

F – Mangroves expanded

G – increase in mangroves

- Shape and extent of mangrove and seagrass patches have changed in some places
