Water quality of surface waters in Whangateau Harbour – Stage One

Prepared for Watercare Services Ltd

February 2015

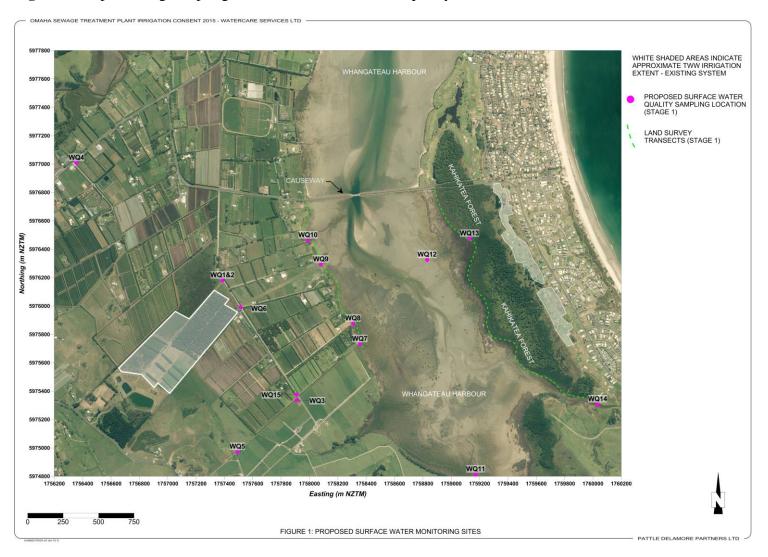
Figure 1. Map showing sampling locations for surface water quality.

- Collate, analyse, graph and report on the dataset for Ti Point (1991-) and for the causeway (since July 2014). The data is to be assessed for trophic state and comparisons made between Ti Point and the causeway to see how representative the Ti Point location is and whether there are differences in the Waikokopu Arm.
- Initiate a survey of water quality in surface drains between the irrigation areas and the Harbour to be carried out monthly monitoring. The sites to be sampled are provided in Figure 1 plus there will be a sample site at the mouth of where the Waikokopu Creek enters the Harbour.

A monthly monitoring programme has been initiated by Watercare with samples analysed using standard and accredited procedures by Watercare Laboratory Services. The sites are shown in Figure 1. Sites were selected following a site visit with the Consultative Group:

- Sites 1, 2, 6 and 15 are in the Jones Rd drain downstream of the irrigated area.
- Sites 3, 4 and 5 are control sites well away from any influence of the wastewater treatment
- Sites 7-10 are where surface waters flow into the Waikokopu Arm
- Sites 11 and 14 are major stream inputs at the head of the Arm
- Sites 12 and 13 are a stream which drains the kahikatea Forest/wetlands.
